GEOTECHNICAL ANALYSIS OF CARSINGTON DAM FAILURE

Sukiman *

Abstract

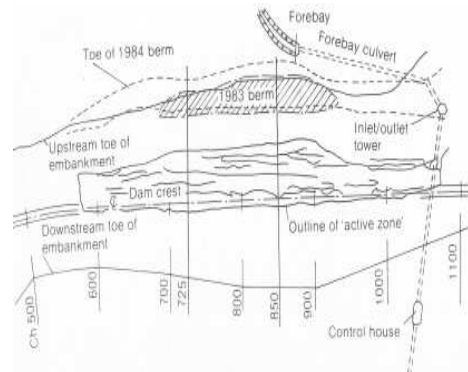
Figure 2. Failure in Carsington Dam at 8 June 1984 (chainage and elevation in meters)

Carsington Dam is located near the village of Hognaston in Derbyshire and has a maximum design height of 35 m. Plan of the Dam is presented in Fig. 1. This Dam was due to finish placing of filling material back in May 1984 when a crack was reported on the dam crest of its upstream part. This crack enlarged and had not stopped until 6 June, with the berm enlargement continued for a few more days. In chainage 675 m, the upstream toe had moved 13 m laterally and had lifted by about 2.5 m in addition of severe disruption of the upstream slope (Fig. 2).

An early exploratory trench at chainage 620 m revealed the slip plane in the base layer and gave some understanding of the distortion at the toe. Further extensive exploratory works in trenches at chainage 720 m and 825 m (Fig. 2) provided more information and allowed sampling of embankment and foundation materials. From survey and interpretation, the geometry of the failure surface was derived and is presented in Fig. 3.

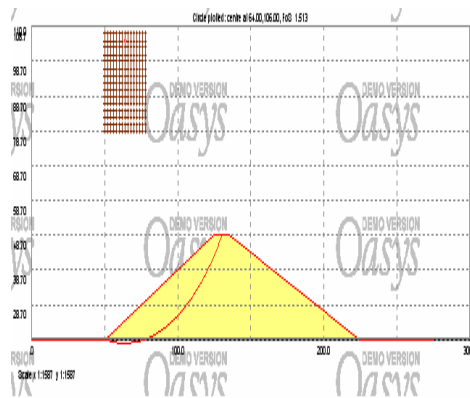
Figure 6. Graphical Output of Slope Stability Analysis (x=49m, y=20m) using **OASYS-SLOPE**

Set	r_u	common point	circle centre	FoS	Comment
1	0.2	A (49, 20)	(62, 112)	1.513	OK
		B (125, 50)	(200,122)	1.771	
	0.4	A (49, 20)	64, 108)	1.183	needs attention
		B (125, 50)	(200,120)	1.380

0.6	A (49, 20)	(66, 104)	0.855	FoS < 1, failure
		B (125, 50)	(198,114)	0.994	
2	0.2	A (49, 20)	(64, 106)	1.321	Ok
		B (125, 50)	(200,120)	1.532	
	0.4	A (49, 20)	(66, 102)	1.043	needs attention
		B (125, 50)	(198,114)	1.207

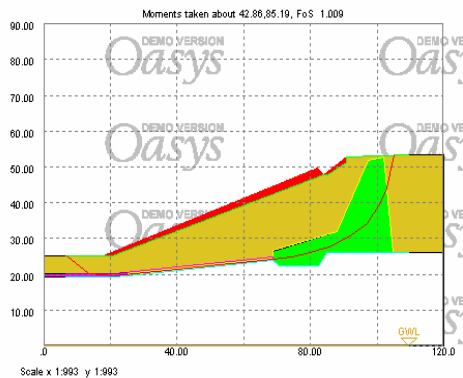
Figure 11. Input Geometry for SLOPE (failure line is highlighted red)

For this analysis, the geometry of the dam was taken from chainage 725 as presented in Fig. 4. The position of the non-circular failure surface was taken from the approximated failure line in Fig. 3. The input geometry for the SLOPE programme is presented in Fig. 11.

No.	Description	Core and Yellow Yellow Clay					Factor of Safety
		Boot		Clay 1	2		
		Φ' (°)	c' (kPa)	Φ' (°)	Φ' (°)	c' (kPa)	
1	peak values	21	15	20	20	10	1.409
2	post peak values	21	0	20	20	0	1.242
3	predicted values	17.5	0	15	20	3	1.001
4	residual values	12	0	12	12	0	0.762

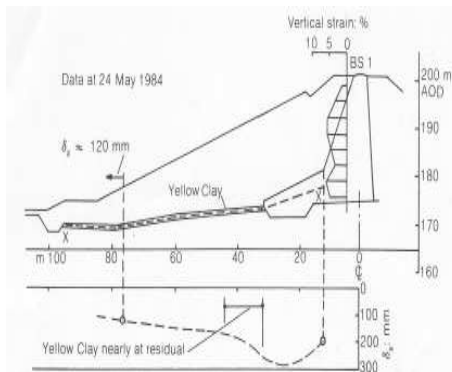
Figure 13. Horizontal movements on line XX and vertical strain in the core (chainage 725)

It is obvious that the strength of the core and boot and the yellow clay 1 are located between their post-peak and residual values and especially the yellow clay 1, it's values is located near it's residual values ($\Phi' = 12^\circ$; $c' = 0$ kPa). This characteristic is relevant to the measured condition of the dam (Fig. 13) in chainage 725 that shows the yellow clay near the boot to be nearly residual.

From this analysis, it can be concluded that the materials in the embankment dam had different conditions. In this case the core and boot material and the yellow clay material (especially near the boot) were estimated to be below their post peak values. This reduction of strength is likely to be the cause of the slope failure.
