ANALYSIS OF THE INSPECTION RESULTS ON THE PRIMARY COOLING PIPE OF RSG-GAS REACTOR

Abdul Hafid

Center for Nuclear Reactor Technology and Safety (CNRTS)-BATAN

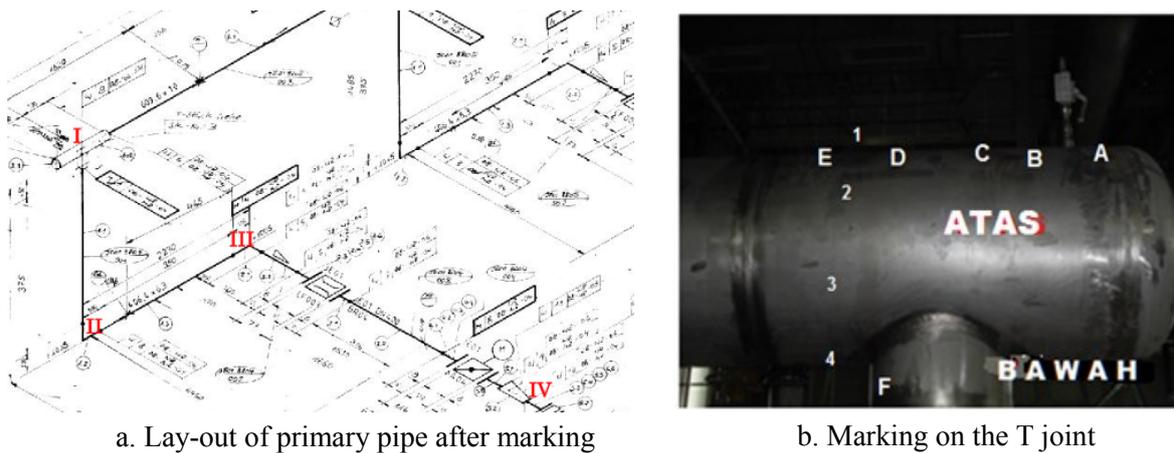
Fig. 4. The procedure for numbering the primary pipe lay out and flagging in-situ

a. Lay-out of primary pipe after marking

b. Marking on the T joint

The results of measurement conducted in 2014 at the T junction with the marking I in

Table 3 indicates that there is a difference in thickness at the pipe wall. Section A to F has differences in value of 1.53 mm, 1.48 mm, 0.13 mm, 0.21 mm, 0.12 mm, and 0.14 mm. In 2015, starting from A to F, the differen-

YEAR	Pipe Thickness Measurement Results Comparison (mm)					
	A	B	C	D	E	F
2014	9.95	9.88	9.78	9.88	9.87	6.15
2015	9.09	9.29	10.02	10.02	10.04	6.15
Differences	0.86	0.59	-0.24	-0.14	-0.17	0.0

In this section, the thinning of the pipe wall thickness are ranged from 0 to 0.13 mm. For the number 4 to 8, the depletion reached a value of 1.42 mm to 1.53 mm. Similar depletion was also found on the sign B, C, D and E with different values. This result can be considered as a depletion of non-axisymmetric way. Therefore, in the span of one year the thinning pipe corrosion due to erosion can't be ensured. At the T-junction, some values still indicated that the formed thinning is non-axisymmetric.

In addition to the T joint, the testing was also performed on the elbow section as indicated in the marking II of Figure 4a. The elbow section was chosen as the test location because the vortex water flow occurs in the elbow area. This incident causes the pipe wall thinning is faster than elsewhere. This events is also known as the flow accelerated corrosion. The data in Table 4 shows the test results in 2014, while Table 5 in 2015.

Based on the test results in Table 4, the thinning occurs also non-axisymmetrically in the region of 1 to 5. The tendency of thinning occurs on the one side of the pipe wall. Great value is measured with decimation range of 0.2 mm to 0.8 mm. The results of retesting in 2015

also showed the depletion of non-axisymmetric with wider spreads. Based on two test results, the calculation of average values shown in Table 6 indicate that the thinning process is generally very slow because the range of values only changes from 0 to 0.15 mm.

segment tested is the reducer connection as indicated in the marking IV of Figure 4a. The measurement results are shown in Table 7 and Table 8 for the year 2014 and 2015 respectively.

Table 7 shows that the thickness distribution of the pipe at each point is the same. The same thing can also be seen in Table 8, which has the same pipe thickness distribution. By comparing the both results, the differences of the thinning have average value of 0.21 mm. Therefore, the wall thickness distribution has the same nominal value or a symmetric depletion has been occurred. All the test results shows that the differences between the measured and nominal values are still very small. Therefore it

is assumed that the differences in the value of the results are simply due to the measurement uncertainty. In terms of a general trend of depletion, there are two forms of thinning occurring, which are the non-axisymmetric and axisymmetric depletion. Non-axisymmetric shape tends to occur in the area of the primary pipe upward (before) of the primary pump, while the axisymmetric shape occurs at the pipe downward (after) of the primary pump. In order to provide certainty to the thinning process at

the primary pipe of RSG-GAS, re-testing should be performed routinely every 5 years.

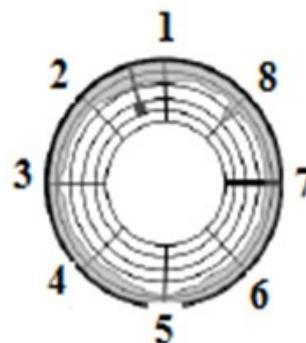
Fig. 6. Eight area measurements on primary pipe

Table 3 shows that the apparent differences in the rotational direction of the thickness of the pipe at number 1 position between A and B was 0.05 mm, then between A and C was 0.06 mm and the biggest difference is between E and B, around 1.51 mm. If the marking is more detailed at any point of testing as shown in Figure 6, the area numbered 1 to 3 are marked A at the T joint.
