Structural Geology Analysis In A Disaster-Prone Of Slope Failure, Merangin Village, Kuok District, Kampar Regency, Riau Province

The geological disaster of landslide has occurred in Merangin Village, Kuok Subdistrict, Kampar Regency, Riau Province which located exactly in the national road of Riau - West Sumatra at Km 91. Based on the occurrence of landslide, this research was conducted to study geological structure and engineering geology to determine the main factors causing landslides. Based on measurement of the structural geology found on research area, there were fractures, faults and fold rocks which having trend of stress N 2380 E, plunge 60, trending NE-SW direction. Several faults that found was normal faults directing N 2000 E with dip 200 trending from northeast-southwest and reverse fault impinging N 550 E with dip 550, pitch 200 trending to the northeast. Fold structures showing azimuth N 2010 E trending southeast-northwest. From geological engineering analysis, the results of scan line at 6 sites that have RQD value ranges 9.4% - 78.7 % with discontinuity spacing 4 - 20 cm. So, It can be concluded that the formed structure was influenced by the extensive northeast-s

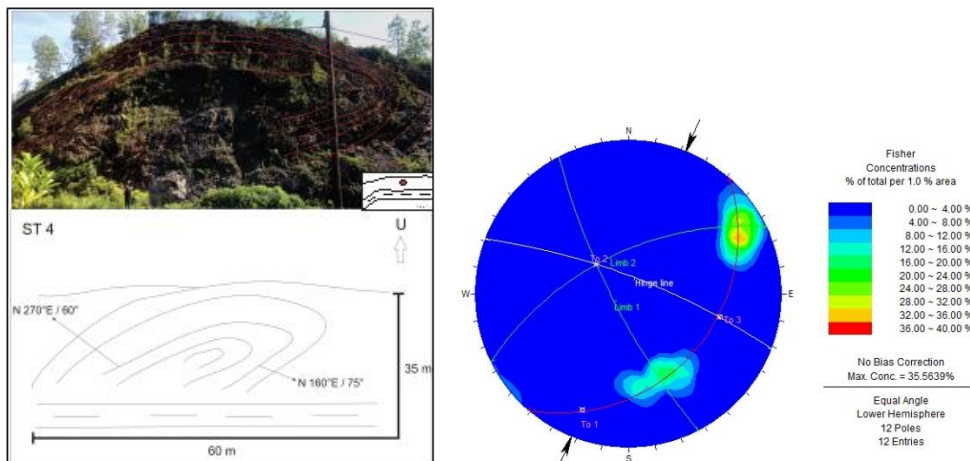
Fold structures that had been found in the study area were classified into type of recumbent fold and symmetrical fold of interbedded sandstone-claystone (Fig. 2). The stress consists of $\delta 1$ N 222°E with 30° plunges, $\delta 2$ N322°E with plunge 17° and $\delta 3$ N76°E with plunge 55° (Fig. 2).

The lithology of this folds was consist of sandstone what has grey colour, non-calcareous, fracture filled by quartz veins and metasediment of claystone. Low metamorphism process had been shown in the outcrop by the presence of foliation, so this outcrop was called meta-sedimentary rock. So based on the analysis, this folded structure interpreted caused by a compression on northeast-southwest direction.

Fig 2. Fold structure ST 6 at research location (left) and stereographic analysis of fold structure (right)

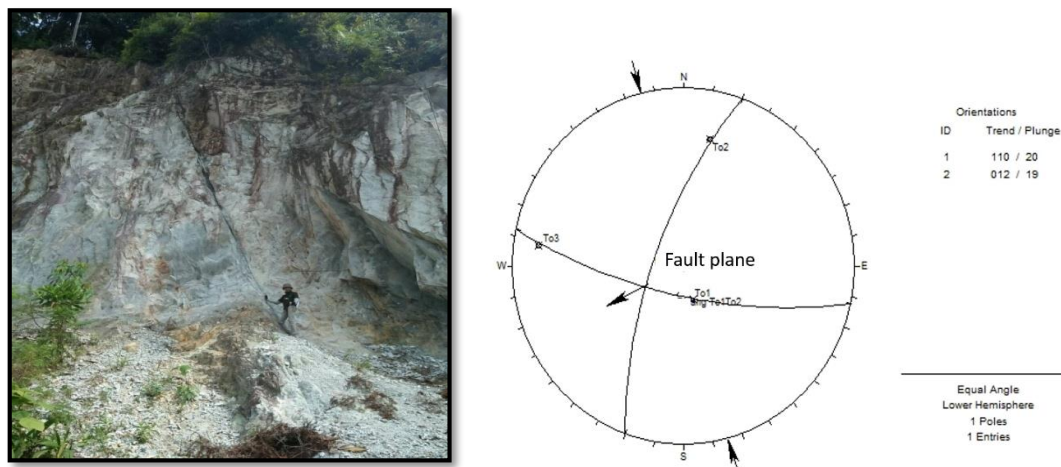
Fault structure happens on Lithology pebble claystone, it was indicated by weak zone and slickenside. Slickenside shows the fault plane in N290°E/70° with 70° pitch and southwest movement direction. Analysis of stereographic projection showing the stress direction of normal fault is in northwest-southeast (Fig. 3). The stress value of the fault gives $\delta 1$ in N52°E direction with 68° plunges, $\delta 2$ in N207°E direction with 20° plunges and $\delta 3$ in N299°E with 10° plunges.

Fig 3. Fault structure in ST 7 at research location classified as normal fault (Left) and Stereonet analysis of normal fault structure (Right)

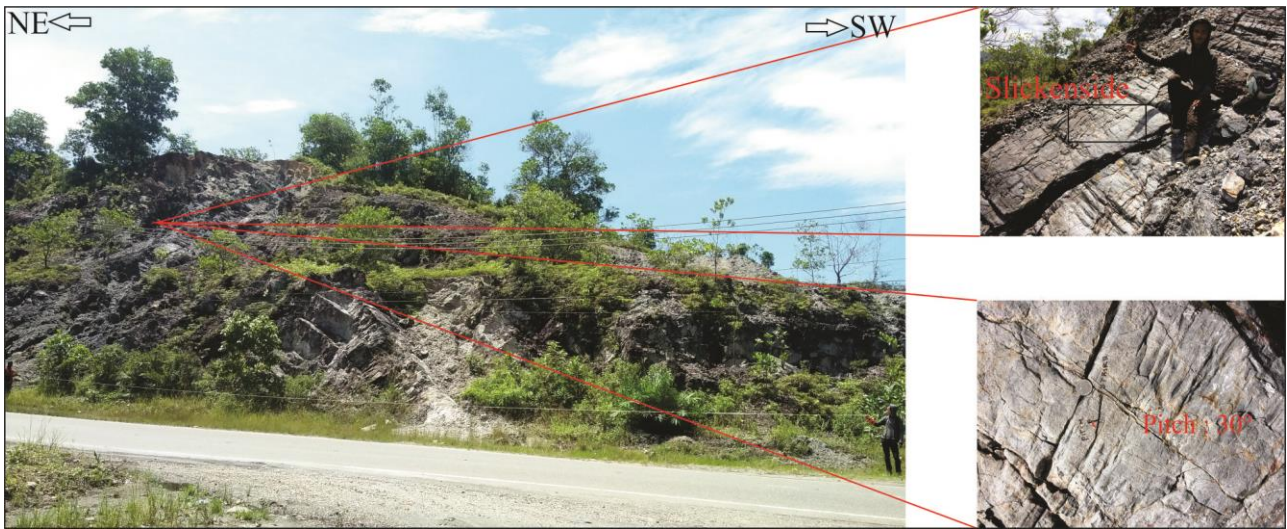
The other fault system was a reverse fault in station 1, having length size 55 m and 22 m high, which consist of greywacke, low metamorphic sandstone, phyllite, conglomerate, quartzite and mylonite. From the measurement, it has indicated that this fault has azimuth value of 140° E/ 45°, pitch 30° and trend N 330° SE directing northwest. Therefore, the stress resulting $\delta 1$ trending and classified as right - reverse fault in ST 1, its called Gulamo Right – Reverse Fault. (Fig. 4).

Fig 4. Reverse fault in ST 1 on research location.

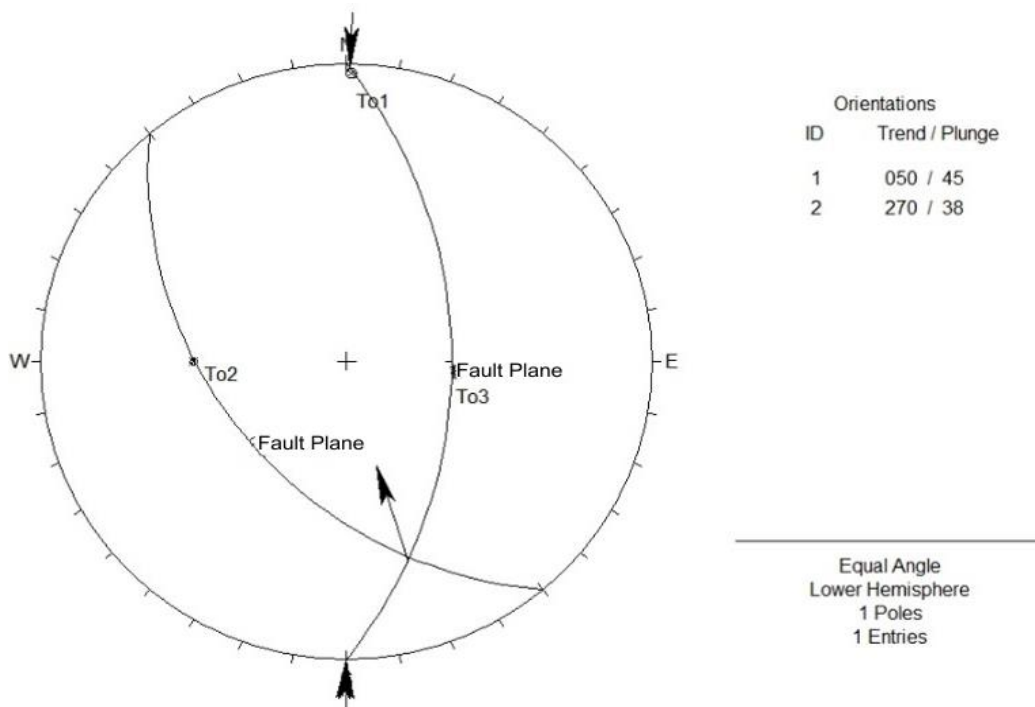
Fig 5. Stereographic analysis of reverse fault at research location.

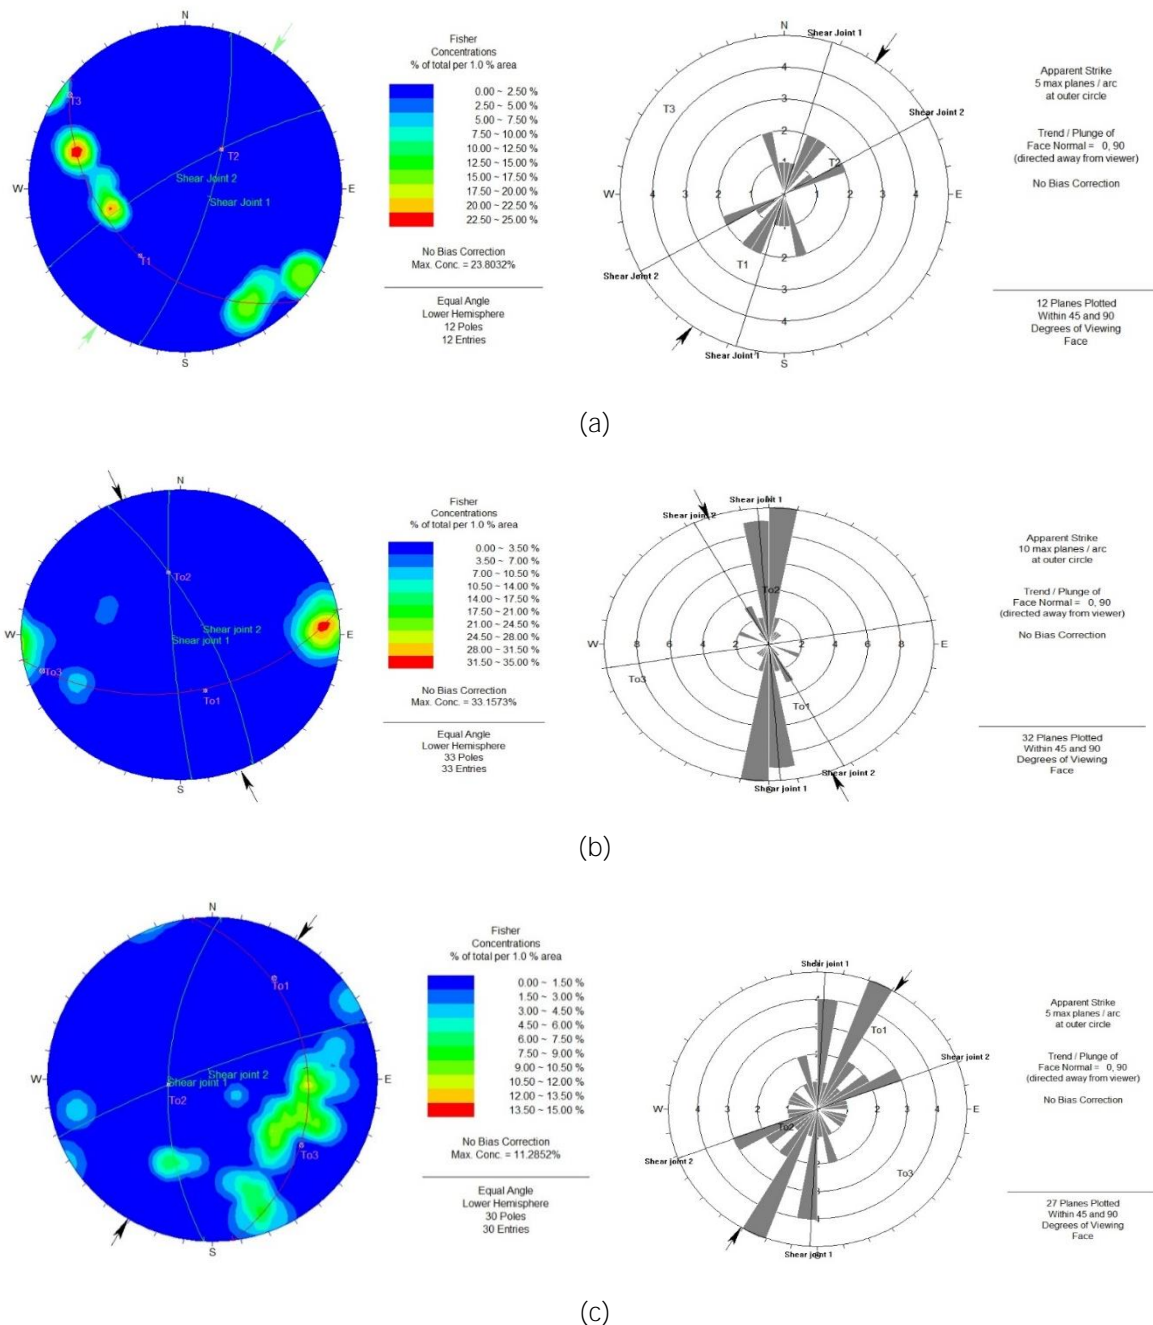
There are 9 (nine) sites of fractures structure (location 1, 3, 8, 9, 10, 12, 13, 14 and 15) shows a similar stress direction in northeast-southwest (Fig 6.). The stress in Station 1 consists of δ_1 in N238°E direction with 6° plunges, δ_2 in N344°E direction with 43° plunges and δ_3 in N142°E with 6° plunges. The stress in Station 5 consists of δ_1 in N3°E direction with 3° plunges, δ_2 in N184°E direction with 4° plunges and δ_3 in N193°E

with 3° plunges. The stress in Station 12 consist of δ_1 in N30°E direction with 19° plunges, δ_2 in N263°E direction with 59° plunges and δ_3 in N127°E with 22° plunge.

Fig. 6. Fracture structure analysis in at location (a) ST 1, (b) ST 8, and (c) ST 12.
