Rapid Visual Screening of Building for Potential Ground Movement in Kalirejo, Kulonprogo, Yogyakarta

Sely Novita Sari^{1*}, Rizqi Prastowo², Rahmad Junaidi³, Amir Machmud⁴

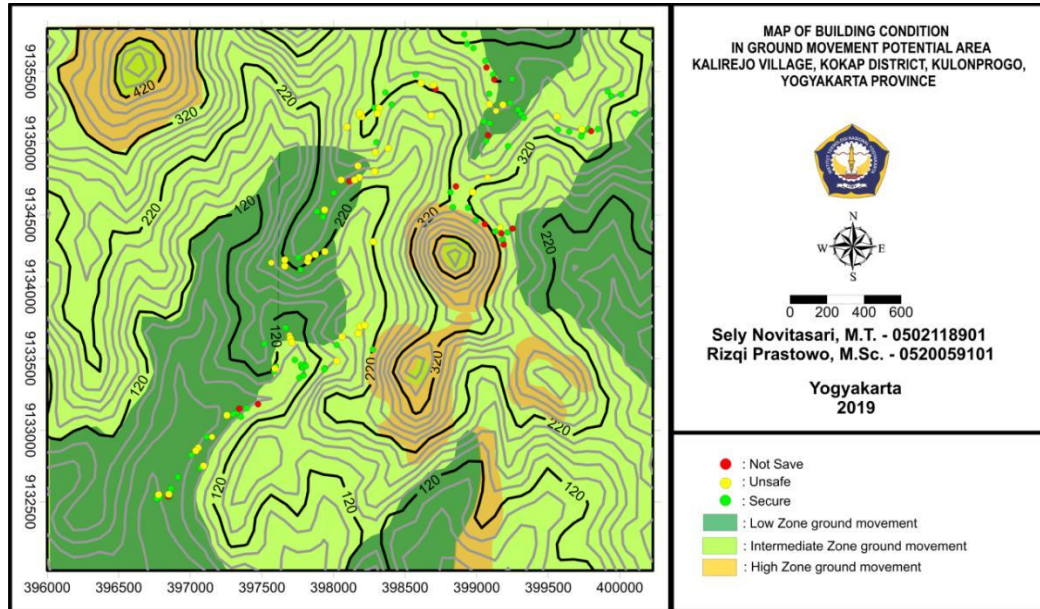
Figure 3. Map of Building Condition of Sample Site at Kokap District, Yogyakarta, Indonesia

The survey was carried out following the agreed coordinates with the reference coordinates using a map of potential building strength in the Kalirejo area, as shown in Figure 3. The surveyor started building appraisal by filling out a simple building appraisal form following the coordinates agreed upon previously (Sjaifuddin et al., 2019). How to analyze it by looking at the answer Yes with a value of 1, the answer Less with a value of 0.5, and the answer is not the value of 0.

The results of the calculation of the building score (Table 2) obtained the value of the condition of the entire building that has been surveyed. In table 2 is a recapitulation of building score results (and the coordinates of his home field) from the evaluation of

simple buildings in the four hamlets in the Kalirejo area. Building conditions are obtained by following the conditions index scale according to table 1 and giving color to each building category. Green color for safe building conditions with building conditions

index value is 70-100%, yellow for unsafe building conditions with building condition index values 40-69%, and red for unsafe

building conditions with building condition index values 0-39 %. Building classification in the form of color can be seen in figure 3.
