2499-Monitoring of Substructure Building of Suramadu Bridge Causeway Segment on Surabaya Side Based on Corrosion Level

Monitoring of Substructure Building of Suramadu Bridge Causeway Segment on Surabaya Side Based on Corrosion Level

A. Setijorini¹, A. Ratnaningsih^{2*}, Krisnamurti³

^{1,2*,3} Civil Engineering Department, University of Jember

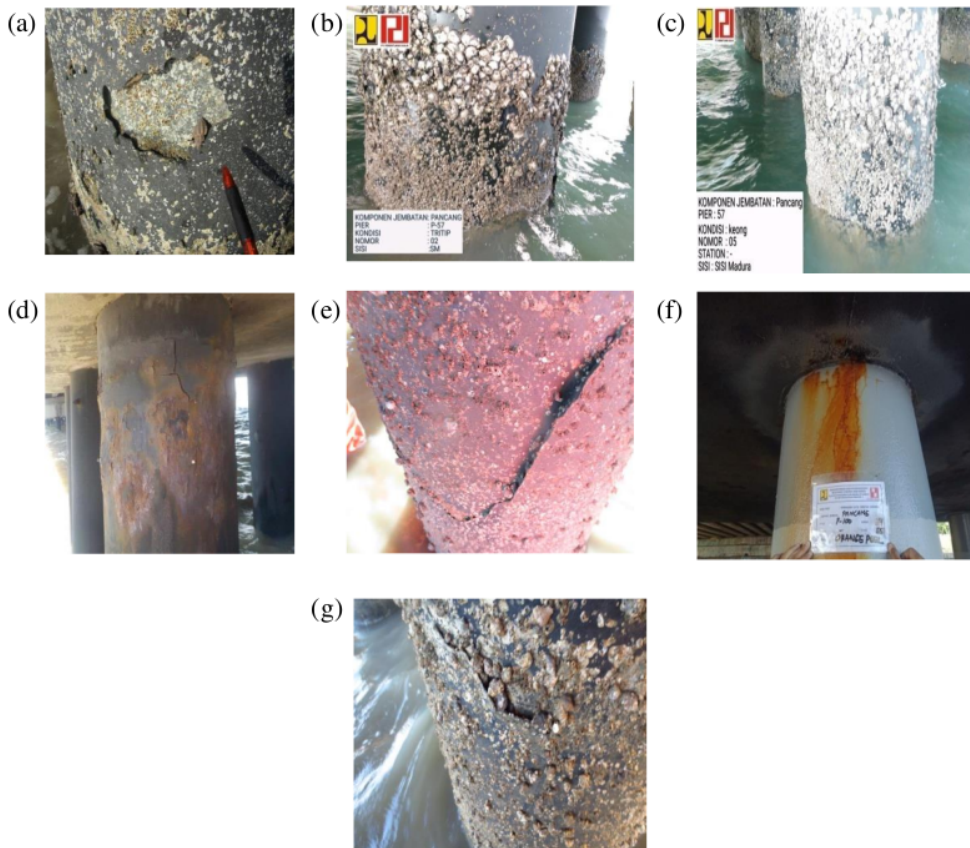
Figure 4 (a) C-005 Metal Expose (b) C-008 Biofouling Tritip (c) C-009 Biofouling Keong (d) C-014 Blistering (e) C-016 Pin Holes (f) C-018 Orange Peel (g) C-020 Chalking Erosion

From **Figure 4(a)**, it can be seen that the damage to the piles with the type of damage to hollow iron and concrete is visible. The damage occurred to 488 piles. **Figure 4(b)** pile damage with the type of damage: many tritip organisms are attached to the pile. The damage occurred in 1580 piles. **Figure 4(c)** damage to the pile with the type of damage, there are many snails attached to the pile, the damage occurred on 234 piles. **Figure 4(d)** pile damage with

rust-type peeling/bubbling coating damage occurred on 150 piles. **Figure 4(e)** damage to piles with the type of damage to iron, torn piles the damage occurred to 72 piles. **Figure 4(f)** damage to piles with the type of damage to iron, corrosion, brownish-orange color, the damage occurred in 72 piles of 403 piles. **Figure 4(g)** damage to piles with the type of damage to the iron piles eroded due to tripping. The damage occurred to 24 piles. The above conditions mainly occur in the Splash Zone area (tidal area and areas affected by seawater splashes) at an elevation of -1.60 m to +1.90 m).

In general, the results of observations of the condition of the piles on the pile are filled with marine life in the tidal area, while for areas that have never been submerged in seawater, the condition is quite good. The splash zone is the area with the highest corrosion level, which occurs because the splash zone area is exposed to alternating currents between wet and dry continuously. In addition, the level of abrasion in this zone is quite high, so a strong protective layer is needed. The existence of damage to the protective layer (coating), both light and heavy, has not disrupted the integrity of the pile. However, the risk of increasing disturbance acceleration is expected to be very fast if corrective action is not taken. For the splash zone, disturbances of marine biota, namely tritip and snails, are identified. The activity of taking tritip by fishers with tools and boat collisions can damage the coating. From the inspection results on the components of the steel pile foundation, it can be categorized as a top priority recommendation to immediately get treatment because the damage is already at level-3 (bad condition) and level-4 (dangerous condition).

From the Figure above, the length of the steel pile coating with a thickness of 2000 microns is 6.0 meters long for the topmost connection (below the bottom pile cap) for the Causeway on the Surabaya side 600 mm (ABT-0 s/d P-36), for the Causeway side Madura 1000 mm (P-57 to P-68) and 600 mm (P-69 to ABT-102). To increase the coating thickness from 500 ~ 700 microns to 2000 microns, it is carried out at the stockyard on land before the steel piles are delivered to the piling location. For steel piles, the handling method is as follows:

- a. Under the Atmospheric Zone pile cap area with a length of 0.65 m from an elevation of +2.55 m to an elevation of +1.90 m, a 2000 micron thick glass flake coating is applied.

- b. Meanwhile, for the Splash Zone area, Jacketing HDPE (Sea Shield Series 200 DM) is carried out with a length of 3.50 m from an elevation of +1.90 m to an elevation of – 1.60 m,
- c. And for the Embedded Zone area, installation/replacement of the Sacrificial Anode is still carried out below the elevation – 1.60 m for 120 Kg (pole 600 mm) and 190 Kg (pole 1000 mm).

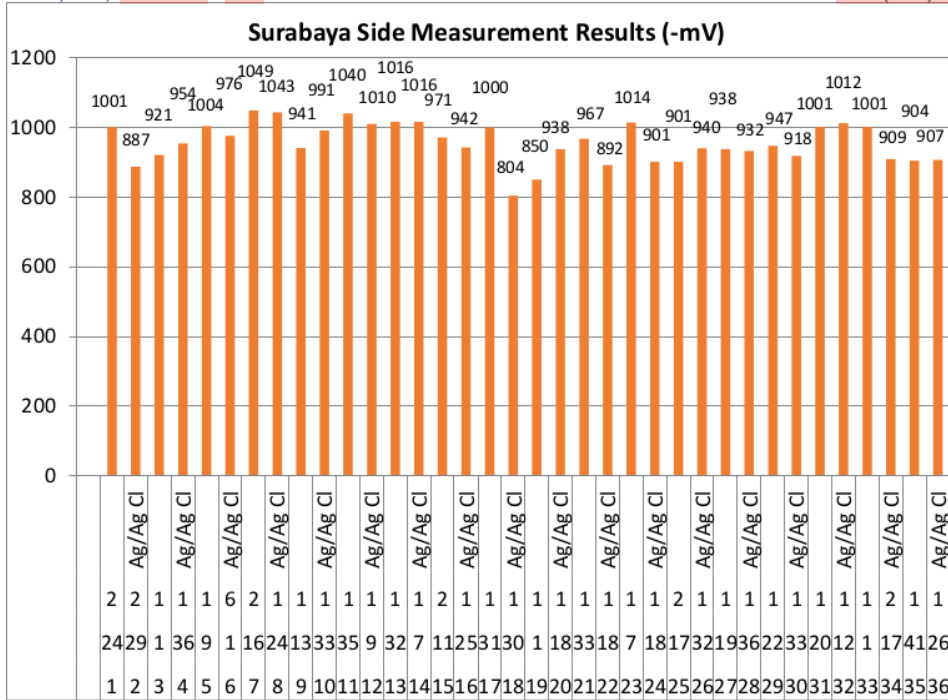
Figure 5. Bar chart of the potential measurement results for the Cathodic Protection Causeway area on the Surabaya side

Based on the graph of the measurement results in the Causeway area on the Surabaya side, there is 1 (one) pier that is on the threshold of protection, namely pier-18. Several other piers approaching the protection threshold value and need to be considered more intensively include pier-19, pier-22, pier-24, and pier-25. With details of P-18 all piles no.1 to no.36, P-19 piles no. 1, 2, 3, 9, 10, 11, 12, 14, 16, 17, 18, 19, 20, 21, 23, 33, P-22 pile no. 20, P-24 pile no. 18 and P.25 pile no.1. So for the Causeway on the Surabaya side, there is a replacement of 120 Kg Cathodic Protection (poles 600 mm) = 55 pcs.

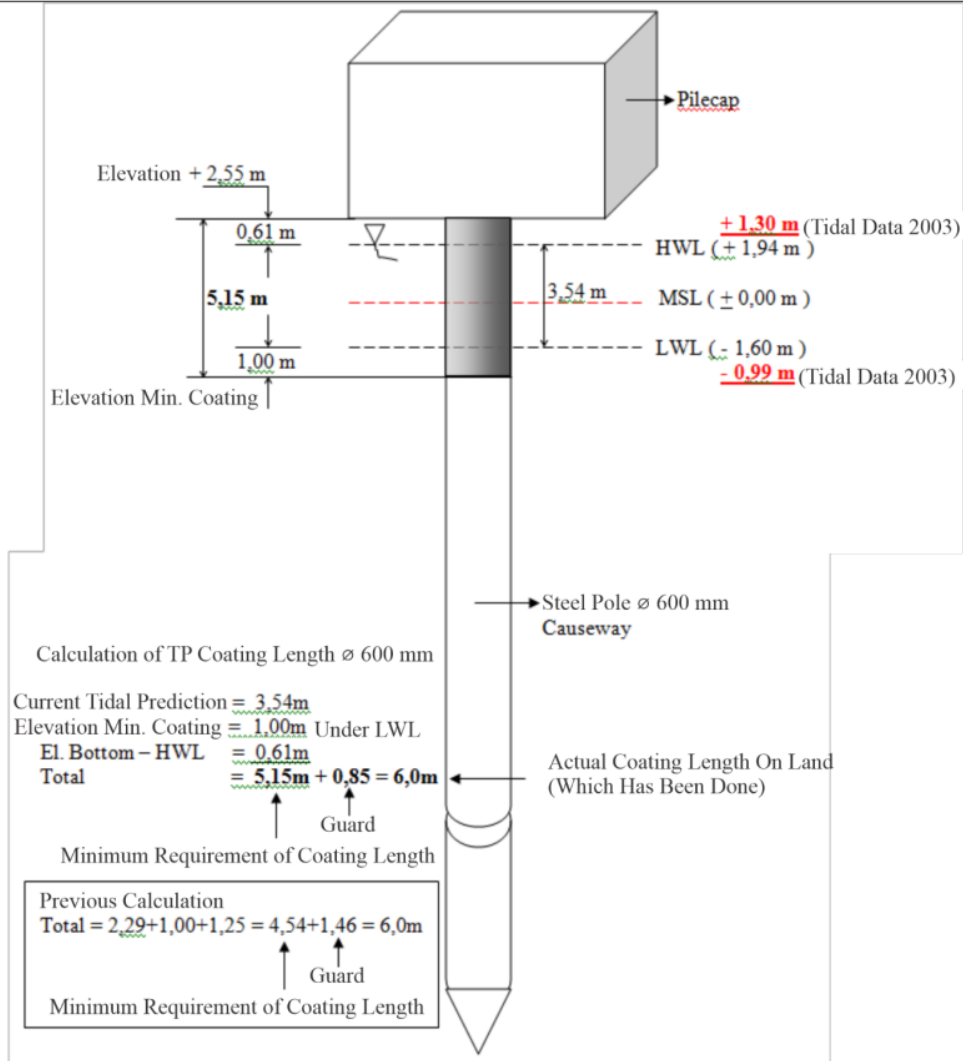
Figure 6. Details of the calculation of the need for coating on the pile
