Failure Analysis at Stem Valve Fire Hydrant in LNG Plant

Abstract- Hydrant is one of fire extinguisher fix system that use pressure water and flowed through the pipes and fire hose. There are more 250 Hydrant in this LNG Plant and based on finding at the field, many stem valve of outlet hydrant in fracture condition, therefore the author wants to analyze about the problem from this material, this reserch aims to find out root cause dan conduct failure analysis, method of reserch that conducted is visual check to predict possible cause from failure of stem valve fire hydrant and then conducted fractographic analysis to find out what type of fracture that happen to this material and Tensile Strenght Test to Find out the the actual strenght of the material.

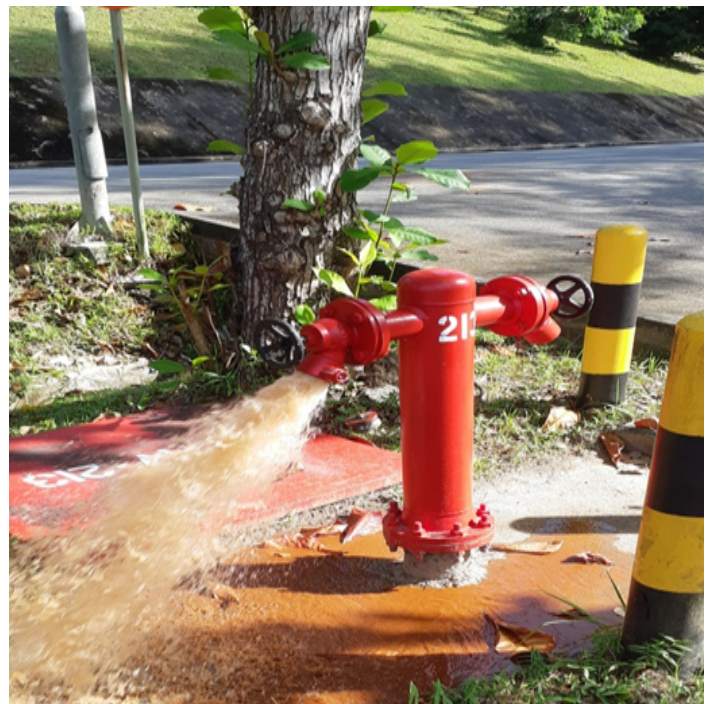
Figure 1. Flushing hydrant

hydrant activity, with that schedule, cycle for open and close the outlet valve definitely occur. with that high intensity, stem valve of fire hydrant usually experience a fatigue condition, and from that condition many founded stem valve of outlet hydrant has a fracture condition [1].

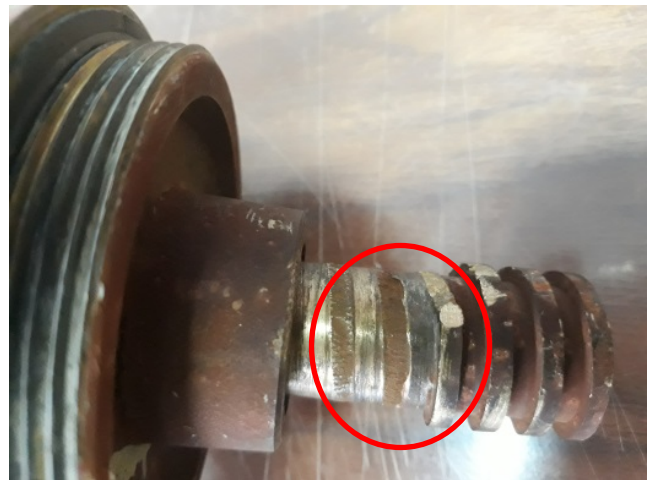
Figure 5. Fracture at Thread of Stem Valve

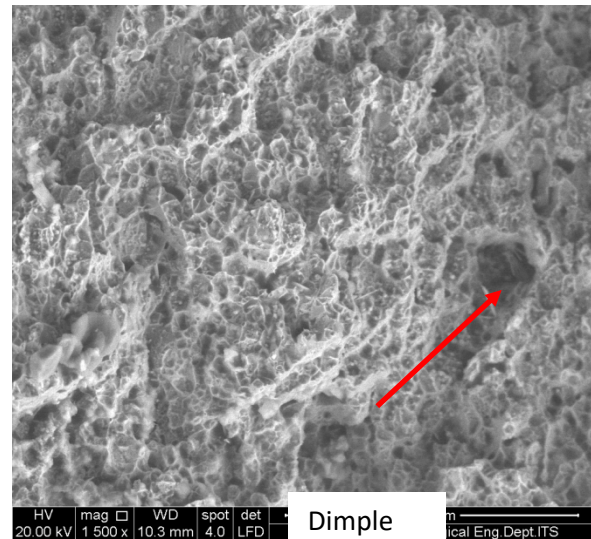
The research was done by Scanning Elecron Mycroscopy at Material Engineering Material Characterization Division ITS Surabaya, observation was conducted in the inner section of the thread, and on the threaded cross section with magnification until 1500 times, so that it can be observed the root cause of the fracture.

Figure 6. SEM Test

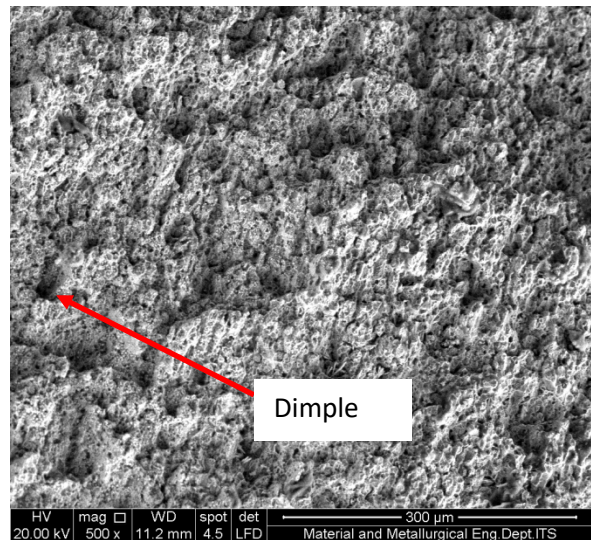
Figure 7. Dimples on the Face of Fracture

Although it is not specific to measure grain size changes, it can be ascertained that there is a change in grain size, it is known from the results of SEM (Scanning electron Microscopy) testing that there are Microvoids or Dimples which indicate that Shear Over Stress results in changes in grain size.

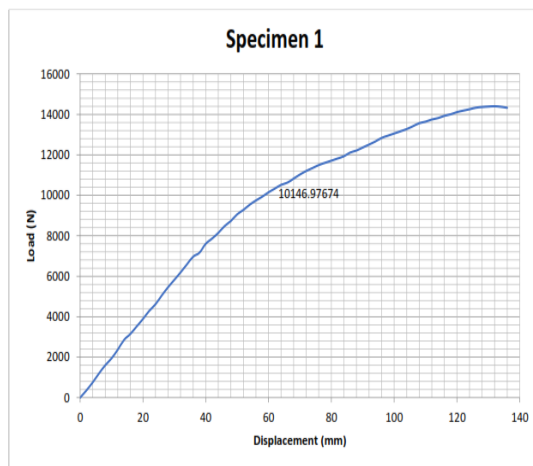
Figure 9. Graphic Tensile Test Specimen 1

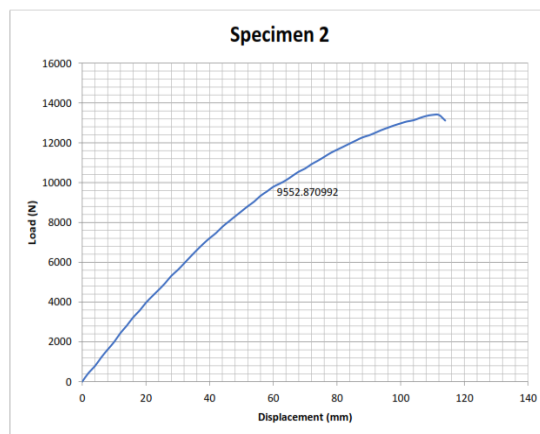
Figure 10. Graphic Tensile Test Specimen 2

From the data, it can be seen that there is difference between the stem valve which has been broken with the new stem valve, this show that there has been decrease in tensile strenght at the material [4].

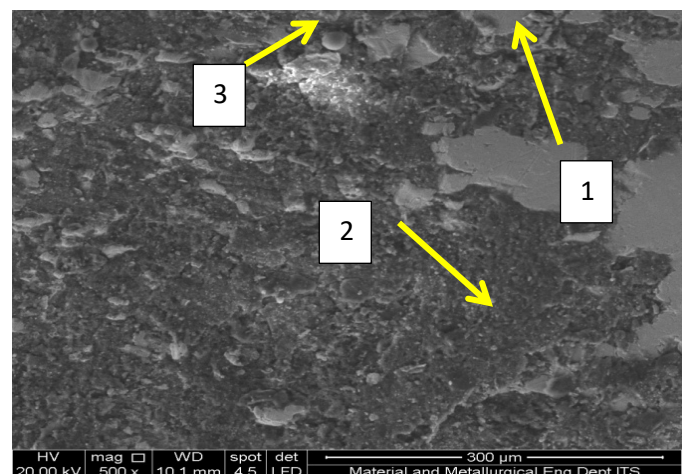
Figure 11. Special sign for stress corrosion cracking

Special sign:

1. The intergranular path of the basic fault shown, appears to be an irregular fracture display
2. Multiple secondary intergranular cracking
3. Corrosion products that appear on the surface

From the characteristics contained in the SEM test results it can be said that Stress Corrosion Cracking occurs in the Stem Valve Fire Hydrant material.

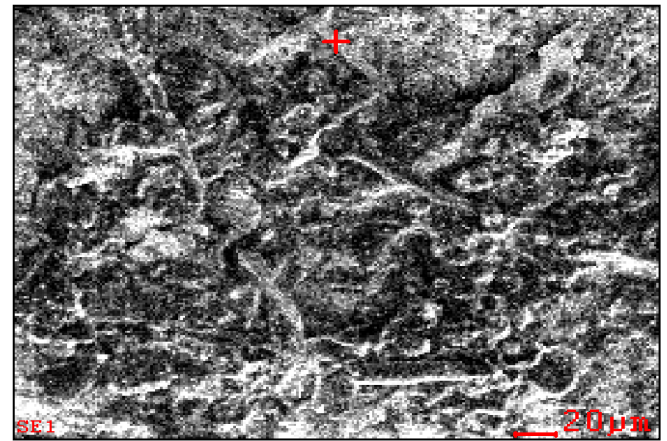
At the sampling point at the other fault location it was also read that there was a high enough carbon content, in many literature it was also mentioned that one of the most found Impurities caused by Corrosion Cracking was carbon and sulfur content following SEM and EDX data at the other fault location:

Figure 12. SEM test result at another location

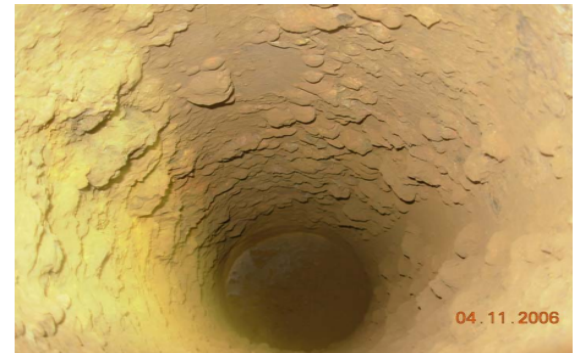
From the EDX test data, it was found that the oxygen content in the Crack area is quite high, where oxygen is one of the elements that can cause Corrosion in Copper Alloy Materials, besides that there is also Fe content on the Crack surface which is one of the elements that can cause corrosion. And from all the elements detected there is a fairly high carbon element thought to originate from erosion in the internal Fire Water pipe, the carbon element was one of the biggest contributors as Impurities [3].

Figure 13. Internal surface condition of fire pipe
