Geological Aspect of Slope Failure and Mitigation Approach in Bireun - Takengon Main Road, Aceh Province, Indonesia

Abstract – A soil and rock slope assessment survey was conducted along Bireun – Takengon main road in Aceh Province, Indonesia. The slope assessment survey was carried out to determine the geological condition, verify and identify the potential areas of slope failure and to study what type of slope stability and protection method could be applied to the road. Several research methodologies were conducted in the field such as rock and soil identification, and slope assessment. The survey was conducted in four selected areas along Bireun – Takengon main road. In study area I, soil creep occurred because of a presence of montmorillonite clay. The mitigation methods to reduce soil creeping in this area are building a retaining wall and pile. The shotcrete, wire mesh, net rock bolting, and rock removal method is suitable to apply in study area II. The shotcrete and soil nails were used because the type of rocks in those areas is sedimentary rock such as shale, sandstone, siltstone, and a boulder of a volcanic rock. The same approach shall be applied in study area IV. stud

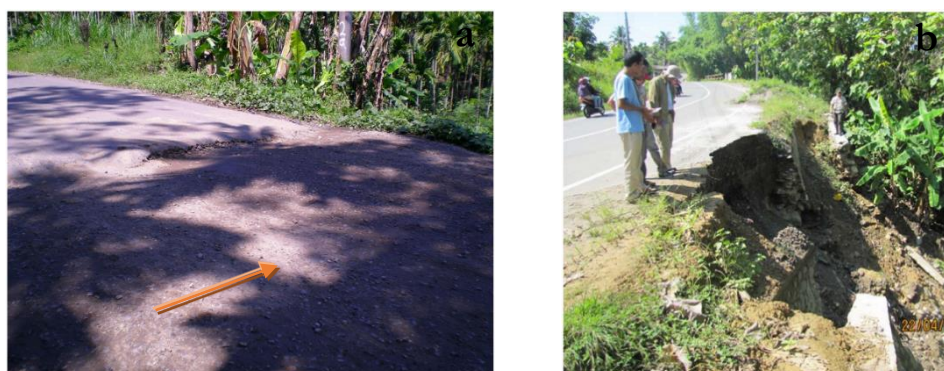
Figure 3. (a) Swelling clay cause soil creeping on the road, and (b) Swelling clay destroy the retaining wall in the Juli Sub – District

The type of landslide on this site is soil creep because of montmorillonite clay present in the subsurface of the road. The montmorillonite is a swelling clay. When it is in contact or saturated with water, the volume of clay will increase about 39% (Aksu et. al, 2015). In this case, the road was constructed, when the montmorillonite clay was saturated with water and in swelling condition. In the dry season, the groundwater decreased, and the volume of montmorillonite clay will shrink and collapse the road (Figure 3). The annual cycle of wetting and drying seasons in the tropical climate causes swelling and shrinking of montmorillonite clay each year.

In addition, the geological map of the Lhokseumawe quadrangle showed the geological structures in this area such as faults and folds. Fold axes have a general north – south directions. An east-west orientated fault indicates a right-lateral strike slip fault (dextral) with the offset being visible along the cut fold axis. The fault has a younger age compared to the fold (Syncline) because it was offset by the fault. Folds and faults are characteristic of a weak zone with the possibility of water saturating the surface layers of soil and rock or soil moving on the sliding plane.

The step of mitigation it takes to reduce soil creeping is to build a retaining wall and pile. The foundation of those buildings shall be constructed beneath the zone of water content fluctuation. The reason is two-fold: the first way is to provide for sufficient skin friction adhesion below the area of drying. The second way is to resist upward movement when the surface soils become wet and begins to swell. Another way of mitigating swelling clay problems is to collect surface runoff and to limit surface infiltration (Roger, 1993).

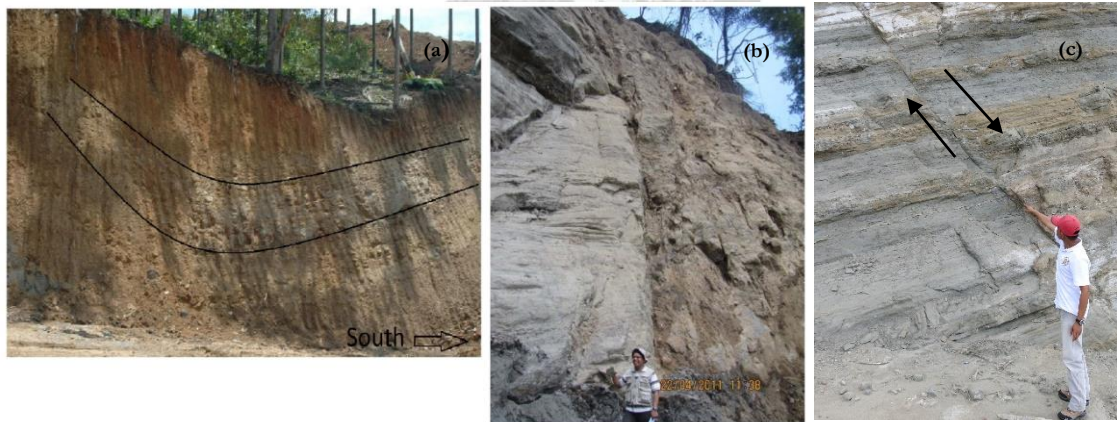
Case study II was conducted in Bireun district of Aceh province and is commonly named Cot Panglima. The type of rock in this location is sedimentary rock; shale, sandstone, siltstone and a boulder of a volcanic rock. Geology and geological structural settings of slopes are the main predisposing factors controlling the mass movement development (Fookes and Wilson, 1966; Varnes, 1978). The strike of sedimentary rock layers in this location is parallel to the line of the road. This condition will increase the possibility of sliding and toppling landslides. Even though this area is far away from the Sumatra Fault Zone (SFZ), in some adjacent area we discovered synclines – and anticlines with north/ south orientation. Joints were also found in several areas, and it indicate an active land movement area with a high risk of landslide. Figure 4 shows the fold (Syncline/anticline), joint and normal fault in Cot Panglima road slope.

Highly jointed or fractured rock of the slopes with principal joints and fracture surfaces parallel to or dipping with the slope provide low mechanical support to overlying materials. It creates avenues for concentrated subsurface water movement. Jointing also provides avenues for deep penetration of surface and ground water (Swanston and Howes, 2001).

Figure 4. Geological Structure in Cot Panglima. a) Syncline, b) Joint, c) Normal Fault

Because of the sedimentary rock type in this location, suitable slope protection and stability can be provided by shotcrete, wire mesh, net rock bolting and rock removal in several areas. On some slopes, the hanging rock/soil shall be removed and re-profiled. To reduce the risk of the existing slopes, the drainage on the slopes shall be steep enough to avoid water ponding and also to prevent infiltration of ponded water that increase the pore water pressure. It is also recommended that any cracks at the top of the slope be sealed with grout or asphalt (West T.R, 2007). Another method which could possibly be applied in this zone is

biotechnical slope protection approaches. Biotechnical slope protection can be implemented on the slope. This method consists of two types, biotechnical stabilization and soil bioengineering stabilization. Both of which entail the use of live materials, particular vegetation (Gray and Sotir, 1996 in Schuster *et al.*, 2004).

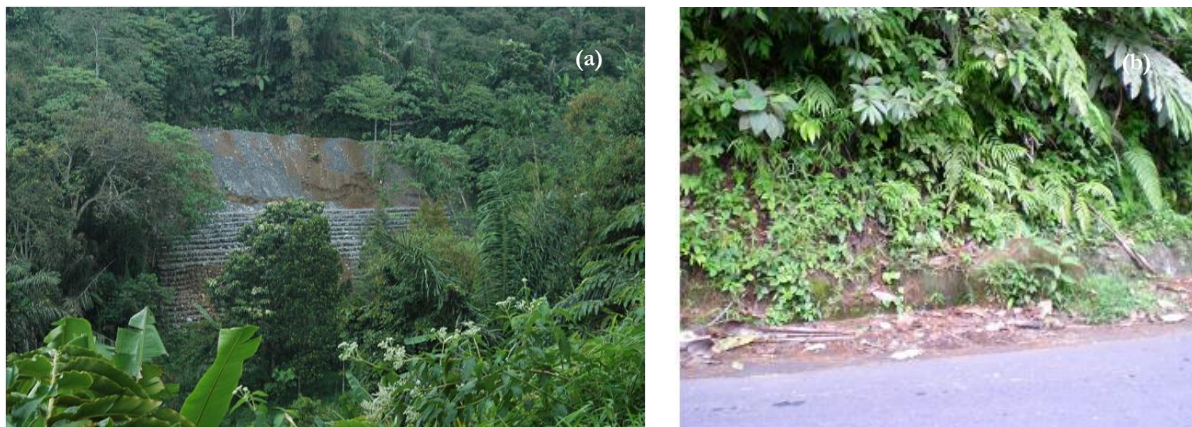
Figure 5. (a) The gabion and (b) Drainages built to prevent slope failure.

Mitigation and prevention efforts will be implemented on this side. The slope is very steep, but the government has constructed retaining walls and a gabion to withstand the slope failure. At the footstep of the slopes, there are drainage channels which very useful to keep the roads from being inundated and control runoff (Figure 5). High vegetation cover in this area can also function as a binder of the soil and the rock. Vegetation cover influences the amount and intensity of rainfall reaching the surface, the quantity of water stored in the overburden, and the strength developed along a potential failure surface. Root systems of trees and other vegetation may increase the shear strength of unstable overburden by anchoring through the mass into fractures in bedrock. It will provide continuous long-fiber binders within the overburden (a fiber

reinforcing effect) and tying the slope together across zones of weakness or instability (Swanston and Howes, 2001).

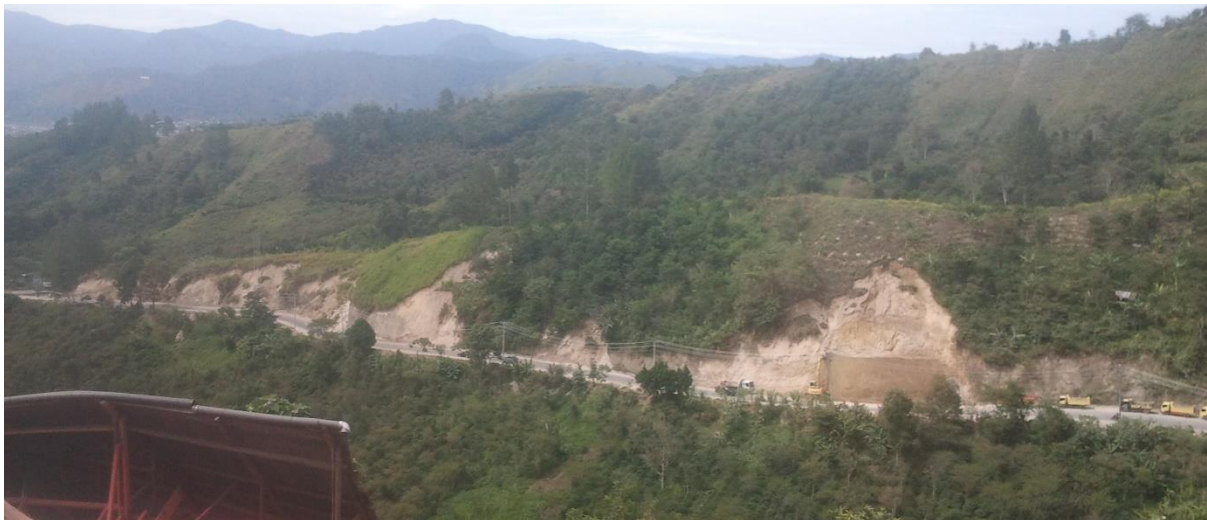
In July 2nd, 2012, several landslides occurred in this area due to a 6.1 Mw earthquake (Figure 7). Keefer, D.K (1984) noted that, in 40 historical worldwide earthquakes, there were fourteen types of landslides. The most common type of landslide due to seismic activities are rock falls, disrupted soil slides, and rock slides(?). In this case with very loose pyroclastic sediment exposed, debris avalanches dominated the area. Slope angle is a primary factor of stability at these sites. Slopes at or above the internal friction angle of the overburden material indicate a highly unstable natural state even in the absence of excess water (Swanston and Howes, 2001).

Figure 7. Landslide/slope failure along The Study area due to July 2nd, 2012 earthquake

The mitigation measures that can be applied in this area are, shotcrete, soil nails, re-profiling and trimming. Shotcrete and soil nails can be used in this study area due to the loose pyroclastic sediment. Shotcrete is a slope surface protection method to prevent the rainfall infiltrating the slope and soil nails can be used to support contact between soil and shotcrete (Abramson *et al.*, 2002). If shotcrete and soil nail protection are not possible, re-profiling and trimming are the appropriate methods. Re-profiling is the re-design of a slope to determine a height and inclination that is economical and that will remain stable for a reasonable lifetime.
