## Evaluation Of Life Safety Equipment At Kmp. Powder On A Cross Hunimua-Waipirit In Central Maluku District Maluku Province

*The Hunimua-Waipirit crossing route connects Ambon Island with West Seram Island in the travel time of 1.5 hours and on this route there is a KMP. Terubuk with the life safety equipment that is not in accordance with the rules regarding conditions and numbers. Inadequate equipment in the form of lifeboats, lifejackets, lifebuoys, and need the maintenance on the liferaft.*

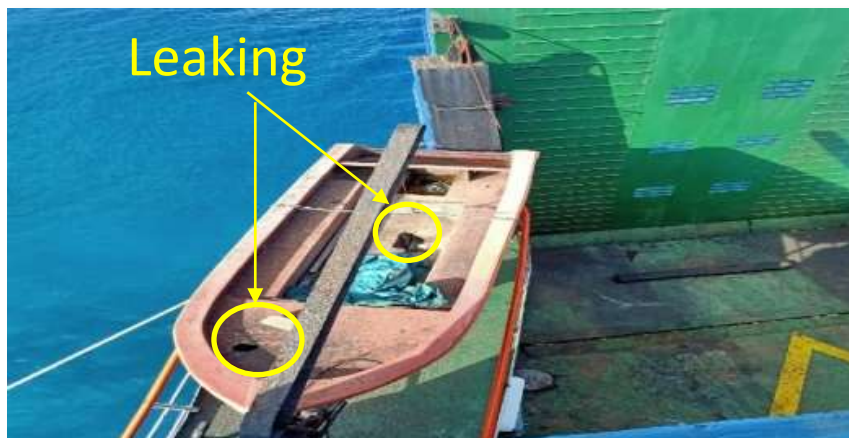
Regulation of the Director General of Sea Transportation No: UM.008 / 9/20 / DJPL - 12	KMP. Terubuk	Information
a. Must be completed with 1 savior bag.	Has been equipped with 1 savior savior which has: <ul style="list-style-type: none"> <li>a. Length 4 M</li> <li>b. Width 1.5</li> <li>c. Capacity 6 people</li> <li>d. Dewi - dewi 1 unit with sling needs to be replaced</li> </ul>	In terms of the number of lifeboats KMP.terubuk has met the applicable regulations but the conditions of the existing lifeboats the state is leaking

Figure 1. Lifeboat Condition

The number of KMP lifeboats. Already in accordance with the applicable rules, but related to the condition of the lifeboat, it was not in accordance with the applicable regulations.

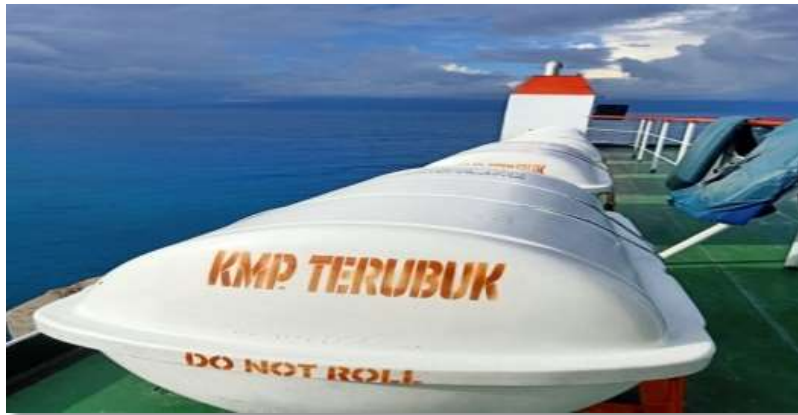
b. Equipped with a category C Inflatable Life Raft that meets the requirements of the Indonesian Flag Non-Convention Vessels Standard Chapter IV Section 6 clause 6.3.1 with a capacity of not less than 125% of the total number of sailors	<ul style="list-style-type: none"> <li>a. Bloating Relief Raft at KMP. Terubuk totaling 13 units with a capacity of 25 people / unit.</li> <li>b. Liferaft equipped with hydrostatic discharge device</li> <li>c. Rescue rafts were placed on both sides of the ship</li> </ul>	Has met the applicable regulations

Figure 2. Condition of the Liferaft

Condition and number of liferaft equipment at KMP. Already in accordance with the rules and the auxiliary tool of the liferaft in the form of a hydrostatic release device, it is according to the rules.

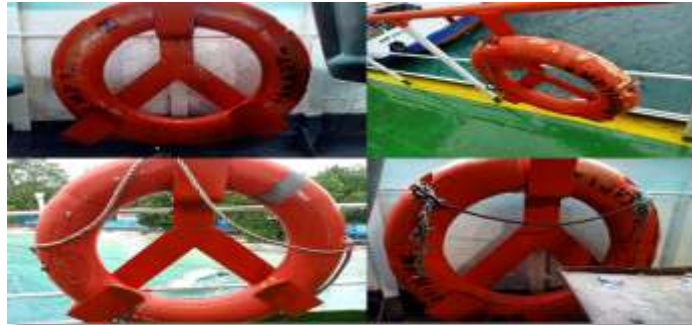
Regulation of the Director General of Sea Transportation No: UM.008 / 9/20 / DJPL - 12	KMP. TERUBUK	information
a. Must be equipped with 6 life buoy units with 4 of the total life buoys equipped with self-lit lights and 2 units equipped with a floating rope.	It has been equipped with 10 auxiliary buoys but not equipped with floating ropes and lights.	Do not comply with applicable regulations
b. Rescuers that meet the requirements of the Indonesian Flag Non-Convention Vessels Standard Chapter IV Section 9.1	The conditions of the helper buoys at KMP. Terubuk are: <ul style="list-style-type: none"> <li>a. Color no striking</li> <li>b. Ropes already rotten</li> <li>c. Not given a reflective material</li> <li>d. The letter of writing the name of the ship and the port of registration is not clearly written</li> </ul>	Do not comply with applicable regulations

Based on the Regulation of the Director General of Sea Transportation No: UM.008 / 9/20 / DJPL - 12 Chapter IV in Article 80 that the lifebuoy at KMP.Terubuk does not comply with the applicable regulations both in terms of quantity and conditions.

Figure 3. Lifebuoy condition

The condition of the helper buoy at KMP. Terubuk is not in accordance with the applicable regulations because Lifebuoy is not equipped with a floating rope, striking colors are the name of the ship and the port of registration.

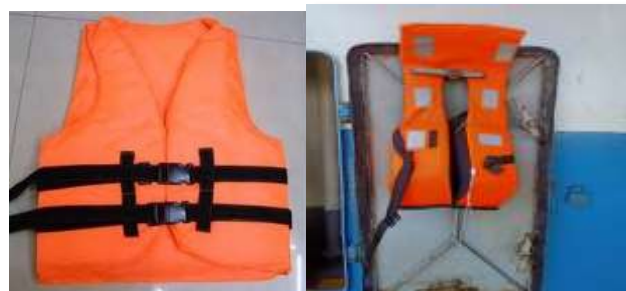
Regulation of the Director General of Sea Transportation No: UM.008 / 9/20 / DJPL - 12	KMP. TERUBUK	Information
b. Helmet category A that meets the requirements of the Indonesian Flag Non-Convention Ship Standard Chapter IV Section 10 equipped with lights, whistles and light-reflecting ribbons	Helper clothes at KMP.Terumbuk a. Not equipped with lights b. Not marked on the clothes of the helper c. Equipped with a whistle. d. Adult lifejacket is not equipped with reflective tape e. Kids Lifejacket comes with reflective tape	The condition of the auxiliary clothes at KMP.Terubuk did not meet the applicable regulations

From the results of the data analysis above, the number of adult Life jacket still does not meet related to the number and the child Lifejacket has met the requirements related to the number and both lifejackets still have not met the requirements related to the conditions regulated by the Regulation of the Director General of Sea Transportation No: UM.008 / 9/20 / DJPL - 12 Chapter IV in Article 80.

Figure 4. Lifejacket condition

2) Condition of life jacket in KMP. Terubuk is poorly maintained.
