Assessing the Spatial-Temporal Land use Change and Encroachment Activities Due to Flood Hazard in North Coast of Central Java, Indonesia

Abstract Demak is known as the second largest region suffering land use change in Java's North Coast. The topographic condition in downstream affects this area becomes susceptible with flood hazard. This research aims to assess the interactions between flooding, land use change and encroachment activities in Mijen and Wedung sub districts, Demak region, Central Java, Indonesia. This research combines the Driving Force, Pressure, State, Impact and Response (DPSIR) analysis. The supervised classification by Maximum Likelihood of time series Landsat images (2000, 2009 and 2014) was chosen for land cover analysis. The land use change shows that paddy field area descended almost 6%, mangrove forest fall 79% meanwhile settlement grown up almost double in 2000-2014. The result of overall accuracy assessment is 78.23%. The DPSIR result shows that land use change not too affect the flood events but floods influence land use pattern in north and south area of Mijen and Wedung.

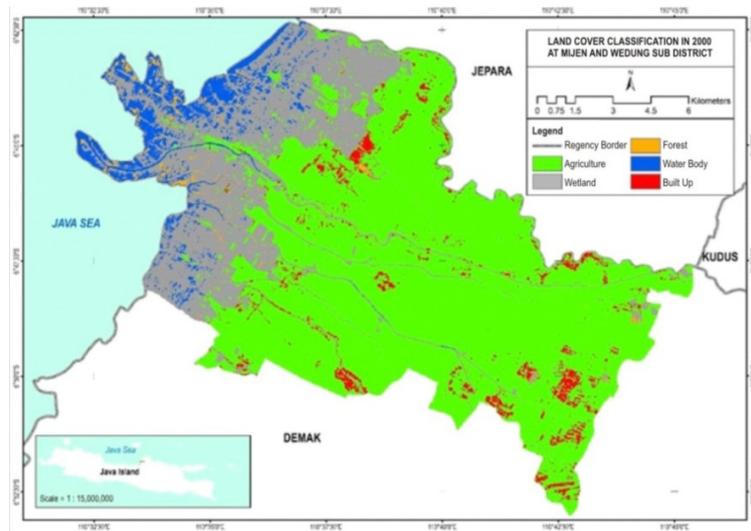
Figure 1. Map of Land Cover at Mijen and Wedung Sub District at 2000.

This research defined five land cover classes which are: built up, agriculture, wetland, forest and water body. Built up area was grown up respectively each period. Interestingly, they were transformed from the separated location from the first became collected settlement as known as villages/sub-villages. Most of villages/sub-villages located at along sub district bordered. The development of land cover classes in Mijen and Wedung sub districts from 2000 to 2014 are shown in Figure 1, 2 and 3.

The development of wetland rise significantly. It is known from the three previous maps where map of 2000 shows that the wetland class area is rare in some region and it completed in the next periods (2009 and 2014). Some green area (agriculture) is also changed into wetland in 2009 and 2014 periods.

Meanwhile, forest exists on along north coast of Wedung sub district in map of 2000. The numbers become smaller and almost disappear in 2009 and 2014. It happens because some of them were transformed into wetland (such as ponds) and influenced by tidal flow also wave erosion from Java Sea.

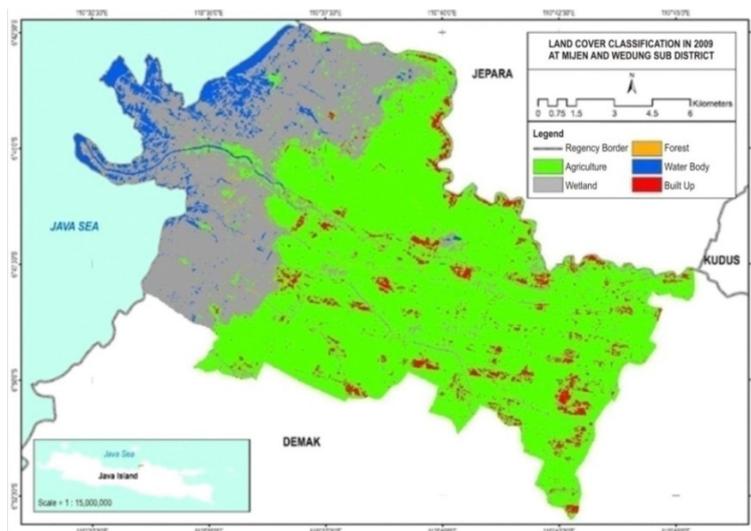
Figure 2. Map of Land Cover at Mijen and Wedung Sub District at 2009.

Unfortunately, the development of built up area in 2009 is not clearly showed. It was caused by poor quality of satellite image, although it is the best image from that period. Several part of the Landsat image in 2009 get refraction and color distortion. The counting of the number and total settlement classes is needed to understand the increasing trend of built up area.

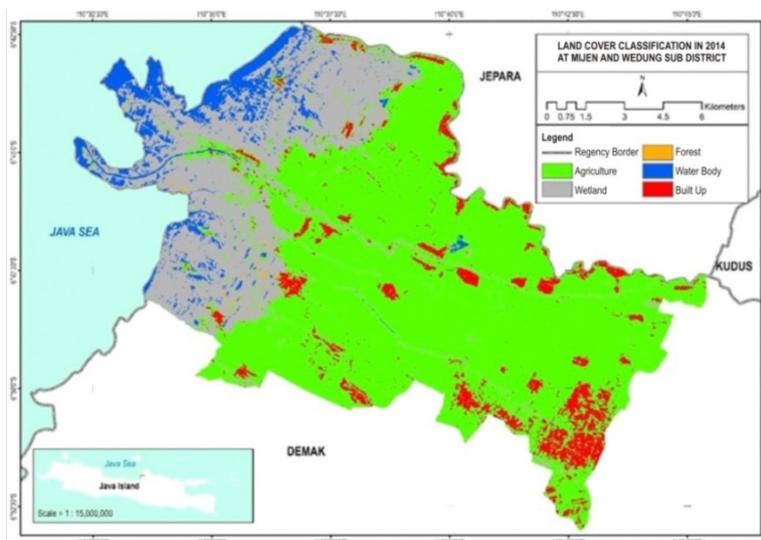
Figure 3. Map of Land Cover at Mijen and Wedung Sub District at 2014.

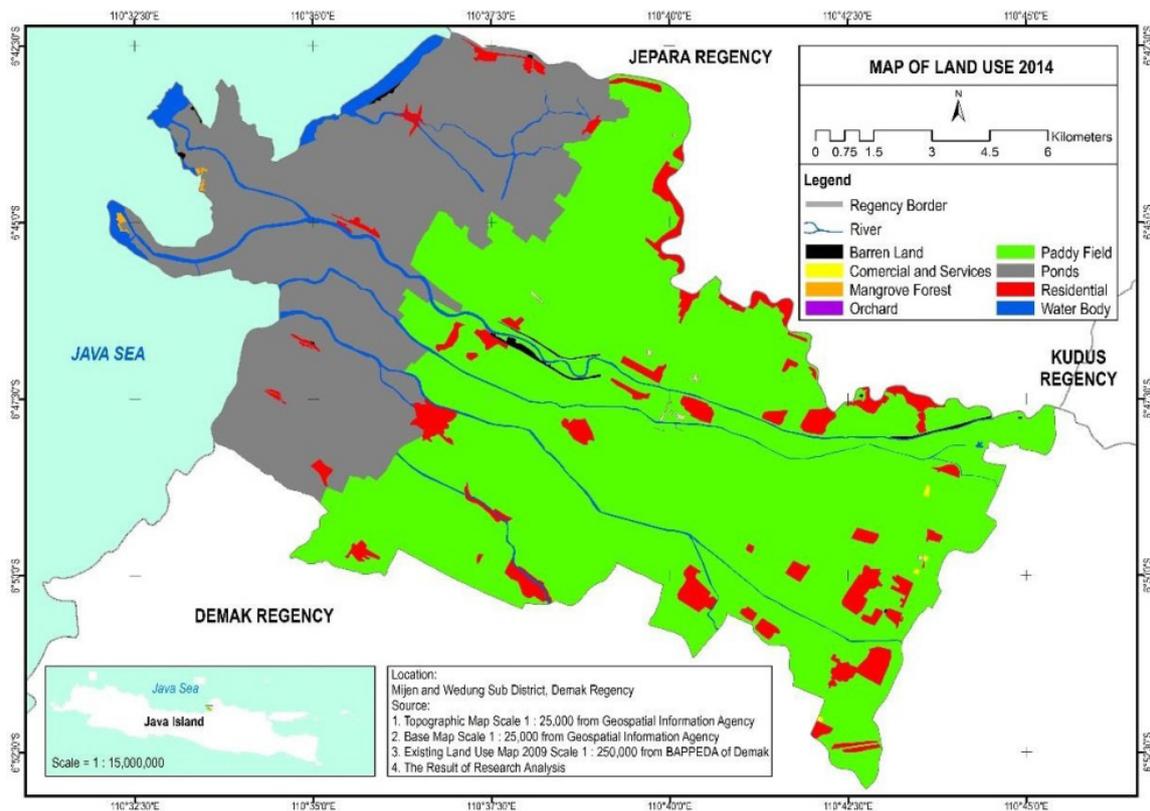
Figure 4. Land Use Map of Mijen and Wedung Sub District in 2014

Land use map was constructed from existing land use map from BAPPEDA [2009] and land cover map in 2014. Anderson's classification is considered to define the classes and nomenclature. The result of this process is illustrated in Figure 4.

The result shows that the biggest area of Mijen and Wedung sub district is paddy field (9,017 Ha) followed by ponds with 4,524 Ha. The smallest area is commercial and services (6 Ha) because in both sub district are lack of company or industry built there. Mangrove forest also limited with 9 Ha only. The observation shows mangrove area only located in certain region near Java Sea especially at Berahan Wetan. Meanwhile along coast of Kedungkarang and Kedungmutih, there is limited mangrove plantation with spread individually.

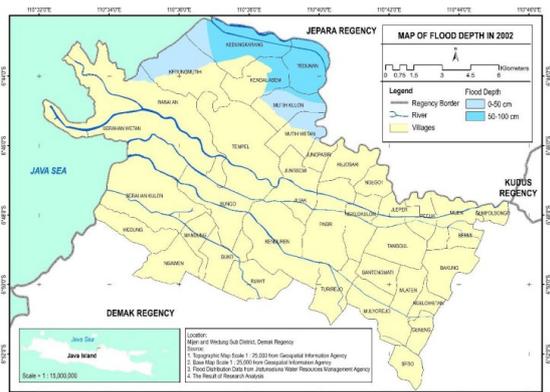
Figure 5. Map of Flood Depth in 2002

From interview result and secondary data collection, Mijen and Wedung sub district was hit flood four times in period 2000-2014. In 2002, river flood happened in Kedungkarang, Tedunan, Kedung Mutih, Babalan, Kendal Asem, Mutih Wetan and Mutih Kulon. In January 24th, 2006, flood localized at Jleper, Ngelokulon, Pasir and some area in Ngegot villages. Riverine flooding in April 2013 striked Mijen sub district (Mijen, Pecuk, Jleper, Ngelokulon, Pasir, Ngegot and Legosari) and some village in Wedung sub district (Jungsemi, Mutih Wetan and Mutih Kulon). In early 2014, flood inundated all villages which are bordered directly with Jepara district (from Kedungkarang to Mijen village). The detail of flood inundation description is shown on the Figure 5, 6, 7 and 8.

in the figure 9. The depth of flood in 2002 was not more than 1 meter whereas in 2006 became smaller to be less than 50 cm. Flood event in 2013 reached until around 2 meters. Flood event in 2014 was the biggest with the water depth reached more than 2.5 meters.

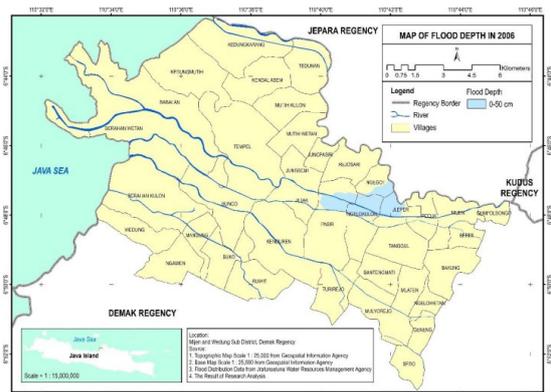
Figure 6. Map of Flood Depth in 2006

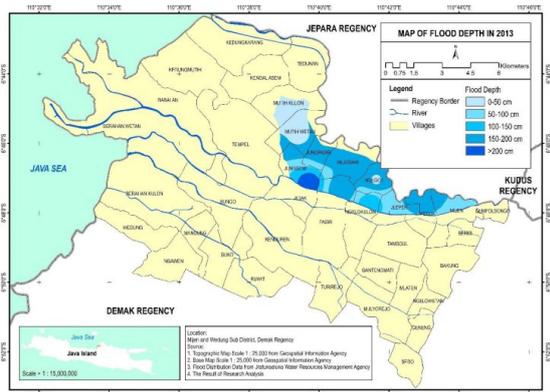
Figure 7. Map of Flood Depth in 2013

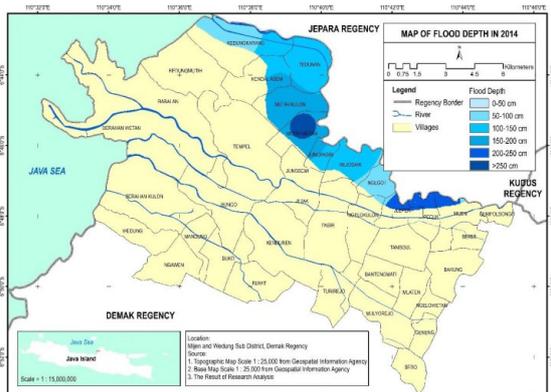
Figure 8. Map of Flood Depth in 2014

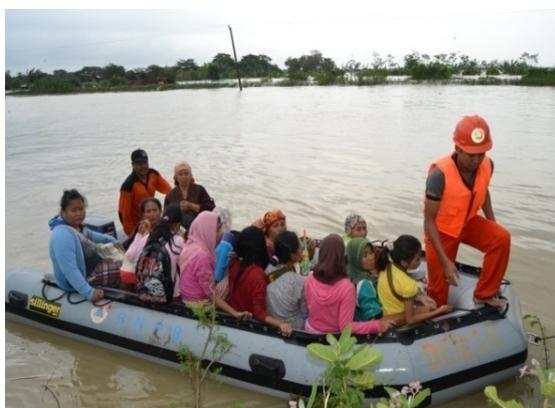
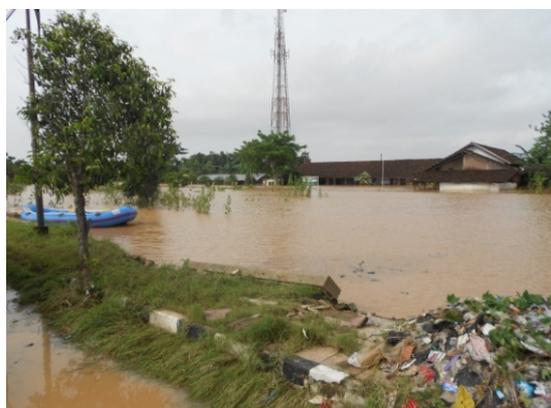
Figure 9. Flood 2004 hits Pecuk (right) and Mijen (left) village [BPBD, 2014].

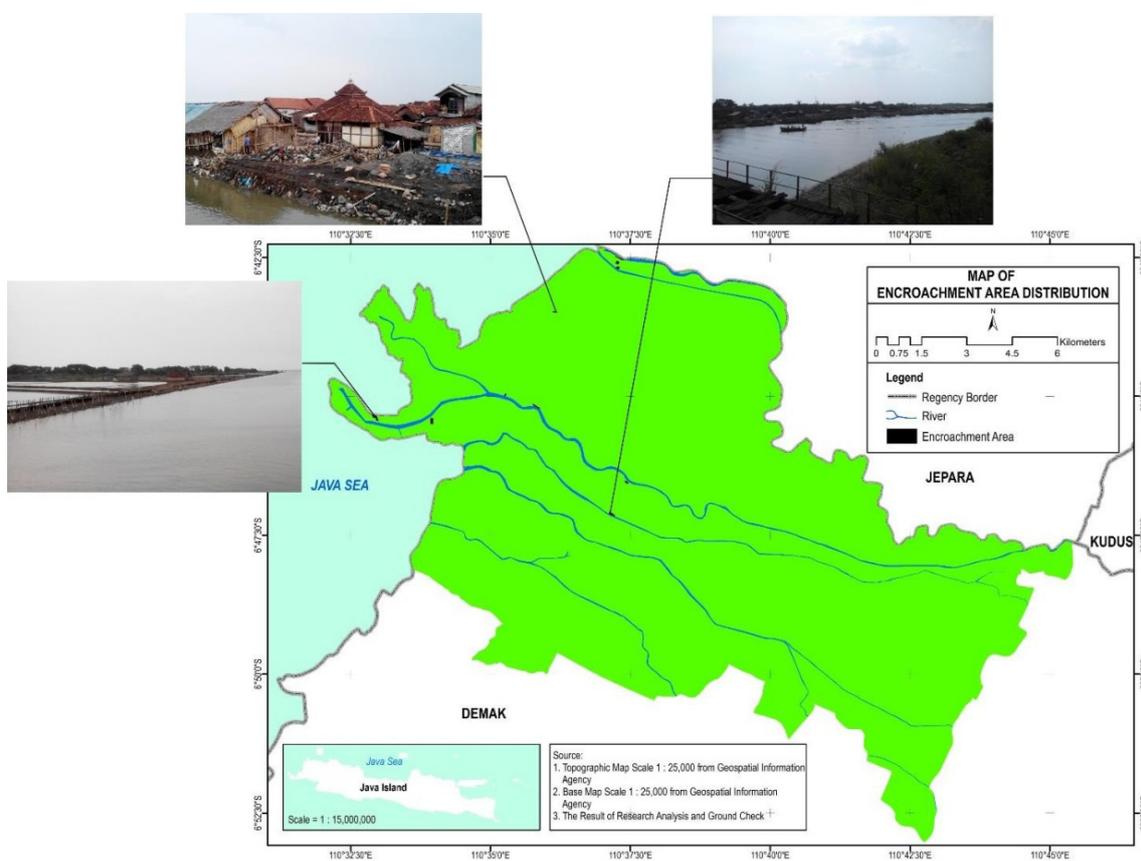
Figure 10. Map of Encroachment Area Distribution

Overall, the total encroachment area is about 8 Hectares (Ha). It shows that encroachment activity happened only in small scale at the research area. However, this encroachment activity became serious problem because most of them were occurred on river borders, mangrove and riparian area. The evidence strongly showed that most of mangrove forest transformed into ponds area. In addition, settlement development take place in river borders and riparian area especially Wulan and Serang river. The illustration showed on Figure 10.

The right picture of previous map shows the existing of settlement along Wulan River at Babalan village. On the left, the picture describes the development of permanent and semi-permanent houses near canal at Kedung Mutih village. The rocks and sand already drop for the beginning of construction phase. The left picture of the map shows the ponds area. People expropriated the mangrove forest and changed it into ponds. The remaining mangrove forest is located in the north of Wulan River that abutted on sea.
