## Quantitative Analysis of Microstructure Deformation in Accelerated Creep Fenomena of Ferritic SA-213 T22 and Austenitic SA-213 TP304H Material

Cukup Mulyana, Ahmad Taufik, Agus Jodi Gunawan, R.E. Sirregar  
Universitas Padjadjaran

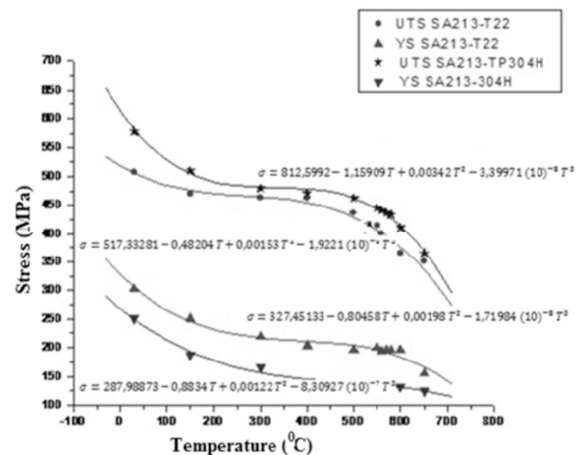
FIGURE 2. Graphic of UTS and yields stress as a function temperature of material SA-213 T22 and SA-213 TP304H

In FIGURE 2 UTS it is change rapidly in the temperature of 520 $^{\circ}\text{C}$  - 600 $^{\circ}\text{C}$ , while UTS of SA-213 T22 decreased faster than the SA-213 TP304H after passing the temperature 570 $^{\circ}\text{C}$ -580 $^{\circ}\text{C}$ . This temperature become limit for the creep test of material SA-213 T22. If the creep test is given above 580 $^{\circ}\text{C}$ , the sample will rupture because of the damage of the microstructure, and it takes place quickly. This temperature should be avoided in the operation of the power plant. But for the material SA-213 TP304H temperature is still in the safe, the limits of temperature is higher than 600 $^{\circ}\text{C}$ .

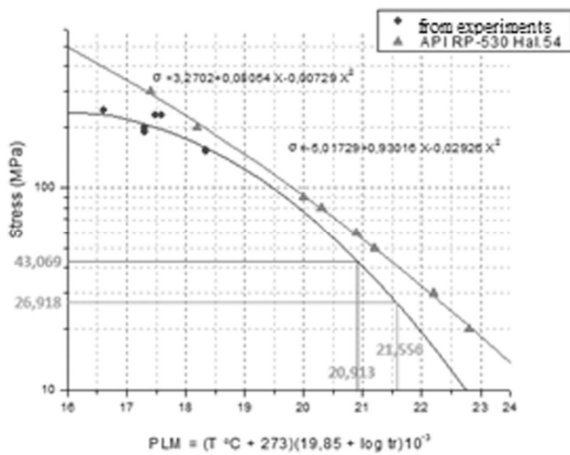
Nominal stress is  $\sigma_r = 26,784 \text{ MPa}$ . Using safety factor 1,6, stress use for predicting is 41, 069 MPa. By interpolating this stress to Larson miler curve, it is obtained the PLM 20,913, with predicted time rupture is  $t_r = 129.653$  hours.

FIGURE 5. Predicting remaining life of SA-213 T22 from Larrson Miller curve with

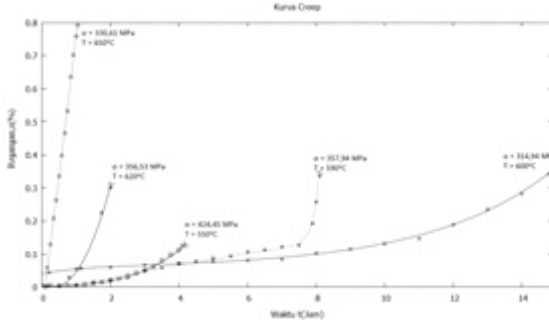
FIGURE 6. Creep curve of material SA-213 TP304H from accelerated creep test, strain Vs time (hour)

For  $\sigma = 314,94 \text{ MPa}$  and  $T = 600^\circ\text{C}$   $t_r = 14$  hours with

For  $\sigma = 357,94 \text{ MPa}$  and  $t = 590^\circ\text{C}$   $t_r = 8,1$  hours with

For  $\sigma = 424,25 \text{ MPa}$  and  $t = 550^\circ\text{C}$   $t_r = 4,1$  hours with

For  $\sigma = 356,53 \text{ MPa}$  and  $t = 620^\circ\text{C}$   $t_r = 2,3$  hours with

For  $\sigma = 330,61 \text{ MPa}$  and  $t = 650^\circ\text{C}$   $t_r = 1,05$  hours with

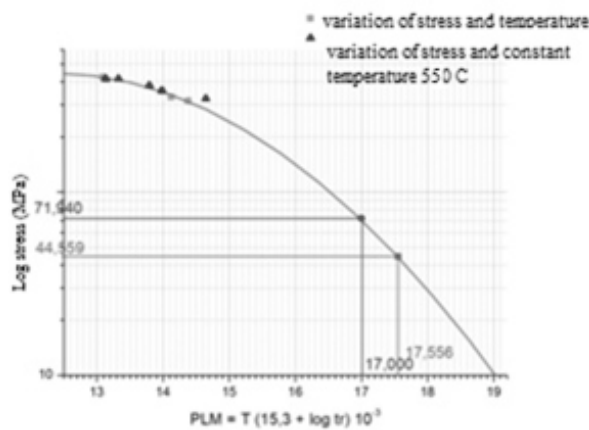
Using equation 10 above the nominal stress of internal tube of material SA-213 TP304H is 71,940 MPa as shown in FIGURE 7 in Larrson Miller curve of material SA-213 TP304H.

By interpolating nominal stress 71.940 MPa to the Larrson Miller curve in figure 7, the PLM is 17.00. Substituting temperature 550°C to equation 4, the time rupture is 252831 hours.

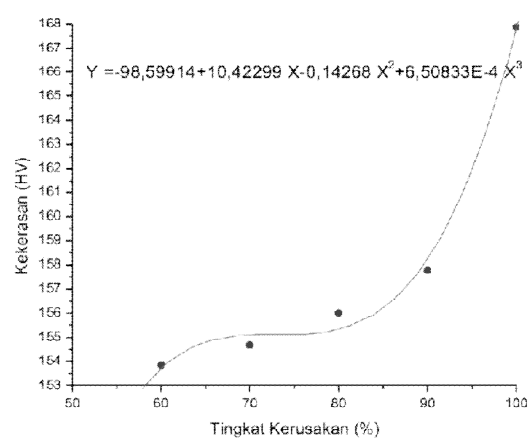
Micro hardness for material SA-213 T22 and material SA-213 TP304H, is taken after the microstructure photo is got. From figure 15 and 16 shown micro hardness of material increase as the level of the damage increase. This phenomena happened for both material SA-213 T22 and SA-213 TP304H.

FIGURE 15. Micro hardness (HV) terhadap tingkat kerusakan untuk spesimen uji creep tanpa putus untuk material SA-213 T22

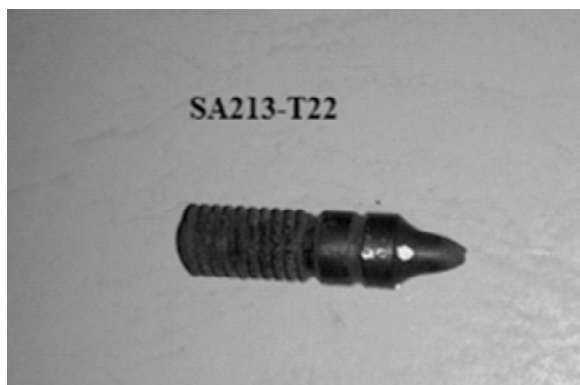
Specimen from accelerated creep test of material SA-213 T22 in temperature 570°C and stress 190 MPa. The result can be seen in figure 17. The surface of the crack is observed under scanning electron microscope. From the photo it can be seen the crack propagation as the pattern combination of intergranular and transgranular crack propagation, as shown in figure 18.

FIGURE 17. Sample from accelerated creep test of material SA-213 T22 observed under SEM.

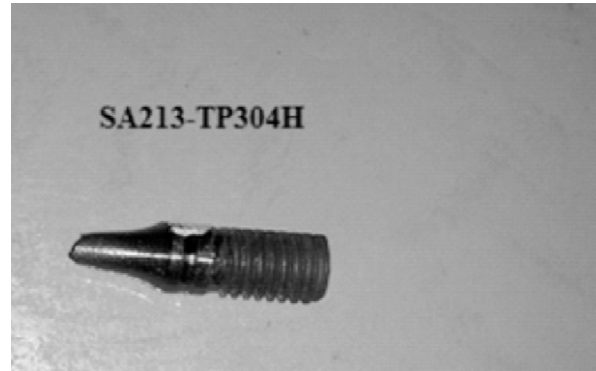
Specimen from accelerated creep test of material SA-213 TP304H in temperature 550°C and stress 424.44 MPa. The result can be seen in figure 17. The surface of the crack is observed under scanning electron microscope. From the photo it can be seen the crack propagation as the pattern dominated by intergranular crack propagation and in a small part shown transgranular crack propagation, as shown in figure 19

GAMBAR 19. Sample from accelerated creep test of material SA-213 TP304H observed under SEM
