Analysis of Steering Wheel Heavy Komatsu Dump Truck Unit (HD) 785-7

Steering system is a system control unit that is used for deflecting the direction of motion straight into to the left or to the right in accordance with the will of the operator. At 785-7 HD unit using the steering system type full hydraulic steering valve, where steering valve serves as a directional control valve to direct the oil flow at the time of engine working (pump work), whereas when the engine died steering valve will serve as a hand pump and directional control valve. Abnormally steering wheel because there is a scratch on spool demand valve causing internal leakage in the demand valve so oil pressure which served as the pilot sensing to move the spool valve is a pressure demand would drop because there is a leak and could not afford to drive the spool until the full open- as a result the oil flow from the steering pump cannot be fully prioritized to steering valve to be forwarded to the steering cylinder.

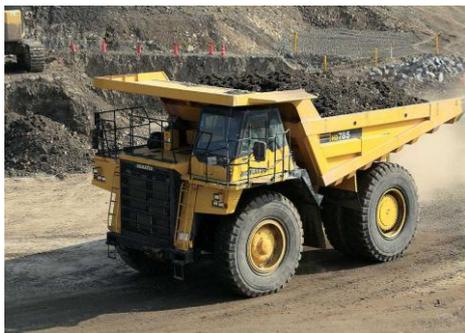
Fig. 1. Komatsu dump truck unit HD 785-7 [1]

HD 785-7 uses a full hydraulic type steering system to ease the operator's work when turning the unit left or right [3]. Based on the results of our survey in the field there is one unit that is experiencing heavy wheel steering trouble on the HD 785-7 unit. This can occur due to several factors, namely the lack of hydraulic oil in the steering system hydraulic tank illustrated for Figure 1.

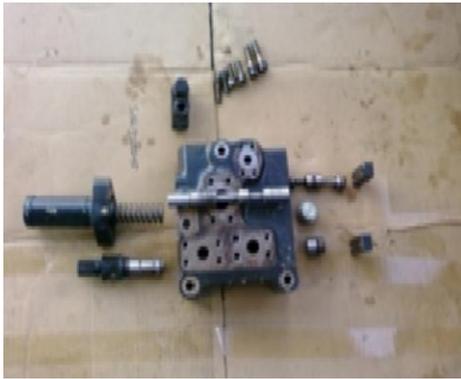
Pressure steering relief valve and pressure relief load sensing are not in accordance with the standard (low pressure), which is 180 kg/cm² at low idle and at high idle 130 kg/cm² while the required standard is 210 kg/cm². Possible causes of damage to the demand valve and must be done disassembly on the demand valve to check to ensure the condition of the components of the demand valve.

Fig. 5. Demand valve after disassembly

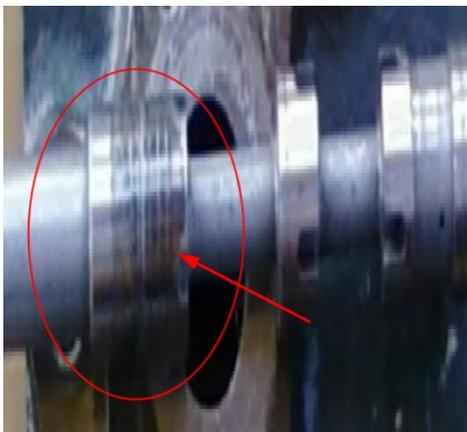
From the results of disassembly, there is a scratch on the spool demand valve. The following Figure 6 is scratch on the demand valve.

Fig. 6. Spool demand valve scratch

From these results it can be identified that this scratch spool demand valve causes the steering wheel to be heavy when rotated. Spool demand valve damage due to lack of lubrication on the valve demand, this can be seen from the level of hydraulic oil that is below low at the time of inspection due to lack of lubrication resulting in the spool demand valve rubbing against the housing so that the spool has a scratch.

Scratch spool demand valve causes internal leakage inside the valve itself and makes the spool demand valve not open fully at high idle so that the oil supply from the steering pump which will be prioritized to the steering valve will be reduced and the pressure will drop and unable to move the steering cylinder. Causing the steering wheel to be heavy when being deflected this is due to the oil pressure that goes to the steering valve and the steering cylinder is low pressure.

After the inspection process is then obtained the results of the inspection and then an analysis of the causes of the damage is done, it can be concluded that the cause of the non-operation of the steering system is caused by damage to the spool demand valve, i.e. the spool demand valve scratch which results in internal leakage, for that to be repaired/replacement of damaged spool demand valve components, replacing damaged parts with new parts.

1. Uninstall Demand valve assy. P/N: 702-21-01502
2. Uninstall Line filter hydraulic
3. Uninstall Hydraulic filter
4. Install Demand valve assy. P/N: 702-21-01502
5. Install Line filter hydraulic
6. Install Hydraulic filter
7. Perform a flushing hydraulic system
