Preliminary Analysis of Slope Stability in Kuok and Surrounding Areas

Abstract

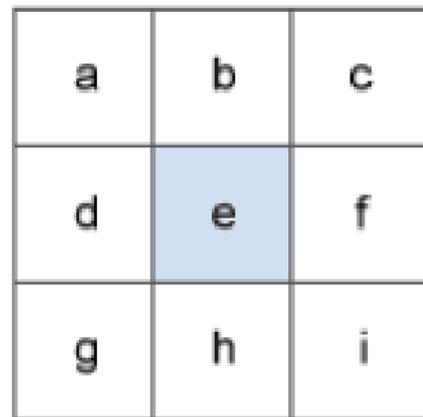
Fig 1. Illustration of pixels that are taken in the calculation of the slope value pixel on DEM / DTM grid raster format (Burrough, 1998).

Data obtained from Digital Elevation Models using SRTM data with raster grid format of pixels that value of the pixels must be counted vicinity to all directions. In calculating the value of the slope of a single pixel, involving a 3x3 pixel as illustrated in Figure 1 and calculations of formula quoted from [3] below.

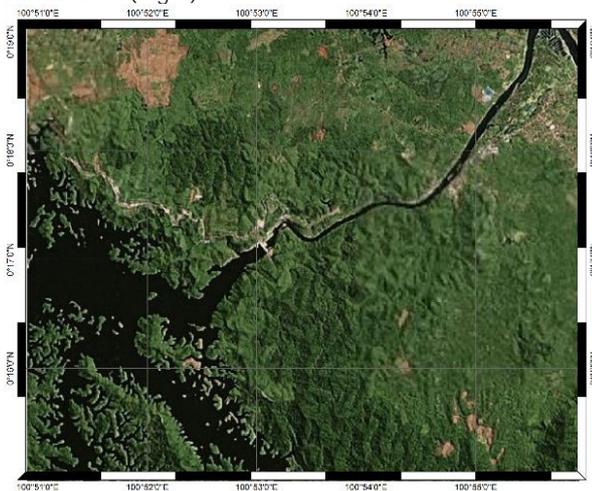
Fig 2. Topography map of research area

Kuok and the surrounding area are composed by several formations and geological structures which formed the topography at recent time (Figure 2). Based on the Geological Map of Pekanbaru [12] suggested that formation on the research area consist of Bohorok Formation (Pub) consist of Wacke, conglomeratic wacke and turbidite deposit; then also at the same age deposited Member of Tanjung Pauh (Pukt) of the Tapanuli Group that consist of muscovit chlorit cabonate schist with strong lineation. Then an intrusion of Granite Pulaugadang triad (MPigg), consist of strong foliation of granite gneiss. On the northeast side, Pematang Formation was deposited containing red and mottled mudstone, breccio-conglomerates and conglomeratic sandstones. After that Sihapas Formations (Tms) deposited on miocene which contains the conglomerate sandstone, and siltstone. The youngest formation on research area is Petani Formation (Tup) consisting of mudstone, carbonaceous, lignite, slightly siltstone and sandstone. (Fig 3).

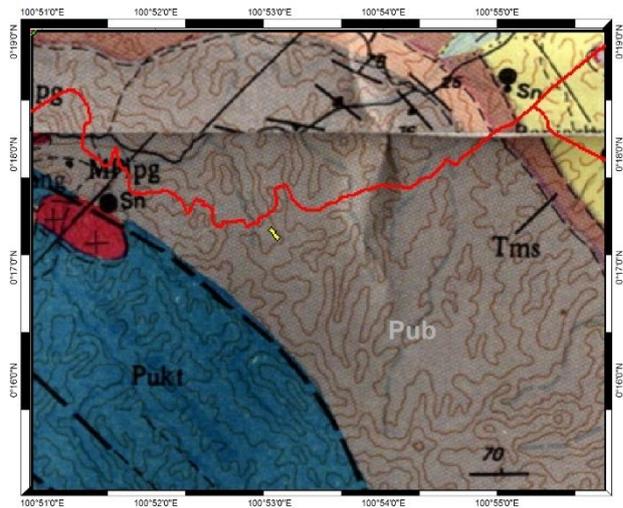
Fig 3. Geological map of research area

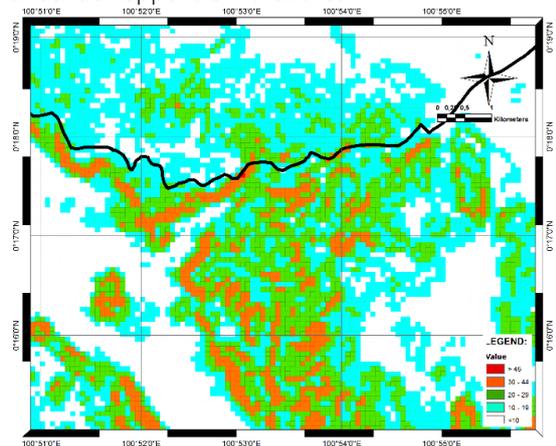
Fig 4. Slope map of Kuok Area and Surroundings

Research area located near the Water Power Plant Koto Panjang which become source electricity for Riau Province. Based on slope analysis in Kuok and Surrounding area, there are five type related with degree of slope in research area, from nearly level to very steep slope. First, nearly level class of slope having 30% on coverage area, this class distribute on NE research area as a habitation and some part in SW are lake of Koto Panjang. Second are moderately sloping that cover 30 % of the area, and then steep area that cover 20 % on kuok area, and class of very steep cover about 20 % in all area. Some of the steep area are located near the road, used as rock mining site for local villagers, this is the potential risk that can become dangerous if landslide happens on that area.

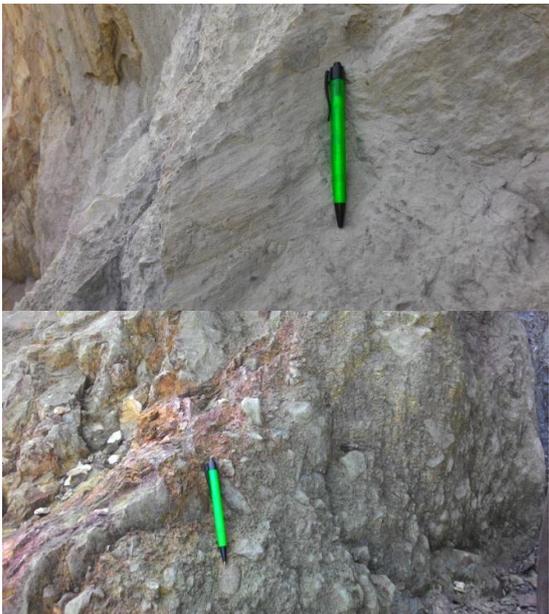
Fig 5. Fault breccias and slicken side feature indicating the slope was affected by a fault system.

A slope stability analysis had been assessed to the cut slope. The slope was considered as heavily jointed slope due to a fault system that developed in the site (Fig 5).

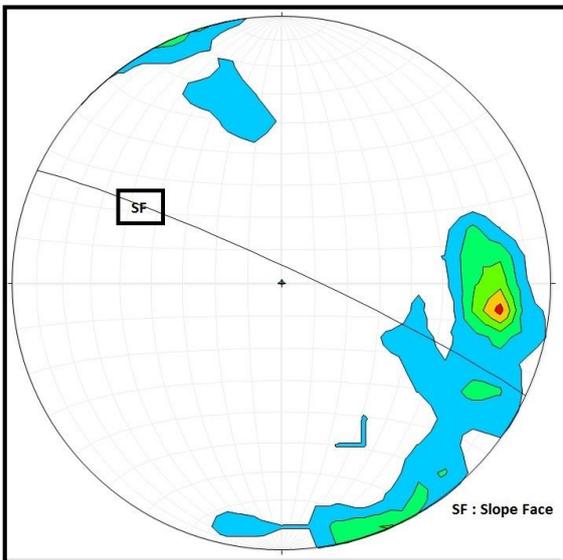
Fig 6. 1% area contour analysis to determine the major sets of joint.

The analysis had been conducted using Stereonet software to identify the mode of active failure and the potential failure zone of the slope. The slope face direction is N295E and 85o dip. Overall, 193 joint sets had been plot into the Stereonet and 2 sets of joint considered as major sets based on the 1% area contour analysis (Fig 6). The mode of failure had been analyzed based on the relationship between slope face and major joint sets plane. The mode of failure is toppling failure or rock fall and the potential zone of failure is in the center part of slope (Fig 7).

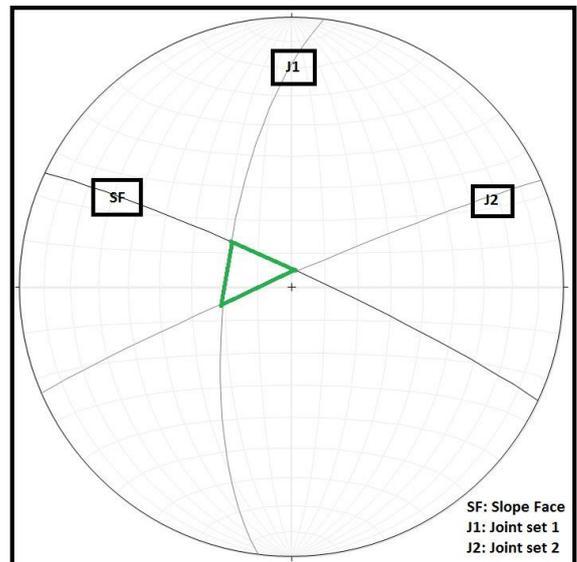
Fig 7. The mode of failure is toppling failure or rock fall (indicating by green triangle) and the potential zone of failure is in the center part of the slope.
