Engineering Geological Investigation of Slow Moving Landslide in Jahiyang Village, Salawu, Tasikmalaya Regency

*D. Sarah and M. R. Daryono

Research Centre for Geotechnology - LIPI
Jln. Sangkuriang, Kompleks LIPI, Bandung 40135

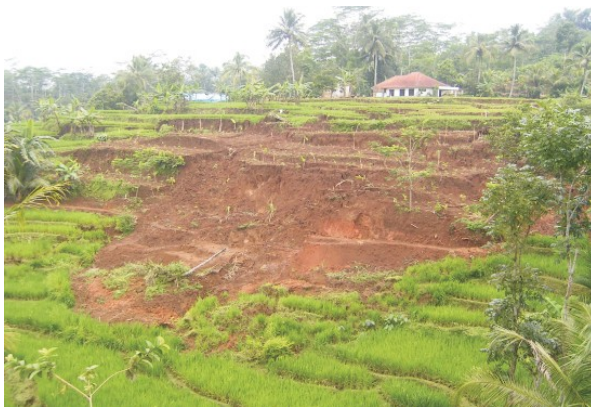
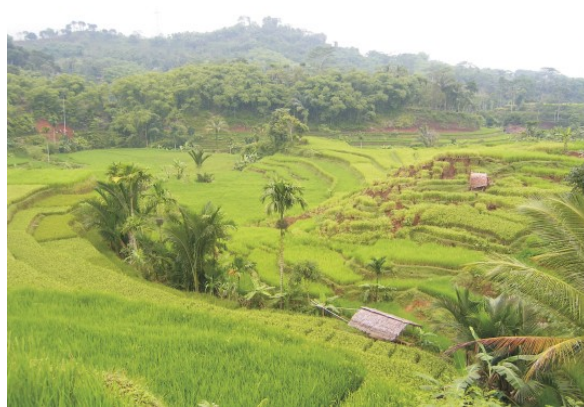
Figure 1. Slow moving landslide in Jahiyang Village causing destruction of rice field and displaced housing.

Java Island is an area with the highest landslide susceptibility in Indonesia with almost 50% of the total number of events (Cepeda *et al.*, 2010). The high susceptibility is mainly due to topographical factors (hilly morphology with slopes inclination over 25°), intense weathering of volcanic soils, uncontrollable land use, and high intensity of rainfall (up to 100mm/day) during wet months (Tohari *et al.*, 2006). The recurring events of landslides every year in the provincial area have claimed a number of human lives and caused great economic losses as well as environmental consequences. According to the landslide forecast map of Java Island, January 2006 (PVMBG, 2006), the Salawu Subregency, Tasikmalaya Regency, belongs to the medium to high susceptibility class. During the year 2006-2007, five consecutive landslide events took place in this region. They were happening on 18 November 2006 in Salawu Village, on 18 February 2007 in Kutawaringin Junction, on 4 March 2007 in Salawangi, Jahiyang Village, and on 9 June 2007 in Nyalindung, Tenjowaringin Village. The landslides occurred in Jahiyang and Tenjowaringin Villages are of slow moving type which is commonly described as creeping. The landslide in Tenjowaringin Village in June had induced cracks to form 150 m length and 3 m depth, causing two houses to collapse and seven others in danger, while the landslide in Jahiyang Village during March 2007 had caused 12 houses to collapse and destroyed a rice field area of eight hectares (Pikiran Rakyat, 5 March 2007) (Figure 1).

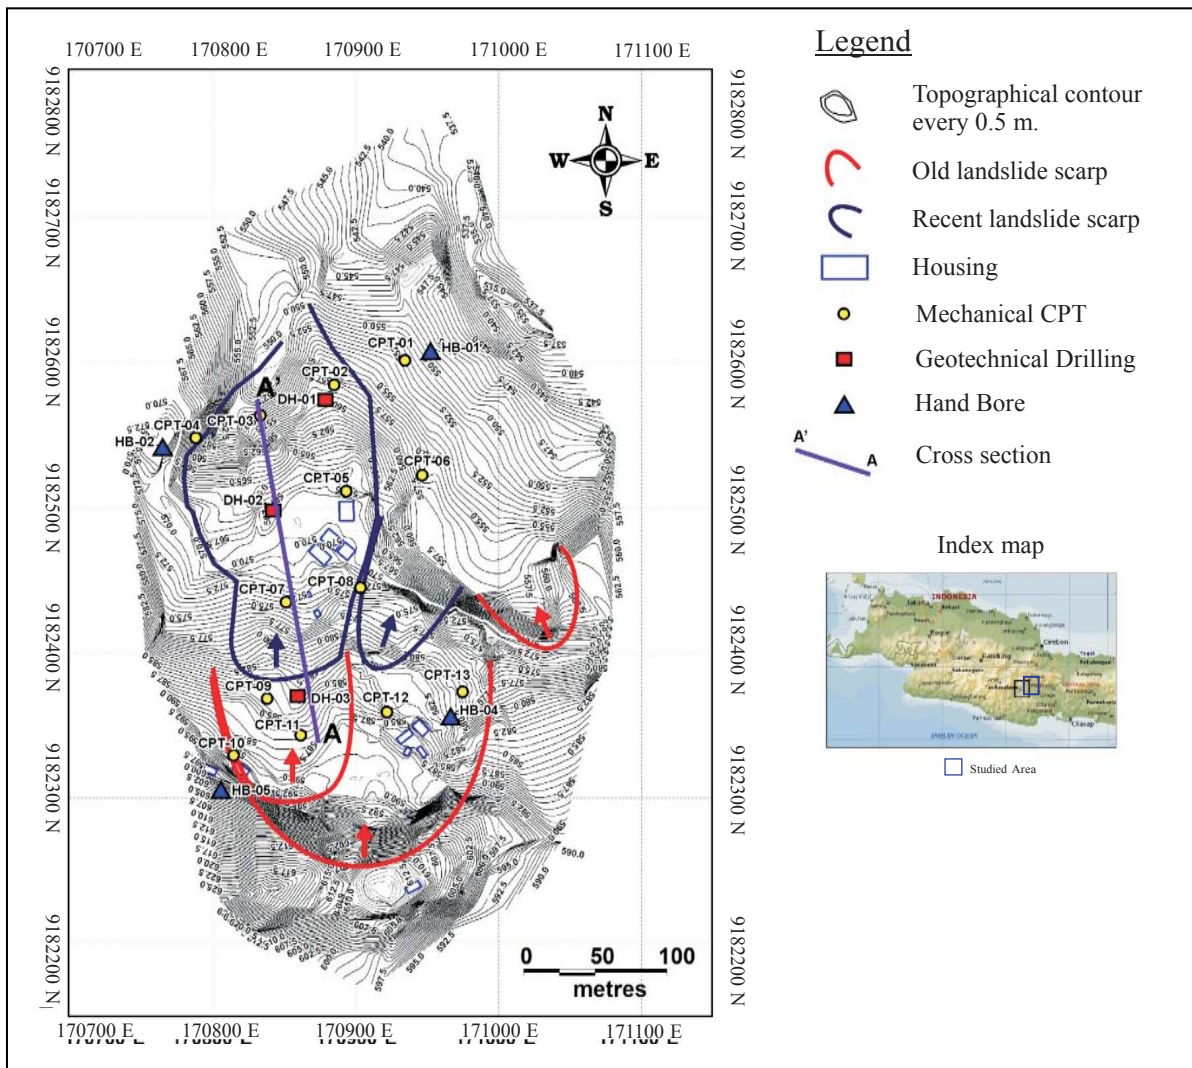
Figure 2. The topographical map of studied location showing points of investigation.

The field investigation began with local geological and topographical mappings, followed by three mechanical drillings up to a maximum depth of 22.5 m, thirteen mechanical cone penetration tests, and five shallow hand borings up to a maximum depth of 6.0 m. Figure 2 shows the topographical map of the studied site and the locations of the field investigation. Mechanical drilling aims to reveal the soil stratification. For this purpose, one borehole was located at the upper and middle slopes, and the last one at the lower slope. The drilling programme also included both the N-SPT tests at an interval of 1.50 m and undisturbed sampling. The depth of groundwater table was measured following the completion of

had forced twenty housings to be relocated due to the unsuitable condition. The topographical map (Figure 2) shows the undulating slope morphology at the upper part and planar slope at the lower part. The map also indicates the development of recent landslide scarp due to the slope movement in 2007 and the existence of old landslide scarps at the upper part of the recent scarp. The development of several scarps indicates that the area is experiencing slow movement (*e.g.* creeping). Tension cracks, depressions, and displaced materials of 20 - 50 cm wide were found during the field investigation along the recent landslide body (Figure 3).

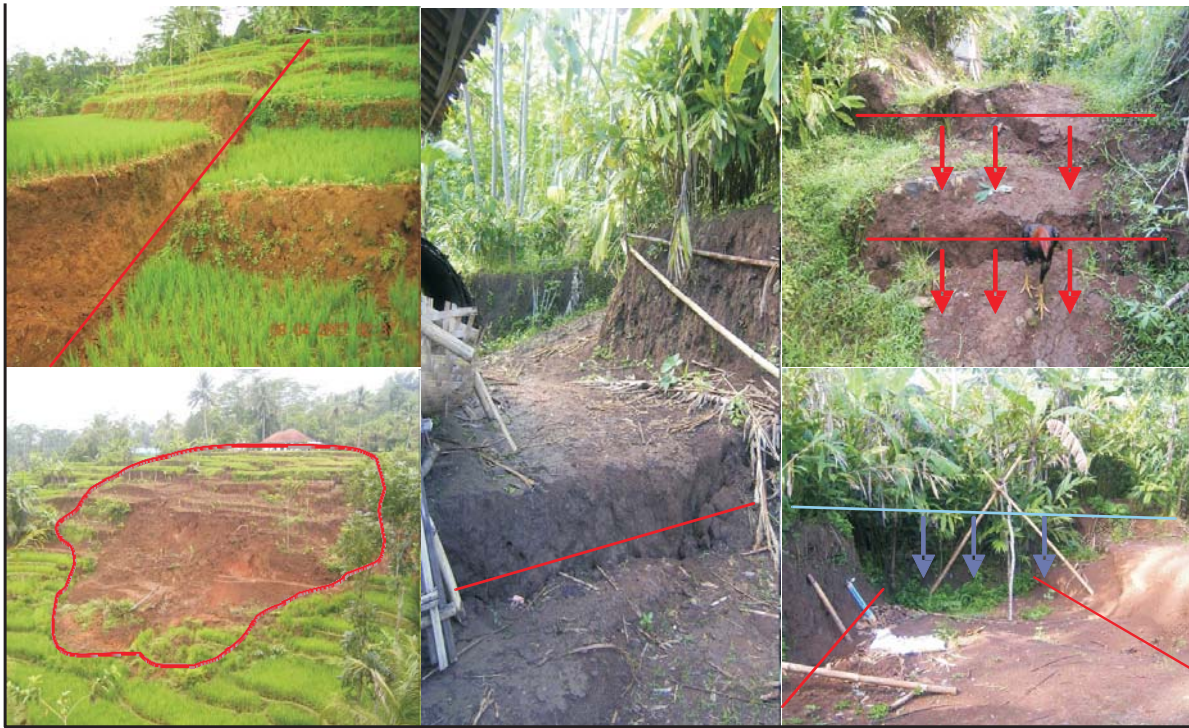
Figure 3. Tension cracks, depressions, and displaced materials observed at the studied location.

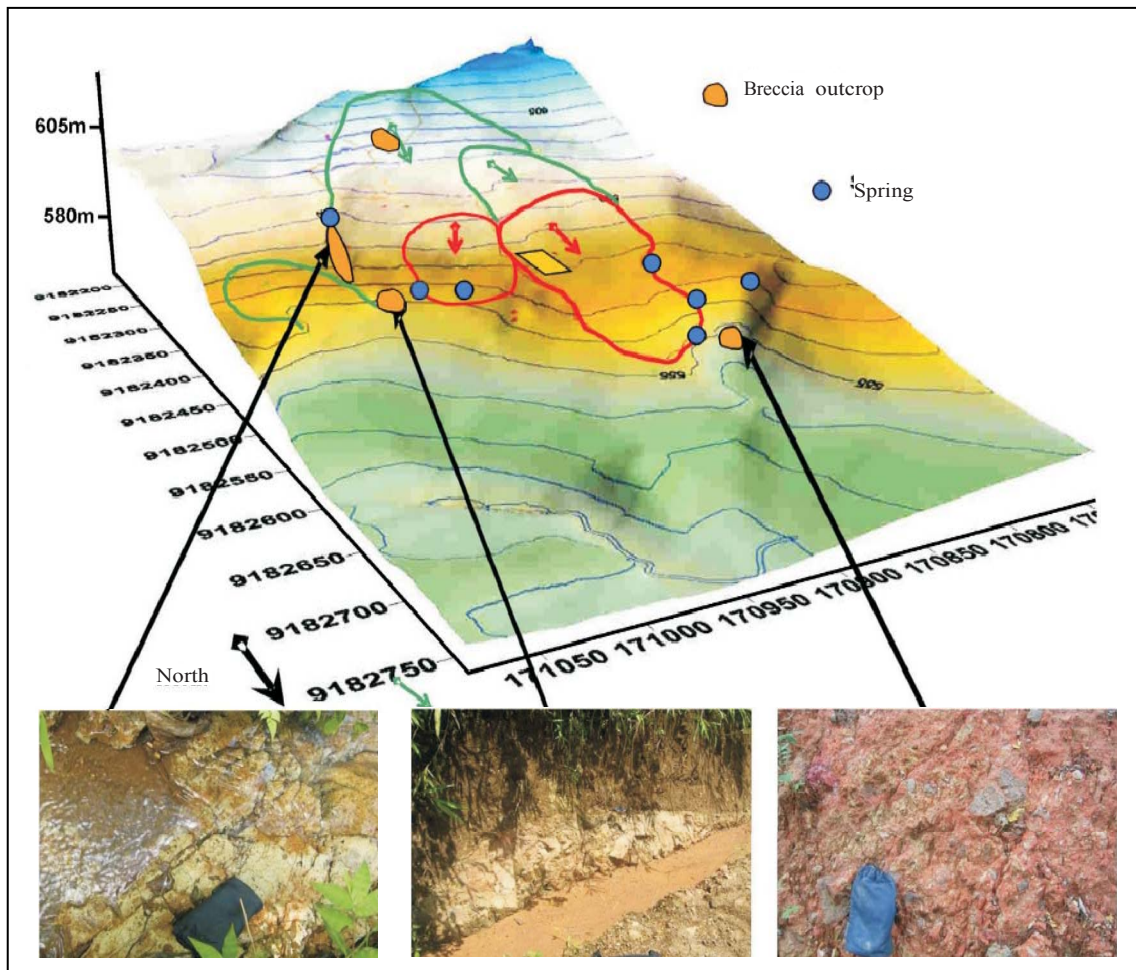
Figure 4. Block diagram of studied location showing the locations of breccias outcrops and springs.

According to the geological map of Tasikmalaya Quadrangle (Budhitrisna, 1986), the studied area belongs to the Old Volcanic Unit of volcanic breccias, flow breccias, tuff, and andesitic to basaltic lava of Gunung Kukul. This unit is of Quaternary age spreading from Nagreg to Garut. Local geological mapping combined with the borehole logs and CPT logs reveals that the studied area is composed of compact breccias, weathered breccias, and residual soil. Figure 4 shows the distribution of springs along the toe of the slope. The cone resistance value (q_c) and N-SPT correlation logs indicate the existence of weak zone (transition of low to higher value of N-SPT and q_c) which is also the area of groundwater fluctuation (Figure 5).

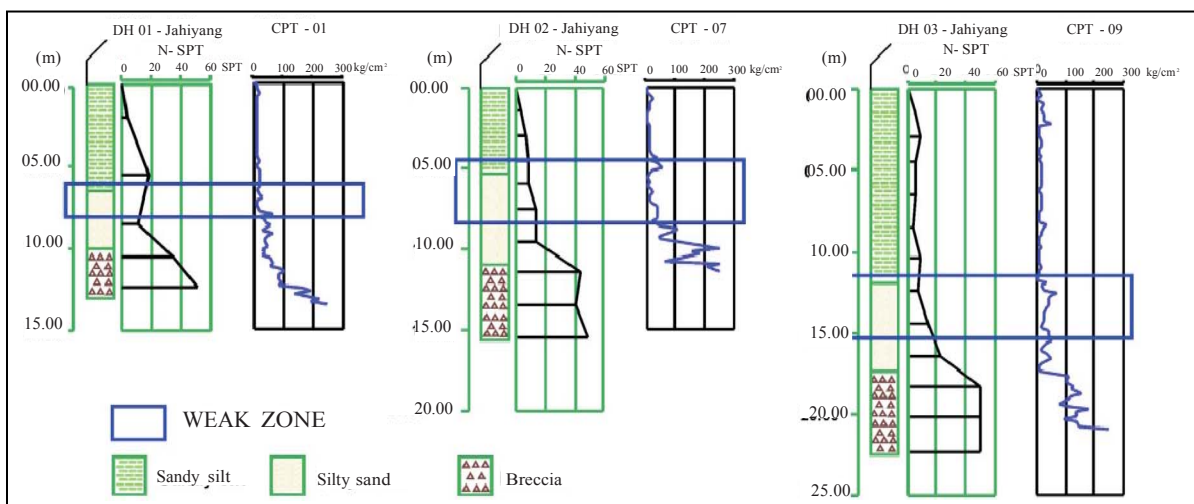
Figure 5. Correlation of cone resistant value and N-SPT showing the occurrence of weak zone.

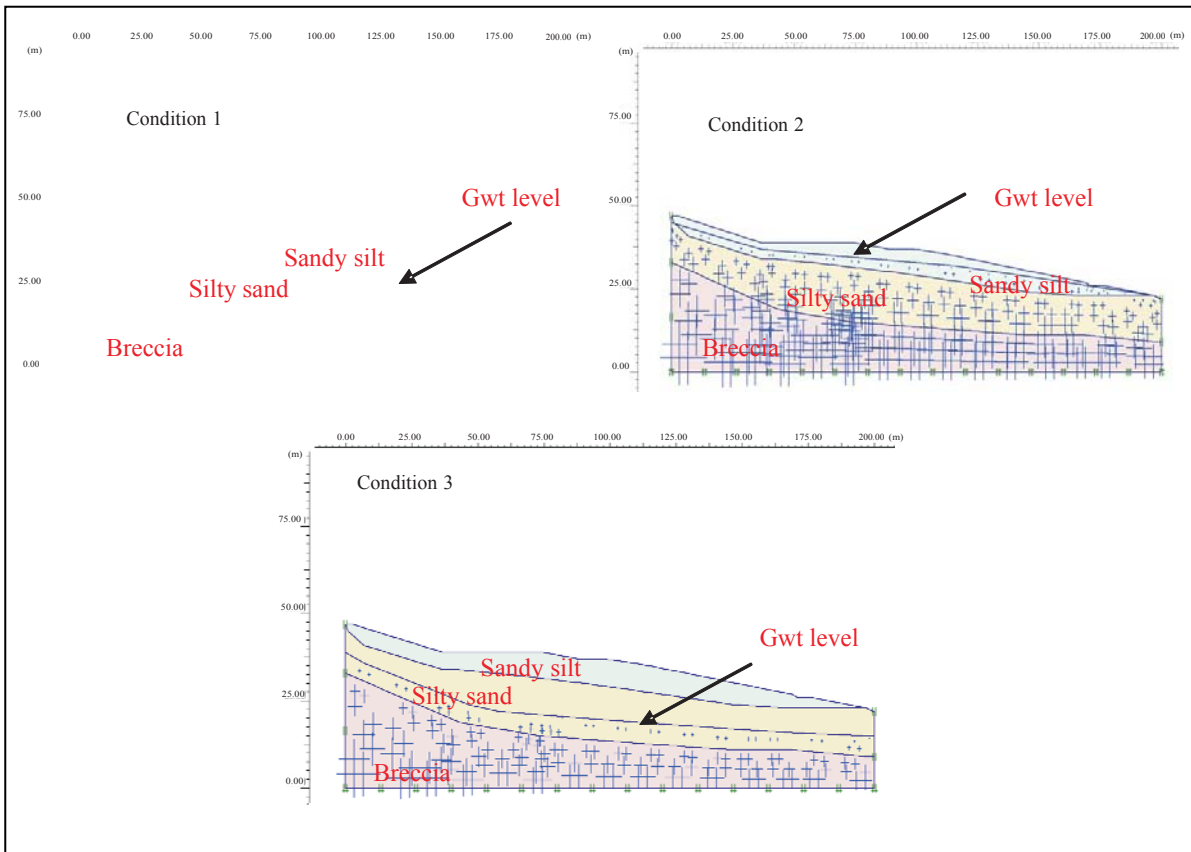
Figure 8. Groundwater level for first, second, and third conditions.

one condition of low groundwater level. For condition 1, the groundwater level is at the boundary of sandy silt and silty sand layer, whereas for condition 2 the groundwater level is 3 m elevated from the first condition (phreatic level at sandy silt layer), and furthermore for condition 3 the groundwater level is 7 m lowered (phreatic level at silty sand layer) (Figure 8).

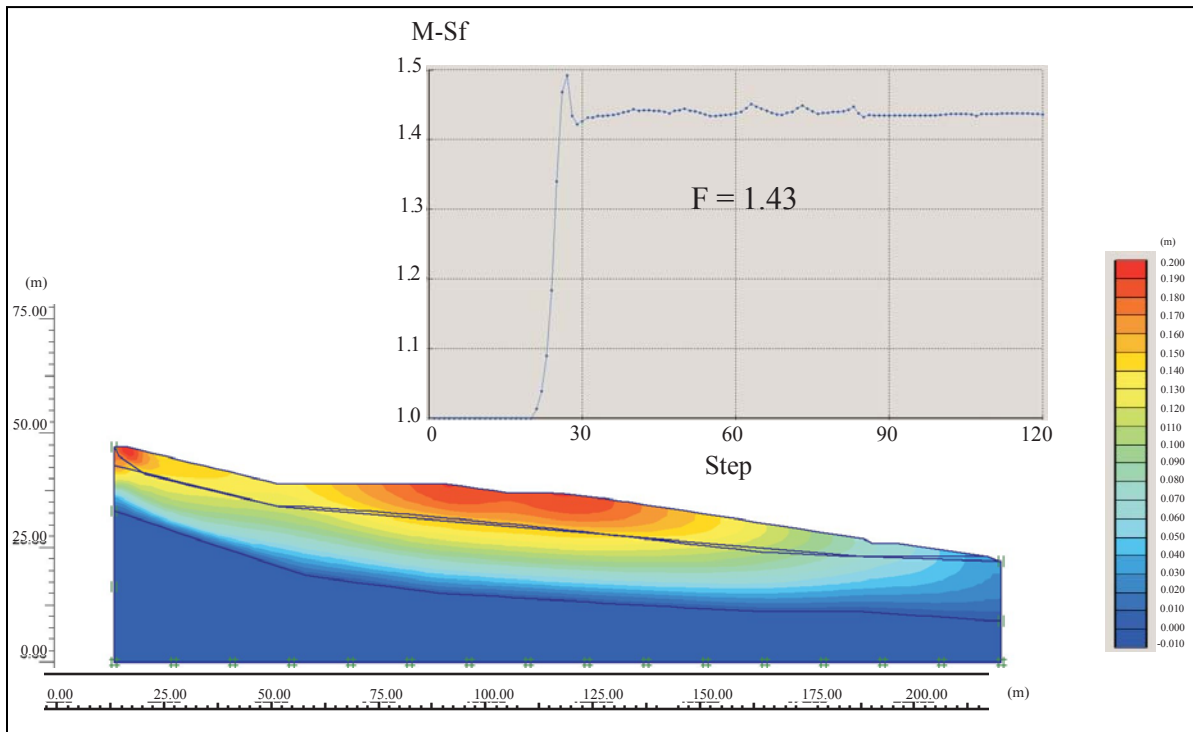
Figure 9. Factor of safety (M-Sf) and slope displacement contour for condition 1.

The results of condition 1 model show that the overall factor of safety is 1.43 and maximum displacement of 20 cm was found at the top and the mid of the slope (Figure 9).

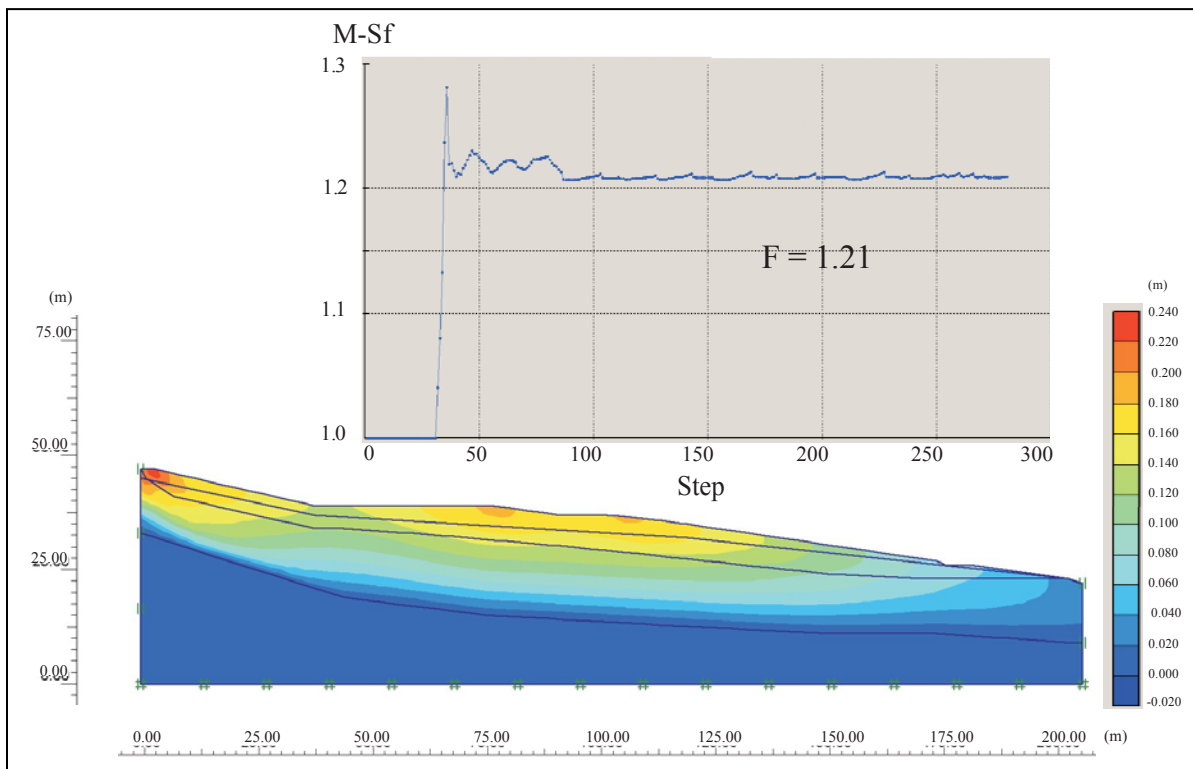
Figure 10. Safety Factor (M-Sf) and slope displacement contour for condition 2.

The largest displacement found at the crest and mid of the slope corresponds to the movement of the landslide body where large cracks and depression were found at the landslide scarp and within the landslide body. The result of condition 2 shows similar pattern with lower safety factor of 1.21 and higher displacement of 24 cm at the crest of the slope and 20 cm at mid of the slope (Figure 10).

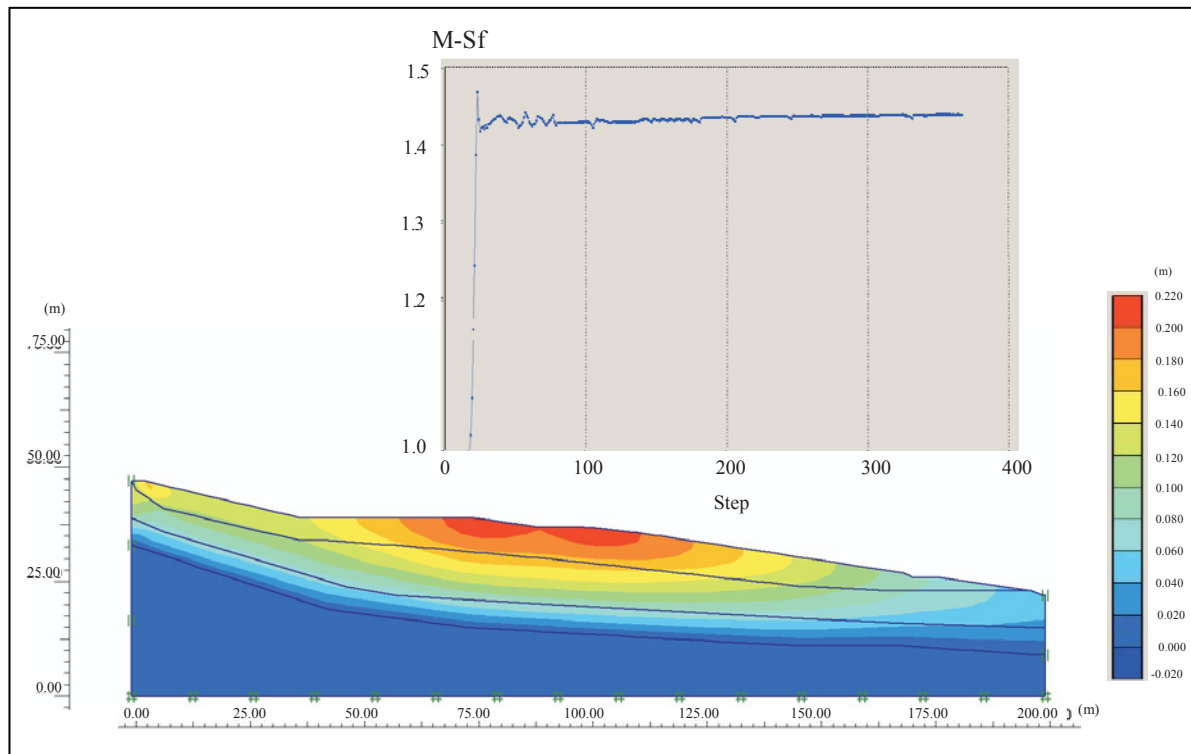
Figure 11. Safety Factor (M-Sf) and slope displacement contour for condition 3.

When the groundwater level is lowered to be within the silty sand layer, the safety factor slightly increases to 1.44 and the largest displacement of 22 cm takes place at the mid of the slope and the displacement at the crest decreases to 14 cm (Figure 11).

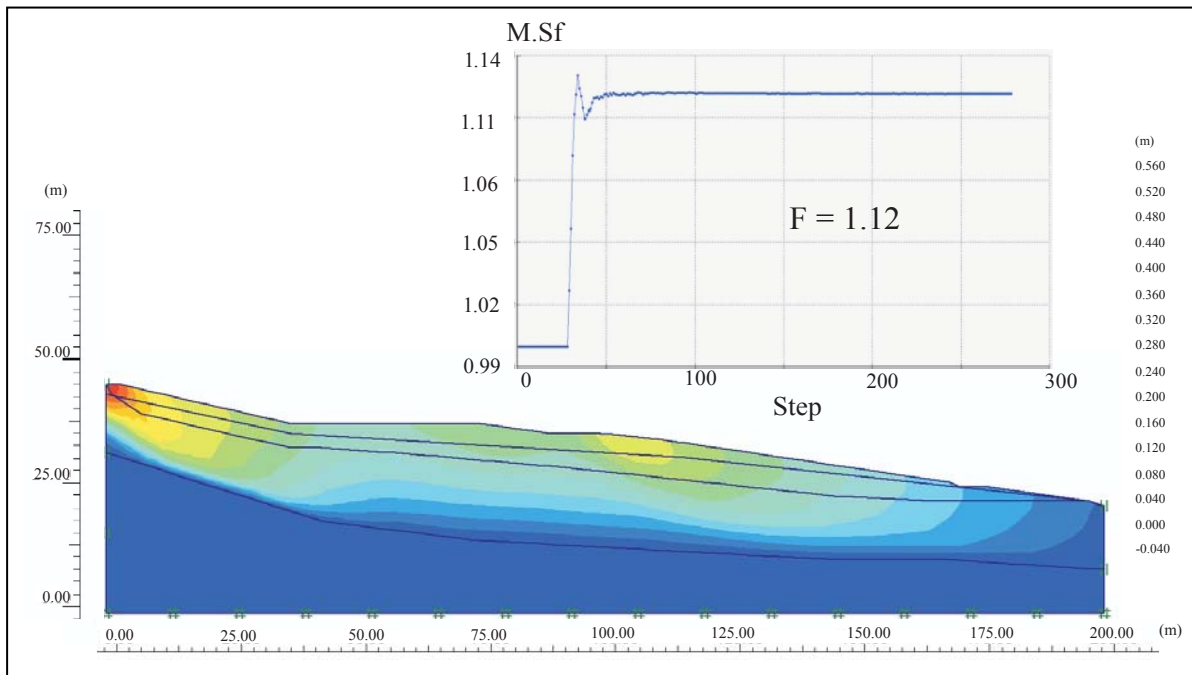
Figure 12. Safety Factor (M-Sf) and slope displacement contour for condition 3.

The result of slope stability at the most critical condition (Figure 12) shows that the slope condition still belongs to critical category ($F = 1.12$). Increased displacement is seen at the crest of the slope (56 cm) and mid of the slope (40 cm).
