Electrical Resistivity and Geotechnical Attributes and The Dynamics of Foundation Vulnerability

Abstract: This research evaluates the significance of geotechnical and Electrical Resistivity methods in studying structural integrity as fundamental factors that may account for failure in a typical sedimentary environment of Ukpenu Primary School, Ekpoma, Edo State, Nigeria. Two methods were used in this study such as the Electrical Resistivity approach involving the use of Lateral Horizontal Profiling (LHP), 2D Electrical Resistivity Tomography (ERT), and Vertical Electrical Sounding (VES) techniques. While geotechnical method involved the collection of soil samples from the study locations for the characterization of the soil properties that are very vital to foundation studies. Nine VES were carried out using Schlumberger array with current electrode spacing varying from 1 to 40 m, with 2-D ERT using Dipole-Dipole electrode array with inter-station separation of 5 m and an expansion factor varied from 1 to 5 while LHP involve Wenner array with an electrode spacing of 5 m interval and was used to determine the vulnerability factors for the building sustainability. The VES interpreta

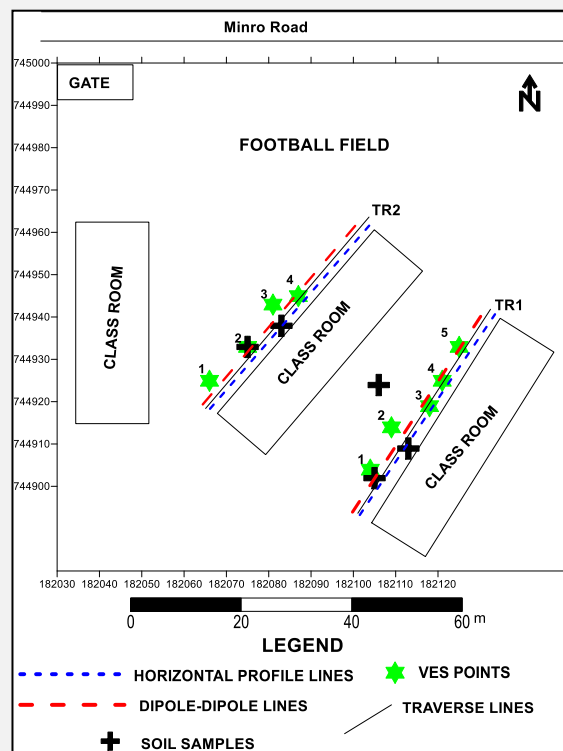
Figure 3. Data Acquisition Map of the Study Area

In this method, three Electrical Resistivity techniques were used, viz; Vertical Electrical Sounding (VES), 2-D Electrical Resistivity Tomography (ERT), and Lateral Horizontal Profiling (LHP) with corresponding configurations such as Schlumberger, Dipole-Dipole, and Wenner (Figure 3).

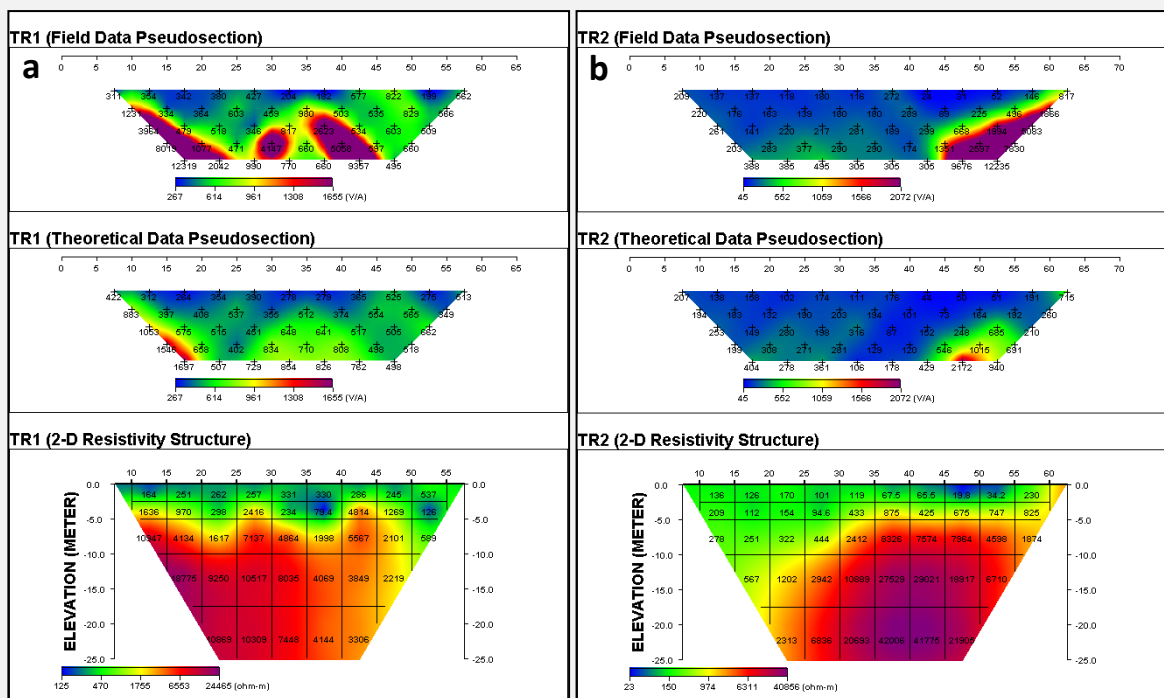
Figure 4. Dipole-Dipole Pseudosection along traverse one(a), traverse two(b)

The analysis of the 2D resistivity imaging using dipole-dipole gave relevant information on the structure settings along the study areas (Figure 4a). Two distinctive formations were obtained from the structural settings, a shallow layer horizon of fewer than 5 m with resistivity variations ranging from 184 to 870 Ω m, reflecting resistivity attributes of moderate structural stability and integrity. While below this layer is an underlying formation of about 25 m thickness with high resistivity attributes values ranging from 1617 to 10899 Ω m, indicative of a layer formation with high structural integrity.

The results obtained revealed the presence of two distinctive formation/structural settings characterized by fairly thick upper layer horizon with apparently low resistivity attributes, characterized of a weak zone/formation with layer resistivity varying from 94.6 to 230 Ωm and layer thickness ranging from 5 to 15 m. this was underlain by a fairly competent but thin layer formation with resistivity attributes ranging from 444 to 8328 Ωm . The characteristic feature of this formation that makes it vulnerable is the drastic fall in the apparent resistivity attributes with depth (Figure 4b).

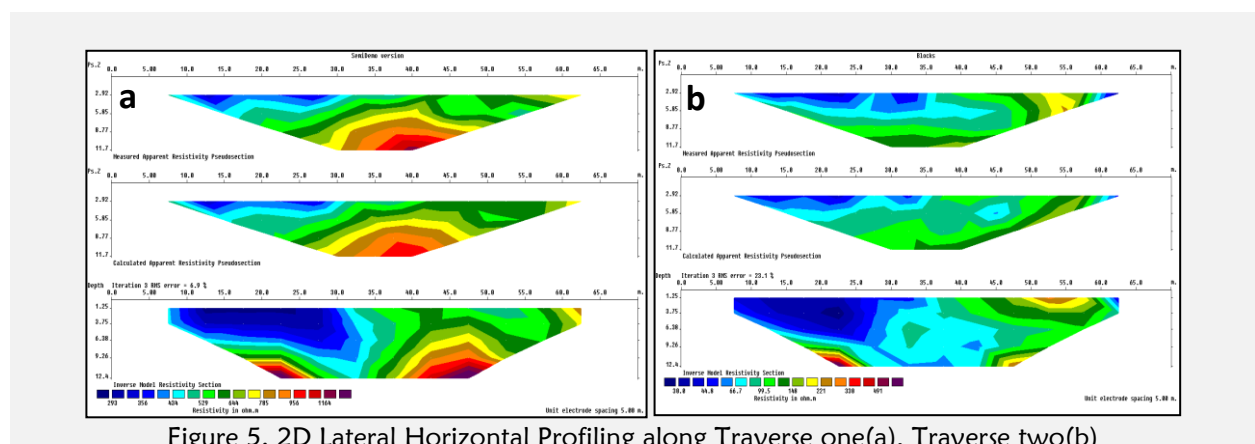
Figure 5. 2D Lateral Horizontal Profiling along Traverse one(a), Traverse two(b)

The lateral profiling conducted at $a = 5\text{ m}$, 10 m , 15 m , and 20 m was processed using RES2D software for a better understanding of its resistivity attributes (Figure 5a). The result obtained showed high structural integrity with layer resistivity variations ranging from 293 to 1164 Ωm . The result explained the reasons for the high vulnerability, low structural integrity failure, and subsidence that occurred along the traverse with apparent resistivity attributes as low as 30 to 99.5 Ωm characterizing more than 85 % of the entire profile (Figure 5b).

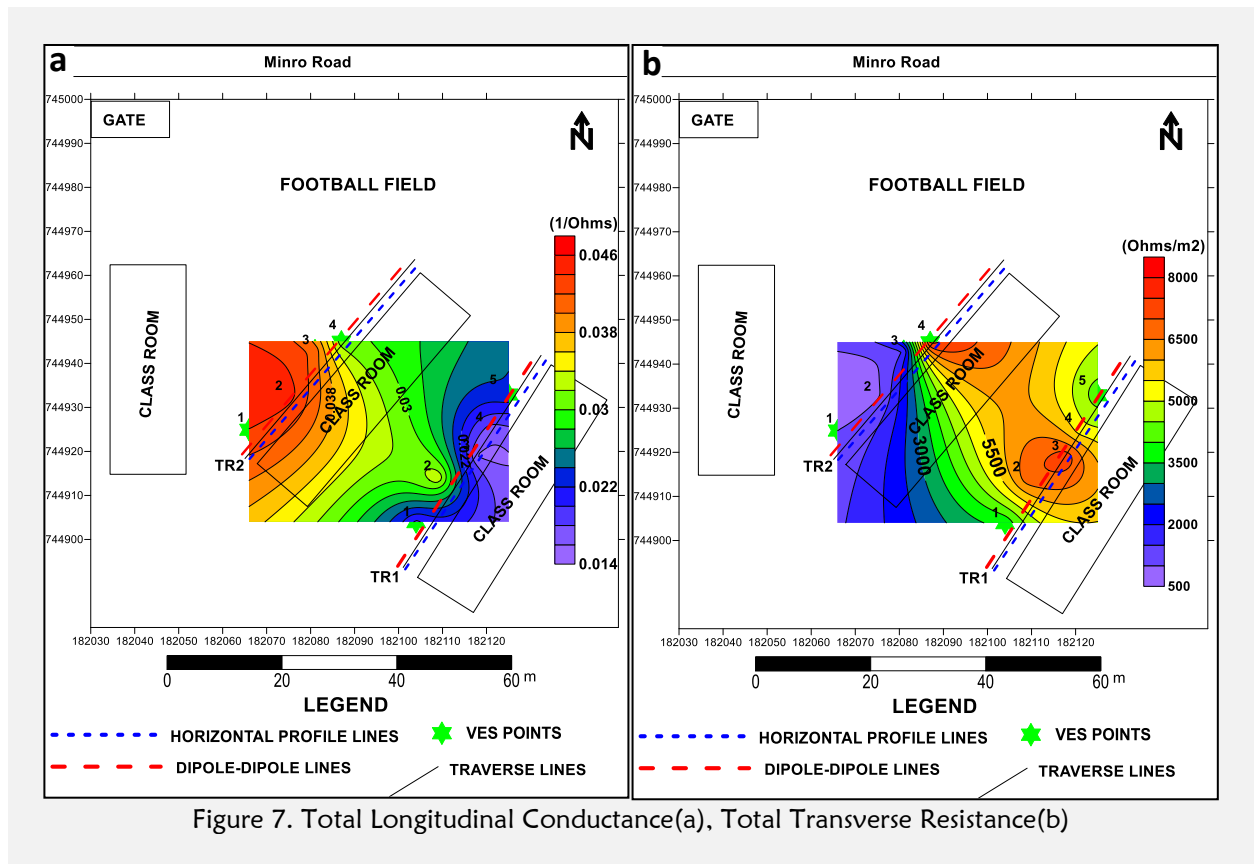
The result obtained from the second-order parameters using the Da-zarrouk principle demonstrates the reason for the failure that occurred mainly as a function of resistivity attributes (Figure 7a). The map was classified into three distinctive regions, mainly regions of high longitudinal conductance with values ranging from 0.038 to 0.046 Ω^{-1} , reflecting zones of high vulnerability at Northwestern, western and central parts of the study area.

The second region falls within the central, northern, and southern regions with values ranging from 0.025 to 0.038 Ω^{-1} , indicating region/zone of moderate weakness, while the third region reflects high resistivity attributes with very low total longitudinal conductance values ranging

from 0.014 to 0.022 Ω^{-1} , reflecting areas of high stability/foundation integrity which correlate effectively with previous results.

Figure 7b showed the total transverse resistance map which clearly explains resistivity attributes of the study area indicative of the structural integrity and was classified into four regions. The western, northwestern, and southwestern part has very low structural integrity with values ranging from 500 to 1500 Ωm^{-2} , while the southwestern and northwestern are indicative of low structural integrity with values ranging from 1500 to 2500 Ωm^{-2} .

The moderate structural integrity with transverse resistance values ranging from 2500 to 3500 Ωm^{-2} was observed at the southwestern and central of the investigated area while the region of high structural integrity with resistivity attributes of transverse resistance values ranging from 4500 to 8500 Ωm^{-2} was observed at the northern, northeastern, eastern and southeastern part of the study area.

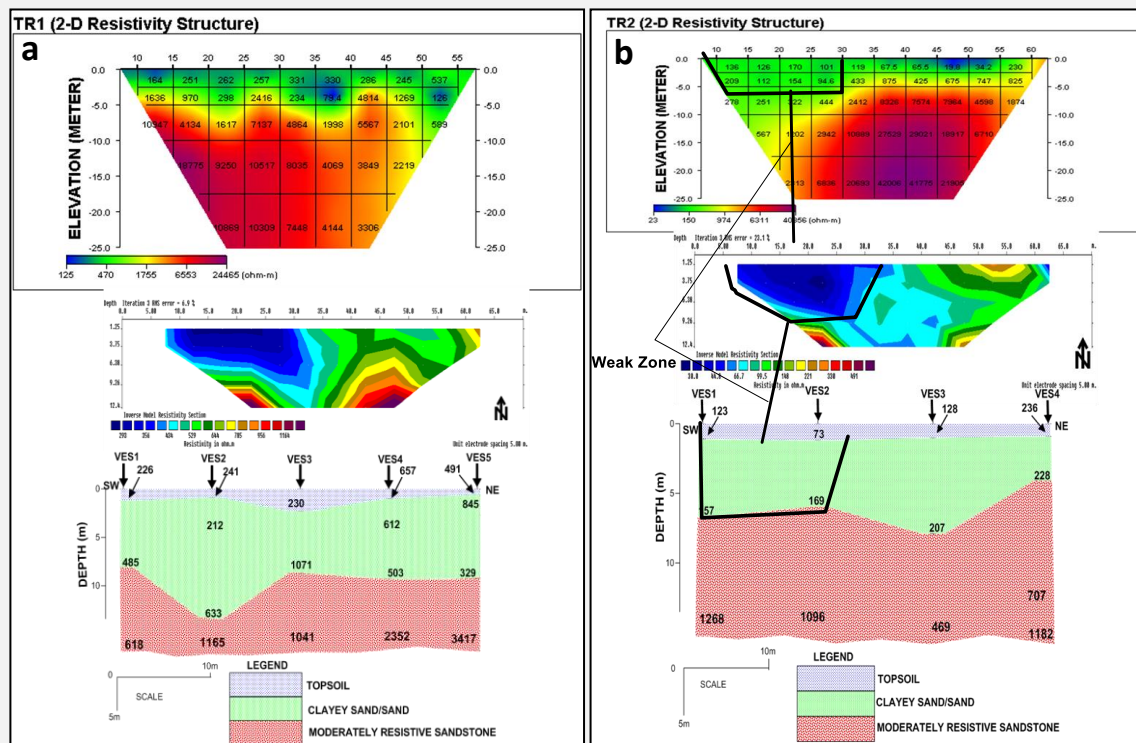
Figure 8. Correlation of Results along Traverse one(a), Traverse two(b)

Figure 8a displays the correlation of dipole-dipole 2-D resistivity imaging, Wenner 2-D resistivity imaging, and Vertical Electrical Sounding along traverse one, which gave relevant information on the characteristic signature of the resistivity attributes. It reveals a near-surface resistive material underlain by thick layer formation of highly resistive materials of high structural integrity which reflected the stability of the structure placed along the profile.

Figure 8b evaluated the resistivity attributes along the traverse from the western part toward the centre of the study area, as revealed that all the three techniques were characterized by near-surface with highly vulnerable materials, and further underlain by materials of very low structural integrity with low resistivity values which justifying the reason for failure and subsidence that occurred along the traverse.

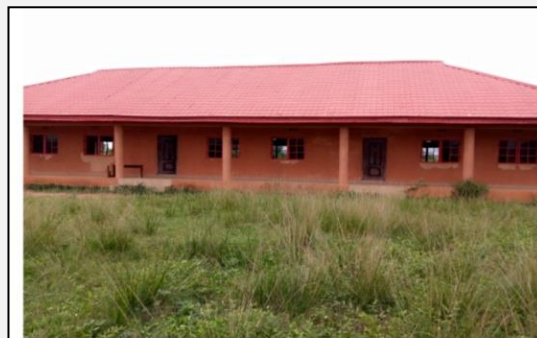
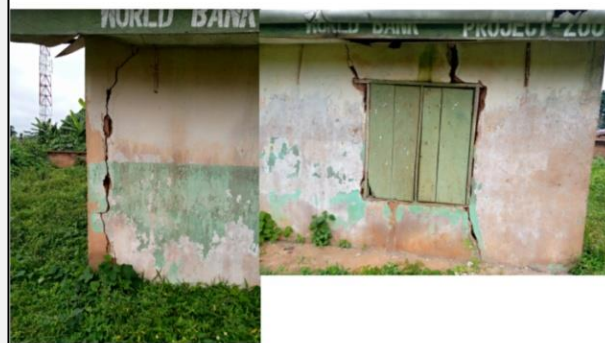
Figure 9. Structure along traverse one and two

The same approach was carried out along this traverse for the various spread length. The analysis of the results obtained indicated that vulnerability factor for the building to fail was 100 % at a = 5 m, 10 m, 15 m, and 20 m (Table 3). Hence, this was what leads to a major crack and sinking that were observed along the classrooms in traverse two.

Furthermore, the vulnerability factor for failure was zero percent (0%), implying a high degree of soil stability and competence. Since the foundation of the building was laid within the upper 5 m, the vulnerability factor that the building will fail was high within the upper 10 m, which leads to a major crack and sinking that were observed along the classrooms (Table 5).

The result obtained from the vulnerability factor of Lateral Horizontal profiling and 2D ERT along traverse one and two at the various spread length of $a = 5, 10, 15, 20$ m, and n of 1 to 5 showed effective correlation. The results were able to explain as well as justify the reason for the high degrees of stability of the structure along traverse one and the reason for structural failures and subsidence that occurred along traverse two (Figure 9).
