The Effect of Welded Splice with Predetermined Gap of Concrete Spun Pile on The Response of Low Strain Integrity Test

Budi, G.S.^{1*} and Tanaya, L.S.²

Abstract: This paper presents the velocity wave of concrete spun piles with welded splice. The stress wave velocity was recorded using Pile Integrity Test. Two specimens were prepared in the experiment. The first sample was prepared visually no gap between the two end-plates of connected piles, while the second specimen was prepared by inserting 5mm thick steel plate into the splice to create a gap in its connection. The results show that a spike of reflecting stress wave still develops at the splice with and without gap, regardless the splice was welded in full circle. The relatively high spikes of reflecting waves at pile toe are noticed for both specimens with and without gaps. It shows that the full welded splice able to transfer stress wave velocity. A good quality of welded splice can be indicated by the reflecting wave at the pile toe, regardless the reflecting wave development at the splice.

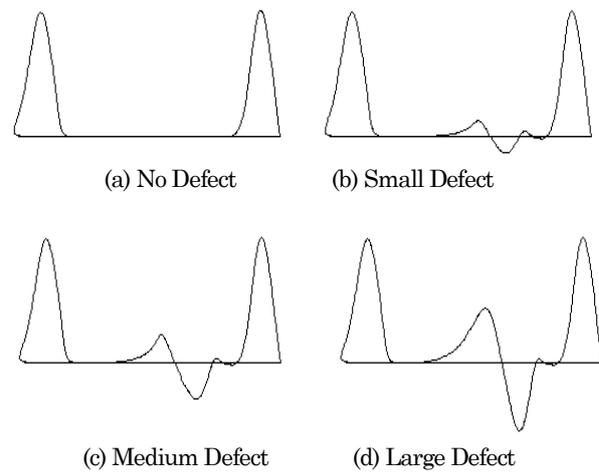
Figure 2. Basic Interpretation of PIT

The recorded PIT Graph is a velocity on time domain function, in which wave propagation mechanics illustrated that the pile integration can be interpreted based on pile impedance, Z . The interpretation of PIT result can be bias because of the number of unknown variable that caused a change of impedance, such as pile defect, soil resistance, pile splice, in-homogenous material, etc. However, the location and severity of pile defect can be interpreted simply by observing the impedance spike on the PIT recorded graph. The basic interpretation are illustrated in Figure 2. Figure 2a shows that the integrity of pile is good since there is no reflecting wave between the two spikes at the head and toe of the pile. The development of spikes of reflecting wave in the area between two spikes at the head and toe of the pile is an indication of defect at the pile. The smaller the spike the smaller the defect, and vice versa, as illustrated in Figure 2b, Figure 2c, and Figure 2d.

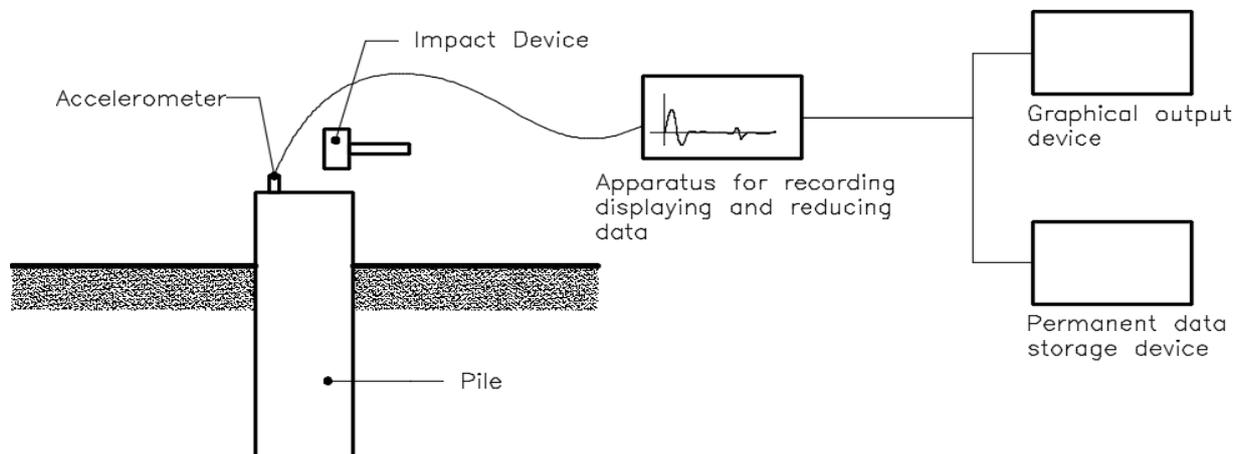
Figure 1. Schematic Diagram of PIT (ASTM D 5882)

Pile Integrity Test (PIT) is used to determine the integrity of pile foundation by mean of recording the travelling stress wave impacted at the pile head.

Pile Integrity Test (PIT) is a Non Destructive Test (NDT) technique, where the methods of testing fall into two categories. The first one is Pulse Echo Method (PEM), where pile head motion is measured as a function of time, and time domain record are then evaluated for pile integrity. Secondly, the Transient Response Method (TRM) is where the pile head motion and force are measured as function of time, the data are then evaluated usually in the frequency domain. Practically, the PIT referred mostly to Sonic Pulse Echo Method, which using an accelerometer and hand held hammer which known as low strain in dynamic testing (ASTM D5882). The schematic diagram of PIT is depicted in Figure 1. Details of the theoretical background and the development of PIT are discussed in various literatures [6-8].

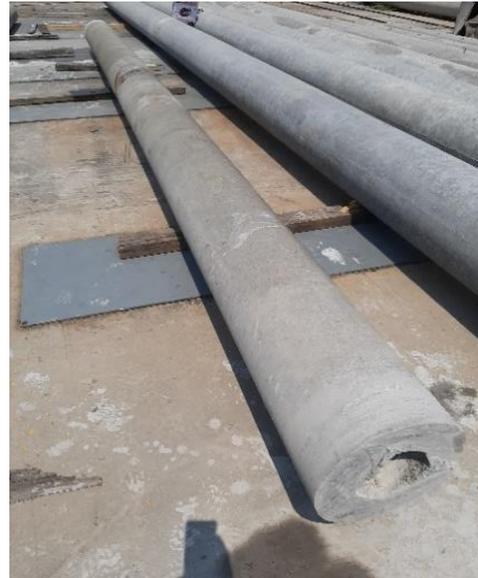
Figure 3. Precast Pile Specimens

The research was performed to investigate the response of recorded stress wave velocity at the welded splice of precast prestressed spun pile diameter of 350 mm using PIT. There were two (2) sets of spun piles connected by welding at its endplates. The splice of the first specimen of pile was welded without any gaps (observed visually) between the two endplates, while the second specimen was prepared with predetermined gap between the two endplates. The gap was generated by inserting a 5 mm thick steel plate. The total length of the specimen was 7000 mm, which was connected in the middle of its length (Figure 3). The pile specimen exhibits concrete strength (f_c') of 42 MPa, 6 PC-bars with diameter of 6 mm, and 6 mm thick steel endplate.

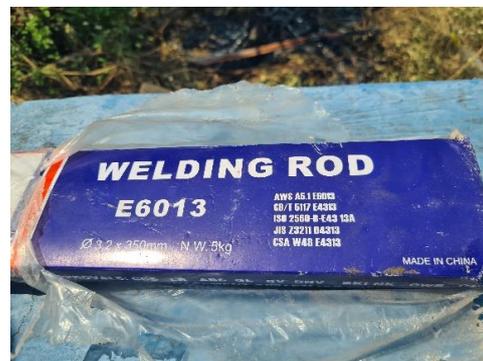
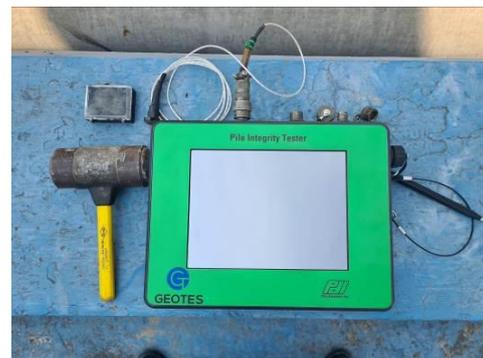
Figure 4. (a) Welding Rod; (b) PIT and its Accessories

The specimen was connected using welding rod type E6013, which has diameter of 3.2 mm (Figure 4a) then tested using low strain integrity apparatus (PIT) as depicted in Figure 4b.

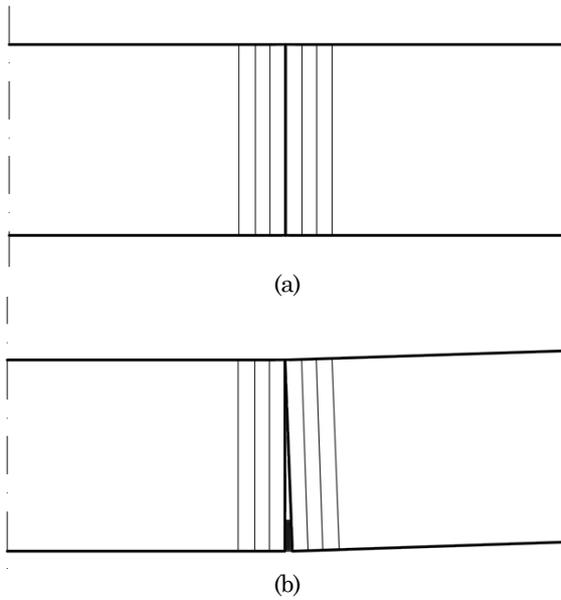
Figure 5. Pile Connection (a) No Gap; (b) With Gap

The first specimen was prepared in such a way that visually there was no gap. There was no special effort to push the two parts of the pile to close the gap. The connection was performed by welding the two end-plates without gap (Figure 5a). Figure 5b shows the second specimen that was prepared with predetermined gap by inserting a 5 mm thick steel plate at one side of the area into the space between endplates. The two endplates of the piles were then welded at four points to tie the end-plates (Figure 5)

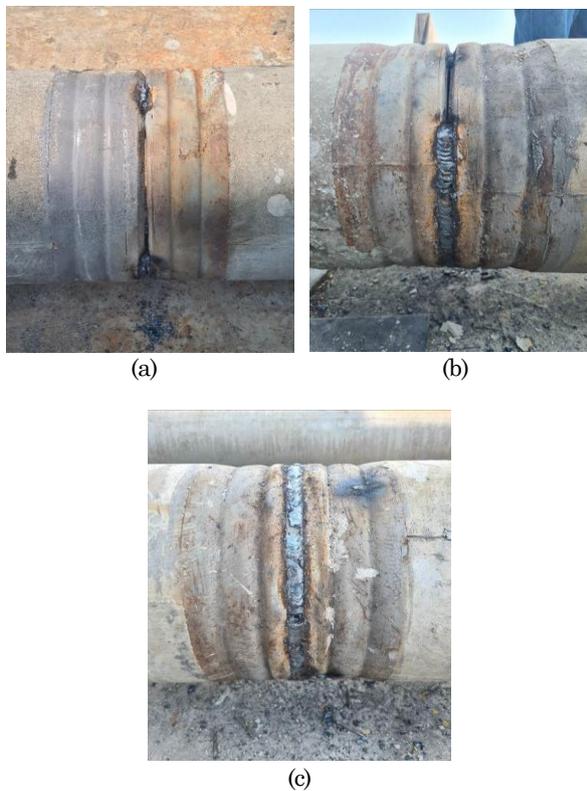
Figure 6. Spun Pile Connection with Gap (a) Welding at Four Points; (b) Welding at Half Circle; (c) Full Welding

First of all, the endplates were welded in four points (Figure 6a), then three layers of welding were applied in a half circle of the splice (Figure 6b). Finally, the splice was welded in full circle in three layers (Figure 6c). The three conditions of the specimen were tested using PIT to observe effect of those change of impedance.

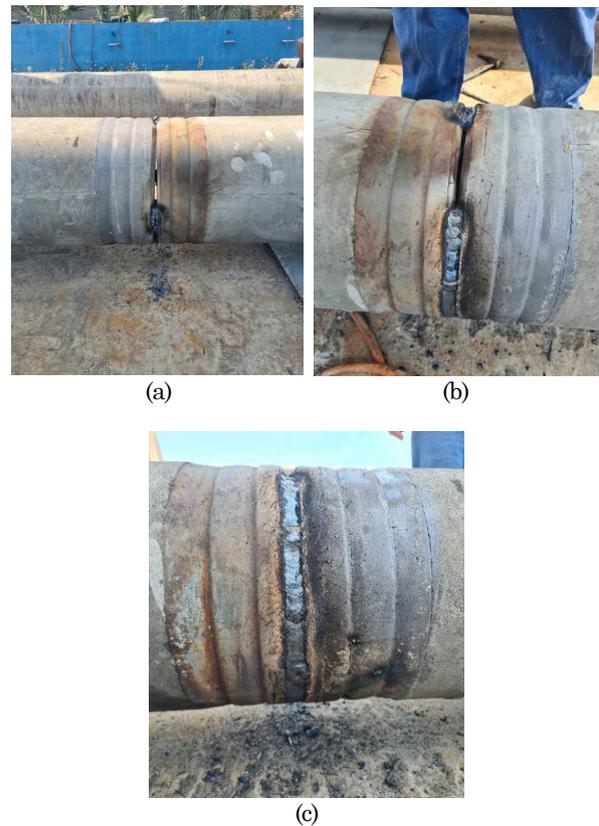
Figure 7. (a) Welding at Four Points; (b) Welding at Half Circle; (c) Welding Full Circle

Similar to the preparation steps for specimen with splice without gap, a 5 mm thick steel plate was inserted into the edge of the two endplates as shown in Figure 7a, then three layers of welding were applied in a half circle of the splice (Figure 7b). Finally, the splice was welded fully in three layers (Figure 7c). The three (3) conditions of specimen were tested using PIT.

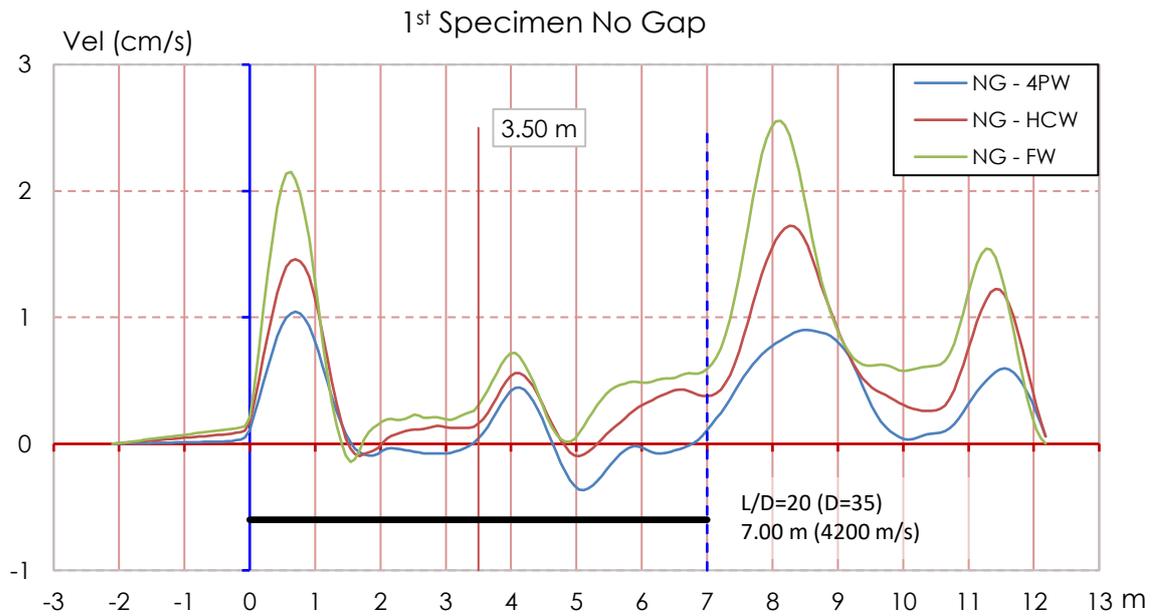
Figure 8. Response of Stress Wave at the Splice with no Gap, which were Welded Together at Four Points (NG – 4PW), Half Circle (NG – HCW), and Full Circle (NG – FW)

The results of PIT on the specimen without gap is depicted in Figure 8. It shows that when the splice of the pile is welded at four points (point welded), the stress wave unable to propagate through the splice; the wave is reflected back. In other words, the pile is assumed exhibits the length of 3500mm. When splice was welded half circle of its periphery, a relatively high spike of response wave (reflecting wave) at the distance of 7000mm (pile toe) was observed. The spike of wave velocity is as high as that of the initial one. When the splice was welded in full circle, the spike of recorded reflection wave

velocity at the distance of 7000mm is higher than that at the impact location. Figure 8 shows that the spike of wave velocity at the distance of 7000mm increases with the welded area at the splice. The spike of reflecting wave velocity at the splice that was welded in full circle might be caused by a gap that still exist between the endplates regardless visually there was no gap noticed. The gap can not be entirely closed since there was no special efforts

to push the two segments of the specimen to contact each other, to replicate the welding process of a splice in the field, where to upper pile that will be connected is laid down in fully contact on the pile head of the lower pile previously installed.

The splice that was prepared visually without gap still exhibits gap, which changes the impedance of the specimen so that generates reflecting wave that recorded as spike of wave velocity

The spike of reflecting wave velocity at 7000 mm (pile toe) for splice welded at four points relatively lower than that of initial impact. It is very likely the repetition of reflecting wave (spike) at 3500 mm (at the splice) rather than the wave response at the distance of 7000 mm (pile toe) since the stress wave can not propagate through the splice

The relatively high spikes of velocity of reflecting waves at the distance of 7000 mm (pile toe) are noticed for splice that welded in full circle for both specimen with and without gaps. It shows that the full welded splice able to transfer stress wave velocity

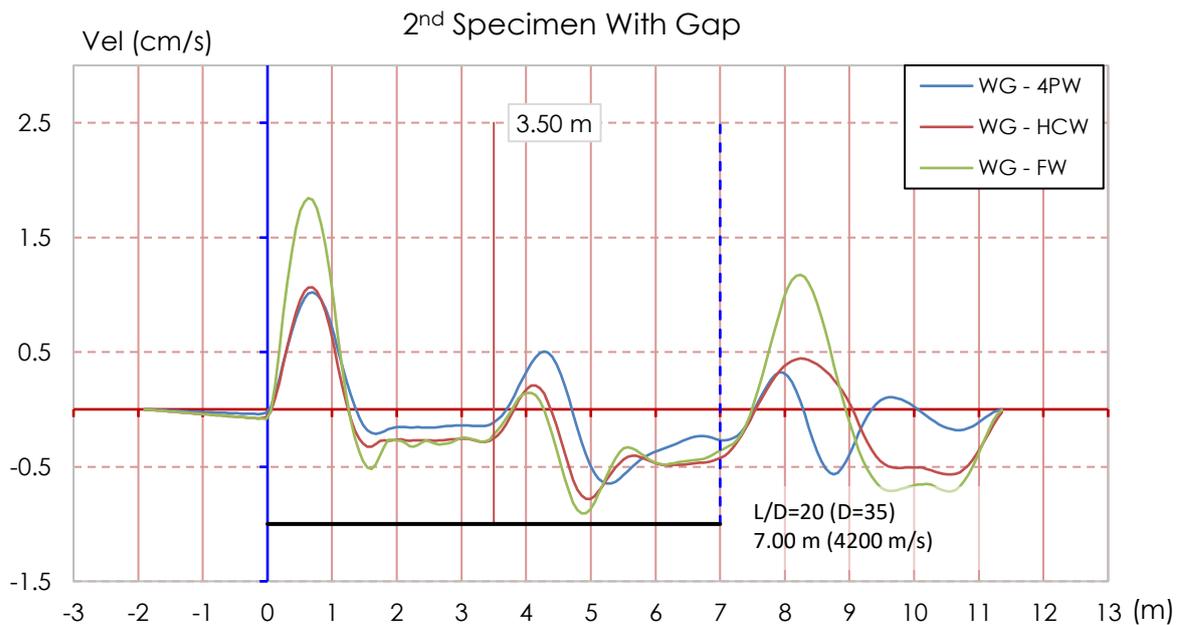
Figure 9. Responses of Stress Wave at the Splice with Gap, which were Welded Together at Four Points (WG - 4PW), Half Circle (WG – HCW), and Full Circle (WG – FC)

The response of recorded travelling wave velocity of the specimen which was connected with a gap at its splice is presented in Figure 9.

A spike of reflecting stress wave velocity still develops at the splice with and without gap of spun piles regardless the steel endplates was welded in full circle.

A good quality of welded splice can be indicated by comparing the peak at the splice to that at the impact. The reflecting wave at the pile toe was apparently clear regardless the reflecting wave development recorded at the splice.
