## LANDSCAPE EVALUATION OF VISUAL ATTRACTIVENESS TO IMPROVE URBAN LIVING AT NAVA PARK

The Botanic Park at Nava Park has an area of 10 hectares, consisting of green areas and open spaces for recreation and various uses, including 3.5 hectares of the artificial lake and a 15 km jogging track. However, a lack of green planning affects its attractiveness to visitors of the Botanic Park, and its existing visual potential has not been optimally utilized. This is apparent from the inexistence of outdoor activities facilities that could take advantage of this potential. The study aims to identify visual potential as the basis for developing the landscape of the Botanic Park. This study used a qualitative method with observation as the research instrument and a potential visual assessment using the Visual Resource Assessment Procedure (VRAP) and Master Plan Evaluation. Data analysis used interval classes, classified according to their visual qualities. The research findings were the visual quality of the landscape, classified into three zones of high, medium, and low visual qualities, which would help place facilities in further landscape development. The best macro visual qualities were f

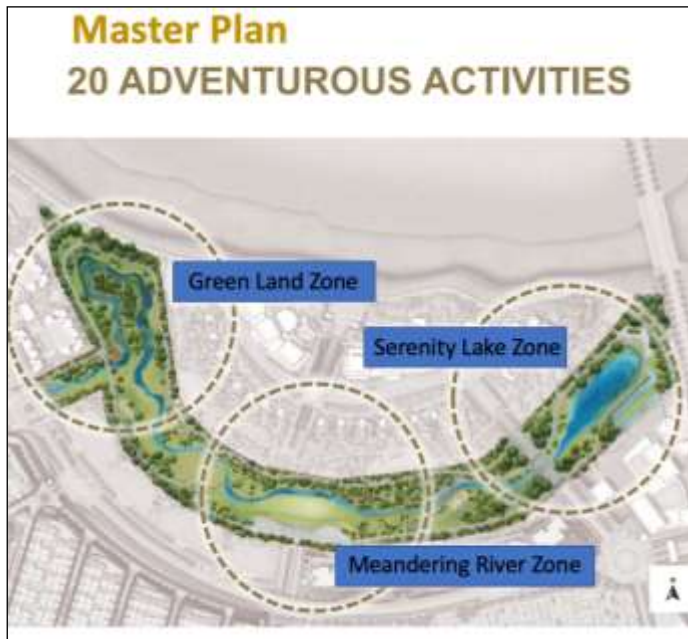
Figure 2. Zoning Master Plan

The Botanic Bark at Nava Park is divided into three zones, which are the Green Land Zone, the Meandering River Zone, and the Serenity Lake Zone. The zoning was based on natural potential found in the site and the types of activities are shown in Figure 1.

- Lawn Seat
- Viewing Deck
- Gazebo
- Water Platform
- Bicycle Station
- Guard House
- Spring Lake
- Artificial Hill
- Adventure Playground
- Jungle Walk
- River Stream
- Plaza/Amphitheater
- Active Lawn
- Recreational Lawn
- Outdoor Fitness
- Wetland Bird Sanctuary
- Jogging/Cycling Track
- Promenade Plaza
- BBQ Pavilion

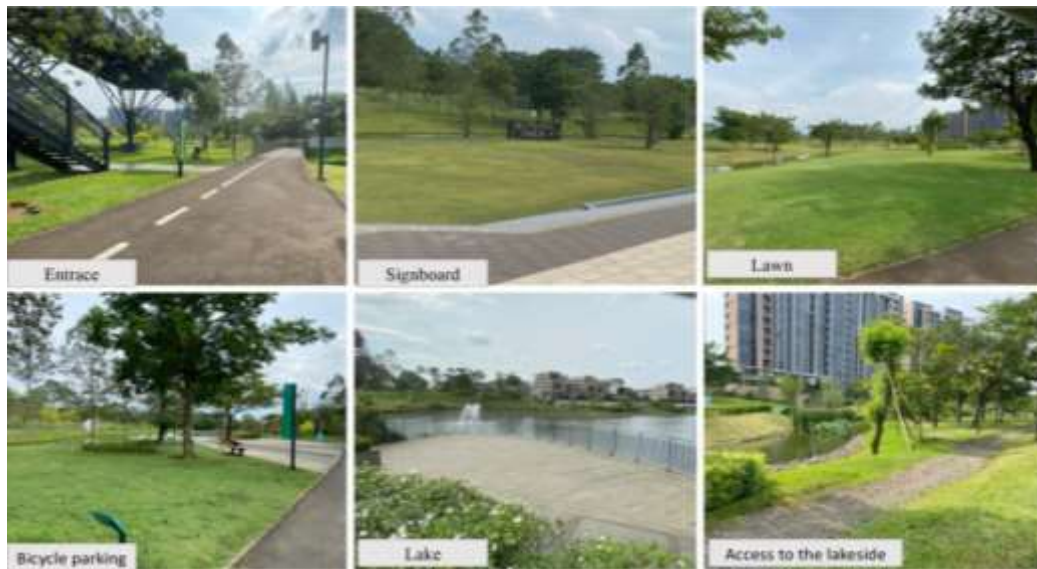
**Figure 4.** Serenity Lake Zone  
 (Source: Agus Purniawan, 2022)

Based on the macro visual assessment of the Serenity Lake Zone (Zone A), the total visual quality score is 12. The above score was added by a score of 3 for a special consideration that the location is free from garbage. Different visual qualities and aesthetic elements were also found. Total score for the Serenity Lake Zone: 12 + 3 = 15 points.

Figure 4 shows that the condition of the Serenity Lake Zone is quite good, but it still has room for improvement by adding visual landscape elements, such as fountains as well as drinking fountains. These could provide an identity and a good image for the zone. Arrangement of the vegetation could be more thoughtful, incorporating plants with different colors of flowers to enhance the zone’s aesthetics and attractiveness for visitors. Tropical trees that grow tall with broad leaves could also be valuable to control microclimate in the zone. Furthermore, it could benefit from better and lovelier lighting to provide interesting landscape attractions at night. The zone could install signages to clearly divide facilities such as the jogging track, the cycling track, and pedestrian track. Last but not least, more trash bins that are strategically placed are also needed.

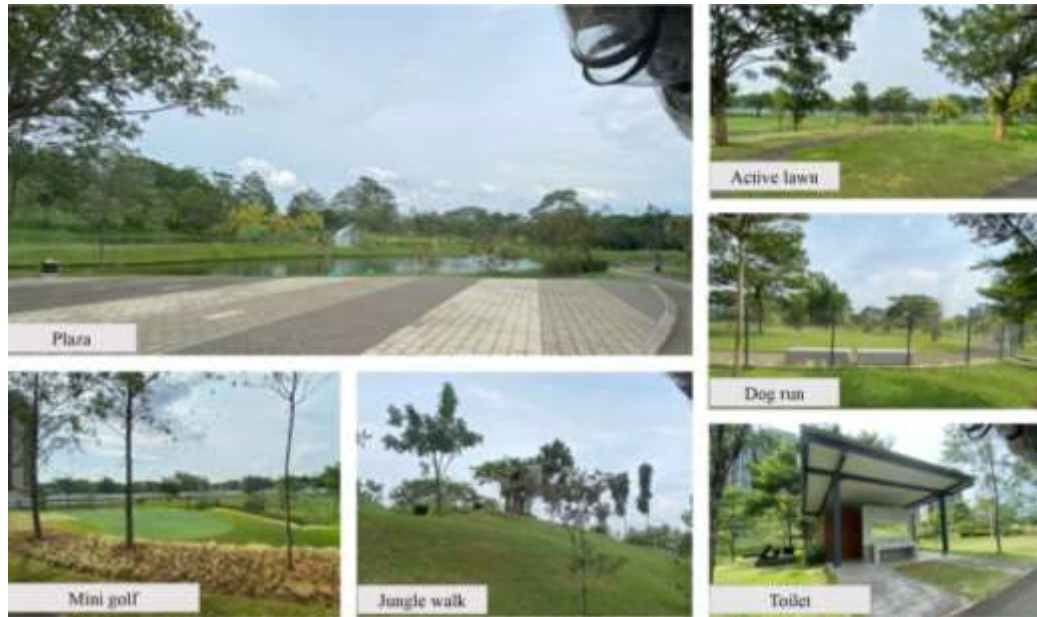
**Figure 5.** Meandering River Zone  
 (Source: Agus Purniawan, 2022)

Based on the macro visual assessment of the Meandering River (Zone B), the total visual quality score is 14. The above score was added by a score of 3 for a special consideration that the location is free from garbage. Different visual qualities and aesthetic elements were also found. Total score for the Meandering River Zone: 14 + 3 = 17 points.

Figure 5 establishes that the Meandering River Zone has done quite well. However, it could still benefit from further improvements. Just like the Serenity Lake Zone, facilities such as fountains and drinking fountains could be added for extra appeal. It is also crucial to enhance the irrigation and drainage systems by installing biopori or infiltration wells to ensure that water is infiltrated before being poured into the lake. A more diverse vegetation, microclimate features such as tall trees with broad leaves, attentive lighting, signages as well as more trash bins could encourage visitors to stay longer in the Meandering River Zone.

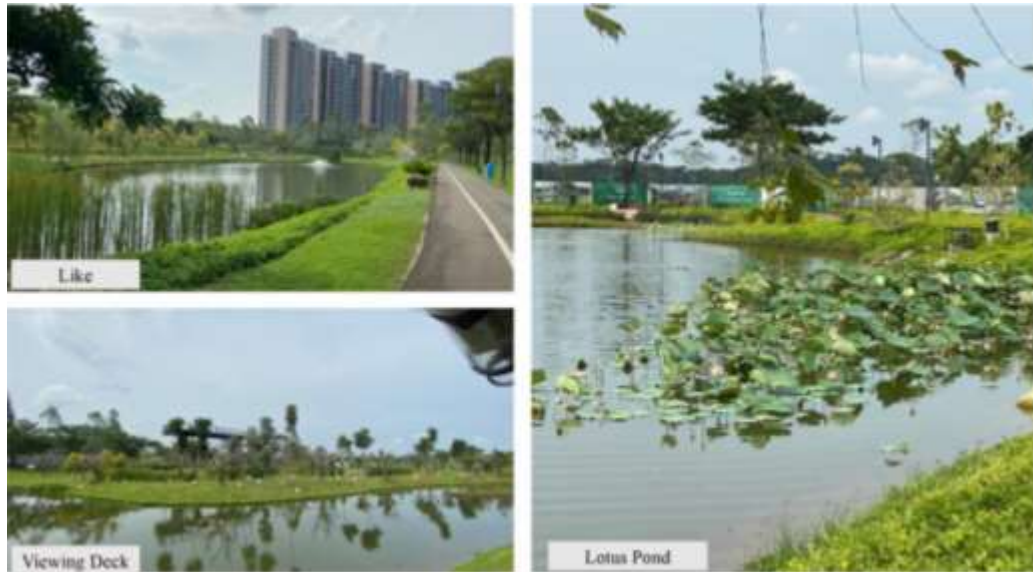
**Figure 5.** Green Land Zone

Based on the macro visual assessment of the Green Land (Zone C), the total visual quality score is 11. The above score was added by a score of 3 for a special consideration that the location is free from garbage. Different visual qualities and aesthetic elements were also found. Total score for the Green Land Zone:  $11 + 3 = 14$  points.

Figure 5 shows a decent condition of the the Green Land Zone. However, improvements could add its aesthetics. Installments of more visual landscape elements, such as fountains as well as drinking fountains are recommended. Just like in the other zones, it also needs more diverse vegetation and microclimate features such as tall trees with broad leaves. Finishing touches such as attentive lighting, signages and more strategically located trash bins could enhance visitor’s enjoyment in the Green Land Zone.
