VISUAL LANDSCAPE STUDY WITH THE VISUAL RESOURCES ASSESSMENT PROCEDURE METHOD AT PEKANBARU CITY GOVERNMENT OFFICES

Ramadhyna Prameswari Asyva¹, Qurrotu' Aini Besila¹, Rini Fitri¹, Titiak Debora¹

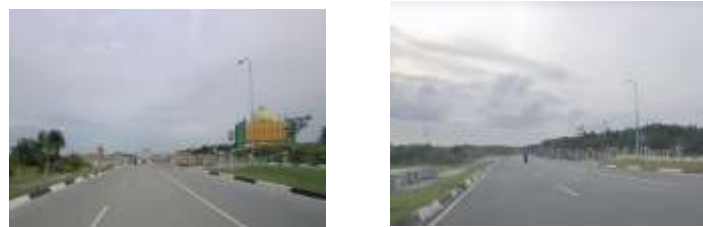
Figure 6. The Picture of Entrance Zone
 Source : Asyva, 2022

The receiving area is the access that is passed from outside the site to the site and vice versa. This area needs a welcoming impression and good aesthetics because it can be the initial and final impression felt by visitors or site users.

NO	VARIABLE	Distinct 3	Average 2	Minimal 1	DESCRIPTION
1	<i>Water</i>		✓		<ul style="list-style-type: none"> Water element in <i>roundabout</i>
2	<i>Landform</i>			✓	<ul style="list-style-type: none"> Flat ground type
3	<i>Vegetation</i>		✓		<ul style="list-style-type: none"> 25-50% Lack of vegetation for shade
4	<i>Landuse</i>			✓	<ul style="list-style-type: none"> Recreation type Sub urban
5	<i>User Activity</i>	✓			<ul style="list-style-type: none"> High frequency
6	<i>Special concideration</i>	✓			<ul style="list-style-type: none"> <i>Landmark</i> Visual facilities Aesthetic elements
Total <i>Visual Quality</i>		6	4	2	12

SPECIAL CONSIDERATION	Yes 1	No 0
Does this zone contain Cultural or Historical Landmarks?	✓	
Does this zone or any known deep area have different visual facilities or animal viewing?	✓	
Is this zone free from pollution and garbage?		✓
Are there other aesthetic elements that add to this resource?	✓	
TOTAL Special consideration***	3

Based on the assessment of the visual quality of the landscape carried out on a macro basis in the receiving zone, the visual quality class management has 12 points, which are included in the partial retention area. In area A it is necessary to add vegetation types both in terms of aesthetics and function, because this zone is the initial and final impression of site users when they want to enter or leave the area, it is also necessary to increase the water element which can be done by developing a water feature or adding a pool to increase comfort.

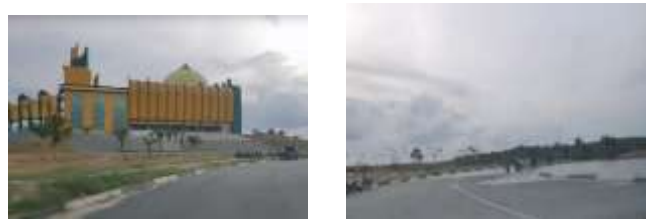
Figure 7. The Picture of Islamic Center Zone
 Source : Asyva, 2022

The Islamic Center is a view point because it has a beautiful building architecture and can be developed in terms of landscape visual aesthetics. This area is often used by site users as a place of worship, therefore it is necessary to consider landscape design in the form of aesthetics, comfort, and potential views that lead to the Roundabout 2 area as a vocal point on the site.

NO	VARIABLE	Distinct 3	Average 2	Minimal 1	DESCRIPTION
1	Water				<ul style="list-style-type: none"> • No water element
2	Landform			✓	<ul style="list-style-type: none"> • Flat land surface type
3	Vegetation			✓	<ul style="list-style-type: none"> • 25-50% • Less diverse vegetation
4	<i>Landuse</i>		✓		<ul style="list-style-type: none"> • Sub urban
5	<i>User Activity</i>		✓		<ul style="list-style-type: none"> • High frequency • Worship
6	<i>Special concideration</i>	4			<ul style="list-style-type: none"> • Landmark • Visual facilities • Free of pollution and garbage • Aesthetic elements
Total <i>Visual Quality</i>		4	4	3	11

SPECIAL CONSIDERATION	Yes 1	No 0
Does this zone contain Cultural or Historical Landmarks?	✓	
Does this zone or any known deep area have different visual facilities or animal viewing?	✓	
Is this zone free from pollution and garbage?	✓	
Are there other aesthetic elements that add to this resource?	✓	
TOTAL Special concideration***	4

Based on the assessment of the visual quality of the landscape that was carried out on a macro basis at the Islamic Center Zone, the management of the visual quality class totaled 12 points, which was included in the partial retention area, by changing some designs that were still less attractive so that the designs were better and more attractive. The availability of buildings that are good in terms of architecture, needs to be balanced with landscape aesthetics, so in zone B it is necessary to add vegetation types both in terms of aesthetics and function, because this zone is a place of worship used by site users, therefore it is necessary to have vegetation and its function.

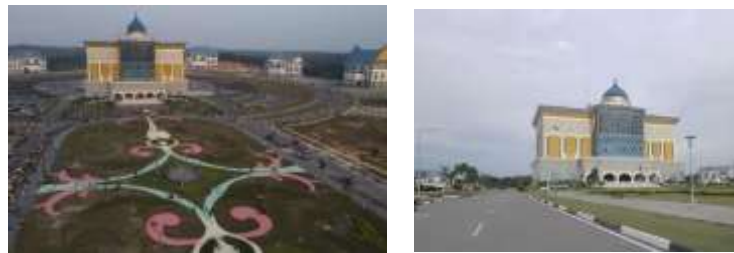
Figure 9. The Picture of SKPD Government Zone
 Source : Asyva, 2022

In this area there are many activities / activities that are often used by site visitors, the plaza area becomes a gathering area for site visitors and this area has the potential for development in terms of landscape aesthetics because it is supported by the potential view of Pekanbaru City Government Office buildings as well as the development of site functions so that user more comfortable.

NO	VARIABLE	Distinct 3	Average 2	Minimal 1	DESCRIPTION
1	<i>Water</i>				<ul style="list-style-type: none"> • Water element in the plaza
2	<i>Landform</i>			✓	<ul style="list-style-type: none"> • Flat land type
3	<i>Vegetation</i>		✓		<ul style="list-style-type: none"> • 50%-75% • Planting pattern can be developed
4	<i>Landuse</i>			✓	<ul style="list-style-type: none"> • Sub urban • Recreation
5	<i>User Activity</i>	✓			<ul style="list-style-type: none"> • High activity frequency • Gathering
6	<i>Special concideration</i>	4			<ul style="list-style-type: none"> • Landmark • Visual facilities • Pollution and waste free • Aesthetic element
Total Visual Quality		7	2	2	11

SPECIAL CONSIDERATION	Yes 1	No 0
Does this zone contain Cultural or Historical Landmarks?	✓	
Does this zone or any known deep area have different visual facilities or animal viewing?	✓

Is this zone free from pollution and garbage?	✓	
Are there other aesthetic elements that add to this resource?	✓	
TOTAL Special consideration***	4

Based on the assessment of the visual quality of the landscape carried out macro in the Office Zone of the Regional Work Unit / SKPD, the visual quality class management totals 11 points, which is included in the partial retention area, by changing some designs that are still less attractive so that the design is better and more functional. The availability of good buildings in terms of architecture, needs to be balanced with landscape aesthetics. Zone C has a high level of activity but still needs a good arrangement of plants to make it more attractive and comfortable. This zone also has the potential to become a landmark because it is located in the center of the Pekanbaru City Government Office Area.
