Analysis Reducing Slum Settlement by Road Improvement (A Case Study: Jawa Lama Village Village, Lhokseumawe, Aceh-Indonesia)

¹Department of Civil Engineering, Universitas Malikussaleh, Aceh Utara

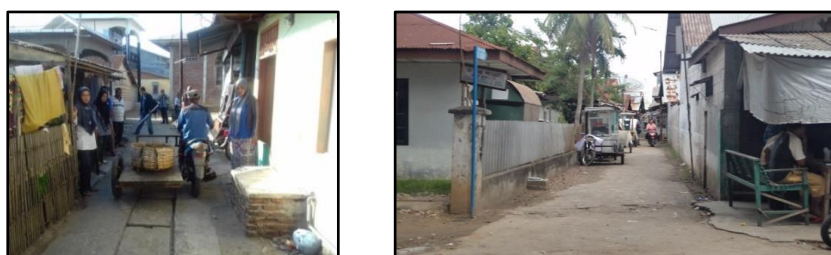
Figure 1. Road Condition at Murthadahuddin Hamlet (left) and road condition at Cemara Hijau Hamlet (right) (Source: Observation)

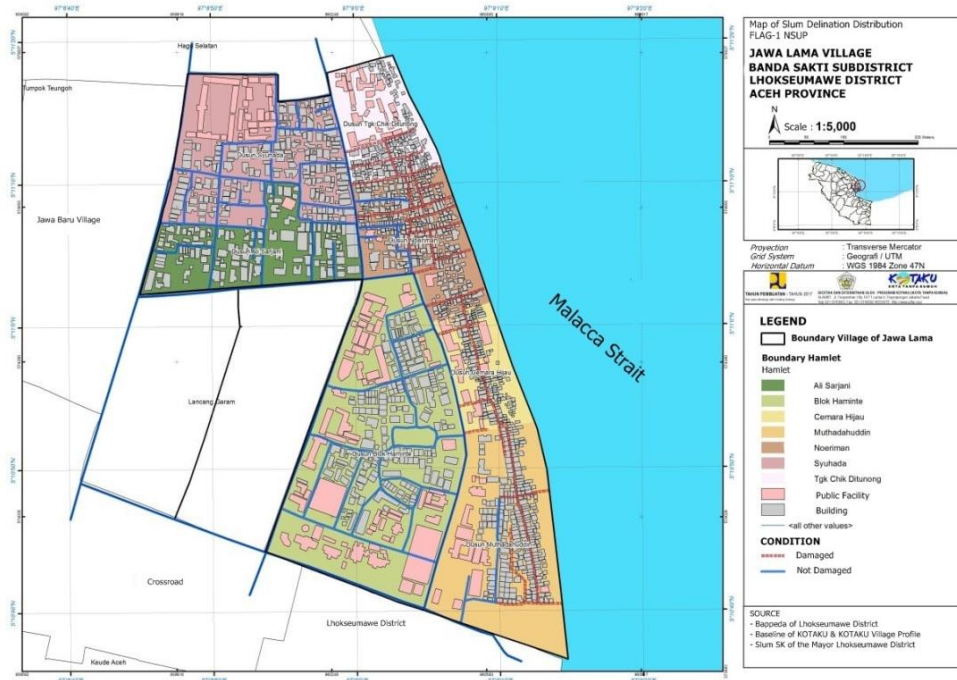
Figure 2. Road Condition Map (Source: ArcGIS map KOTAKU, 2017)

This study suggests the damaged road found only at four hamlets, as shown in Figure 2. The interesting thing is the location of damaged road. This study finds that most the damaged road is at along the seashore and at the back of government and military office. The other slum indicators of damage drainage, poor sanitation, poor waste management, inadequate water supply, building condition, and fire-prone are observed at the same hamlets.

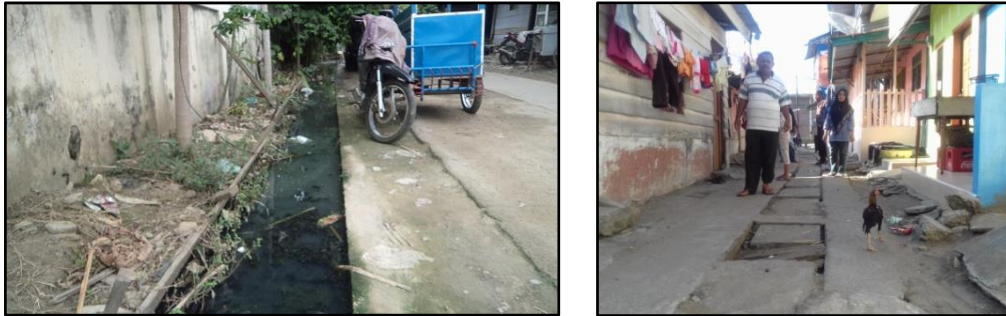
Drainage at Jawa Lama Village is laid along the local road. The drainage system at a local road with width > 1.5 meter is an open system and located on the left or right side, meanwhile the drainage system at a local road with width < 1.5 meter is a closed system and located on the middle road. This study found that the drainage condition is very poor, damage, full and some even overflow.

Figure 3. Drainage condition at four hamlets (Source: Observation)

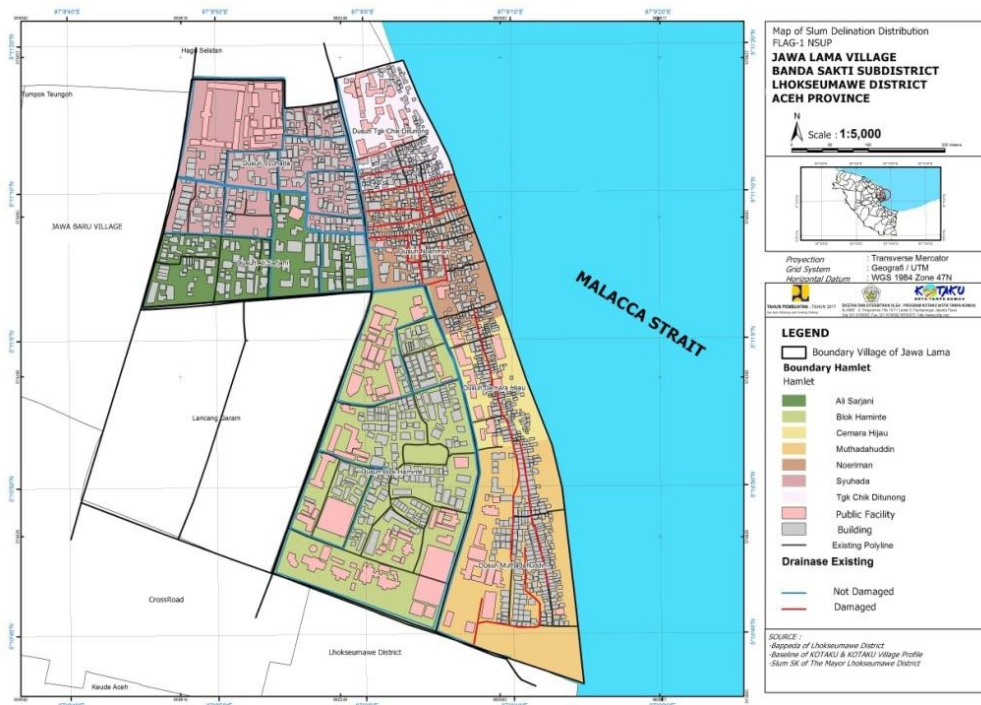
Figure 4. Drainage condition map, Source: ArcGIS map (KOTAKU, 2017).

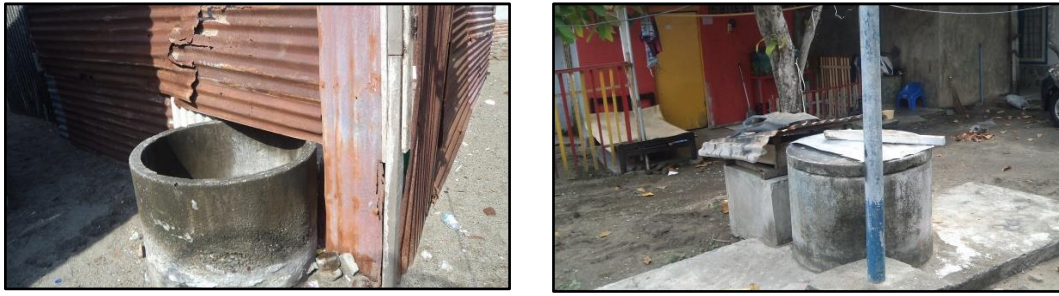
For water supply, mostly community used water well as daily water needs. Water well is used for daily needs, such as shower, laundry, etc. Meanwhile, for drinking water, the community buy and use refill water as daily needs.

Figure 5. Water supply at four hamlets (Tgk Chik Ditunong, Noeriman, Cemara Hijau, and Murthadahuddin), Jawa Lama Village, Source: Observation.

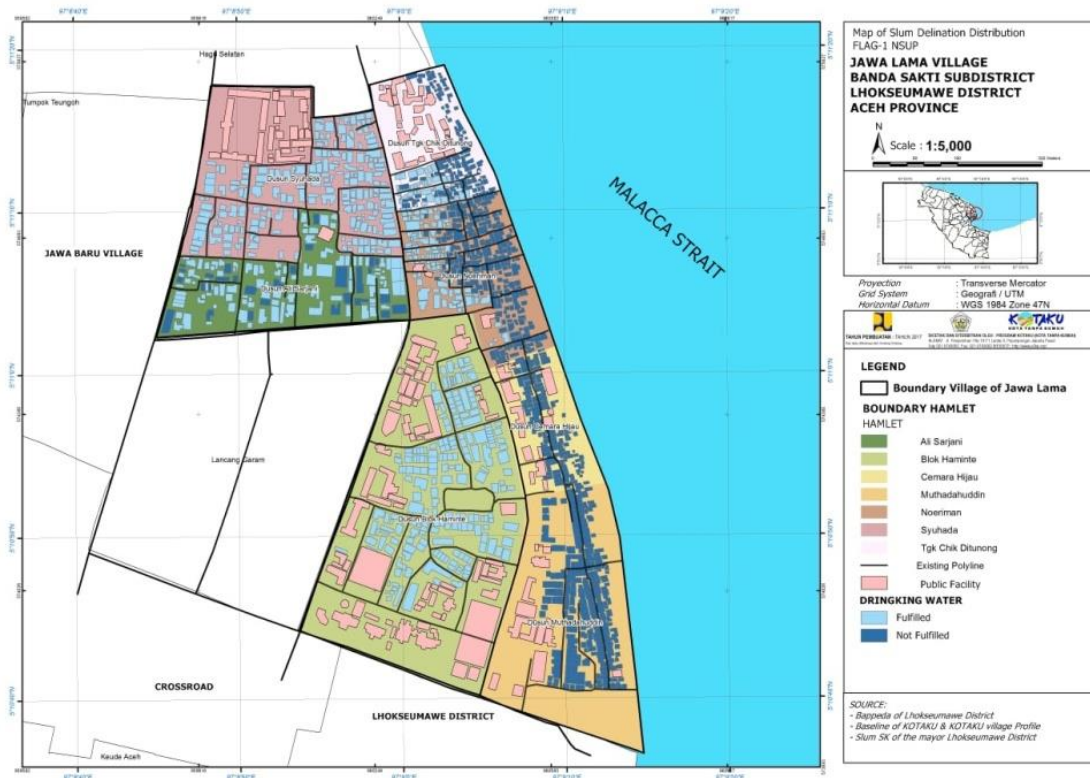
Figure 6. Inadequate water supply indicator map, Source: ArcGIS map (KOTAKU, 2017).

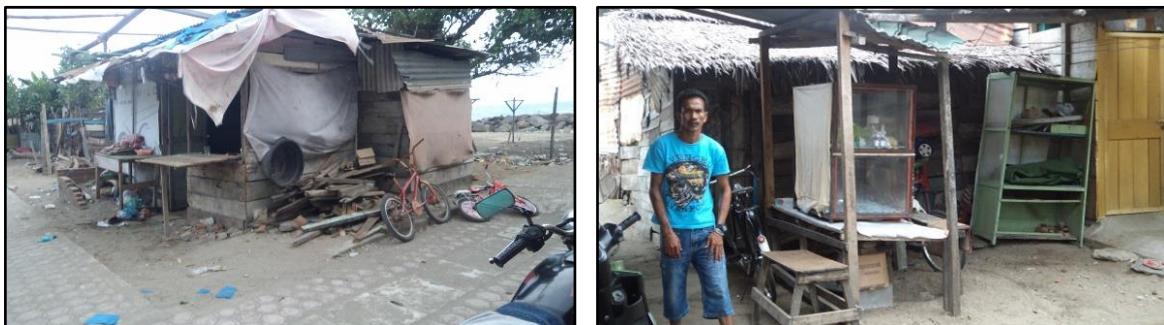
The housing characteristic at four hamlets, Jawa Lama Village, is timber, small, no house yard, semi-detached house, and dense. The dense settlements relate to fire-prone and risk area.

Figure 7. House characteristic at four hamlets, Jawa Lama Village, Source: Observation.

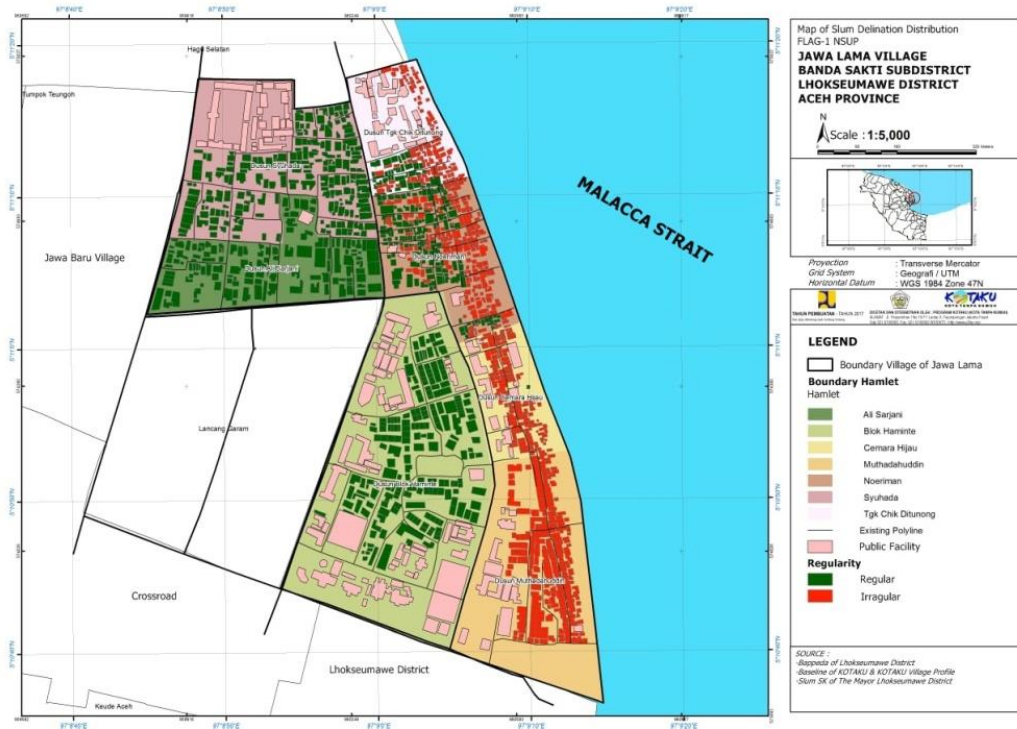
Figure 8. Housing characteristic map
 Source: ArcGIS map (KOTAKU, 2017)

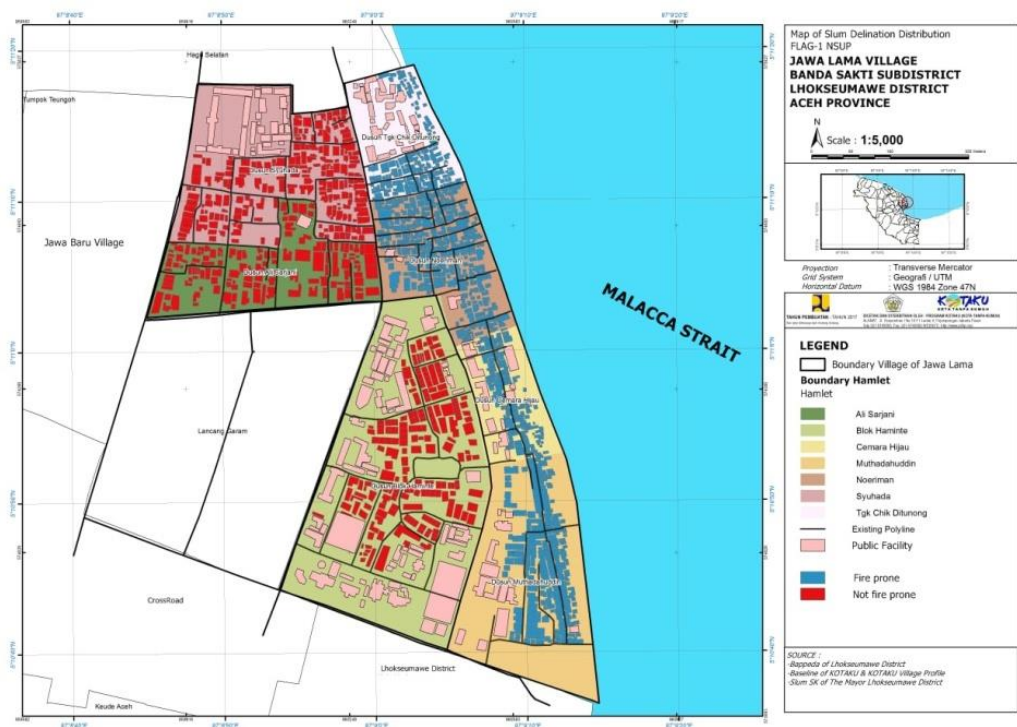
Figure 9. Fire prone maps
 Source: ArcGIS map (KOTAKU, 2017)

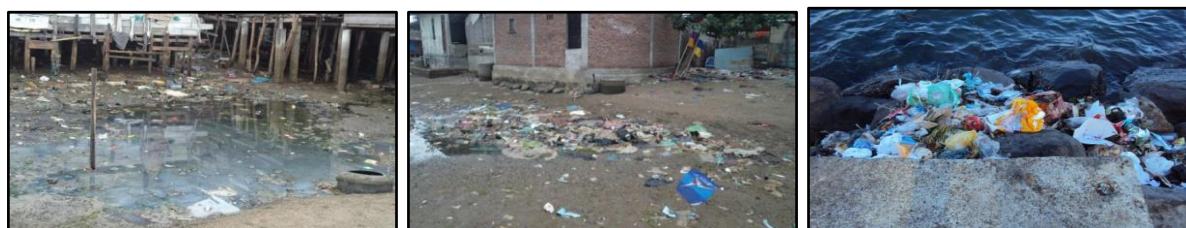
For waste management, each hamlet shows a different pattern as shown in Figure 11. Tgk Chik Ditunong Hamlet, Noeriman Hamlet, and Cemara Hijau Hamlet communities apply open dumping and burning practices in a sporadic open field. But, Murthadahuddin Hamlet uses a better practice by allocating a specific area for managing their trash; burn the trash and/or throw the trash on the sea, along the seashore.

Figure 10. Waste management at four hamlets, Jawa Lama Village, Source: Observation

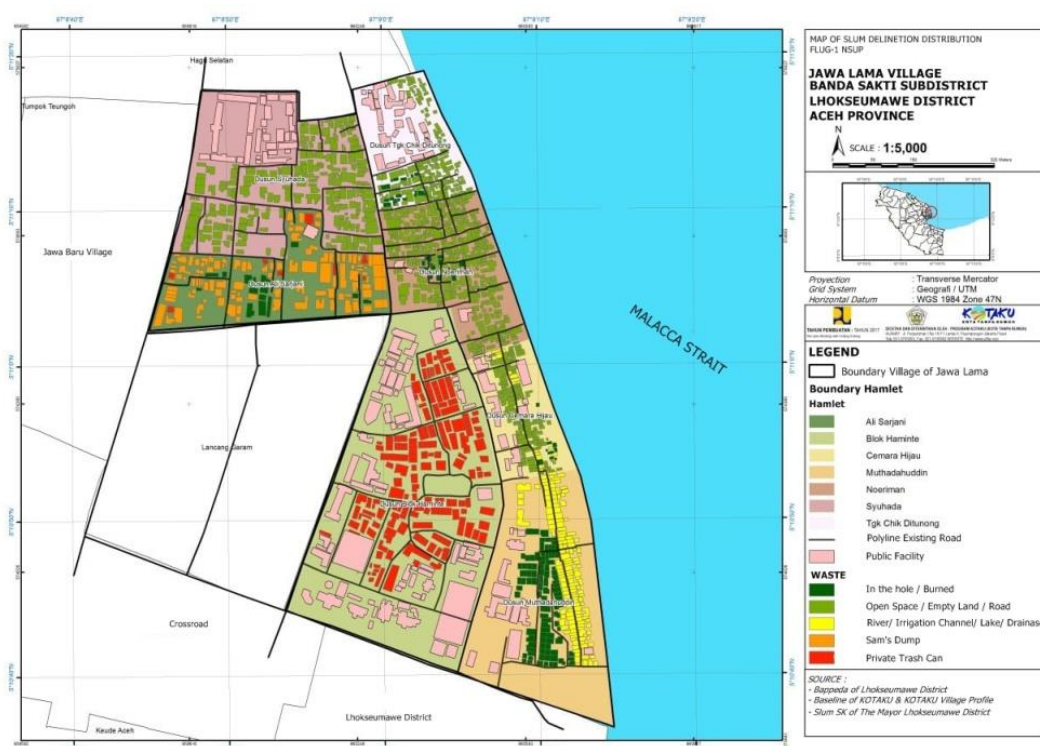
Figure 11. Waste management map
 Source: ArcGIS map (KOTAKU, 2017)
