Efforts To Reduce Rm-1 Refiner Disturbances At Pt Pln (Persero) Ulp Rimo From The Chronic Category With Network Maintenance Based On Inspections Using Thermacam

Adolf Pratama, Siti Anisah, Adi Sastra P. Tarigan

Universitas Pembangunan Panca Budi

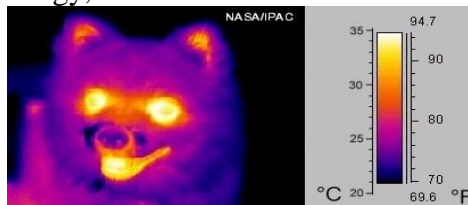
Thermal cameras capture images from heat, not from visible light. Heat (infrared or thermal energy) and light are part of the electromagnetic spectrum, but cameras that can detect visible light will not see heat energy, and vice versa.

Figures 2. Image Results using Thermocam

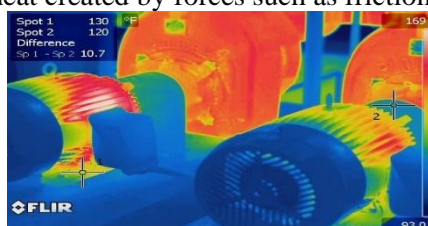
Installation on mechanical machines requires a good level of precision, otherwise the machine will experience disturbances such as excessive vibration or corrugated pressure. Using thermal cameras, we can see the heat created by forces such as friction.

Figures 6. Thermocam Image Results on Electrical Machines

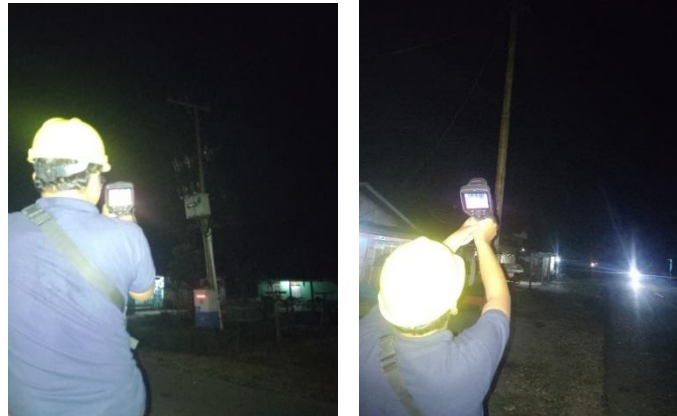
The team conducted an inspection per TM pole along the RM-1 Supplier SUTM network, by bringing a picture of the RM-1 supplier's SUTM network per pole, making it easier to mark the location of the inspection findings. Here is the documentation of the team that is carrying out the inspection using thermacam.

Figures 10. Implementation of Inspection Using Thermacam

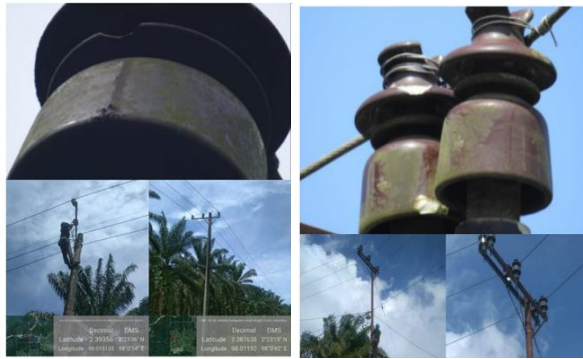
potential for interference in refiners. Although visually there is no visible damage, but because the inspection results show abnormal temperatures, these materials must still be replaced. Here is the realization of material replacement based on inspeksi thermacam:

Figures 12. Material Replacement Based on Thermacam Inspection

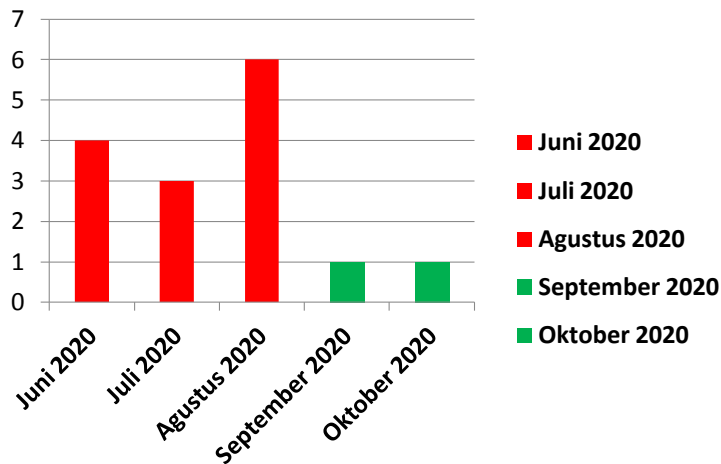
The implementation of the *Workplan* in the Journal resulted in a progression of reducing refiner disturbances. In June-August 2020 the rm-1 repeating disturbance was still high, yaitu 13 times, this was due to the fact that workplan implementation work only started at the end of August 2020. In September 2020, the disruption of refiners has dropped to as much as one cali, and in October once.

Efforts to reduce interference made on RM-1 refiners have succeeded in reducing interference and making **RM-1 refiners out of the chronic category**, here is a graph of the decrease in RM-1 refiner disorders:

Figures 13. RM-1 Refiner Interference Decline Chart

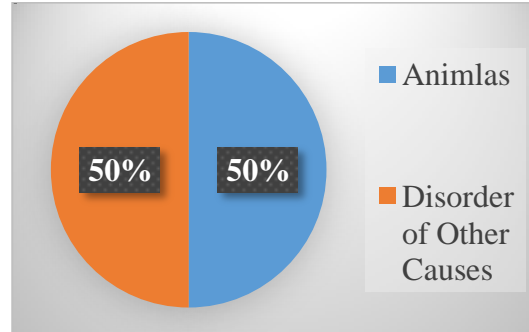
After maintenance in the period September 2020 – October 2020 can be seen in the percentage chart in figure 2.10. From the chart, it can be seen that although there are still disturbances caused by animals and other disturbances, the number has been greatly reduced compared to the period from June 2020 to August 2020 before maintenance was carried out.

Figures 14. Rm-1 Nuisance Cause Percentage Graph September 2020 - October 2020 Calculation
