Technique and device to evaluate lightning air terminal collection volume

Abstract—Lightning air terminals are a very significant part of lightning protection system (LPS) for buildings, structures and facilities. With reference to the facilities requiring lightning protection the position, the apparent height, and the angle of protection of lightning air terminals determines the collection volume (CV) of the protected area. The CV of direct strike lightning air terminals can change due to facilities which are affected by natural disasters such as seismic tremor and flood. If such natural disasters do happen, there are possibilities that the facilities will not be fully protected from direct lightning strikes due to building and structure misalignment the aftermath of seismic tremor and flood related earth movement. So for the safety of equipment and personnel, lightning protection system efficacy assurance is necessary. Therefore, there should be a technique and device to monitor the variation of collection volume afforded by every lightning air terminal on buildings and structures after the occurrence of a natural disaster. This paper presents a new technique as well as a new de

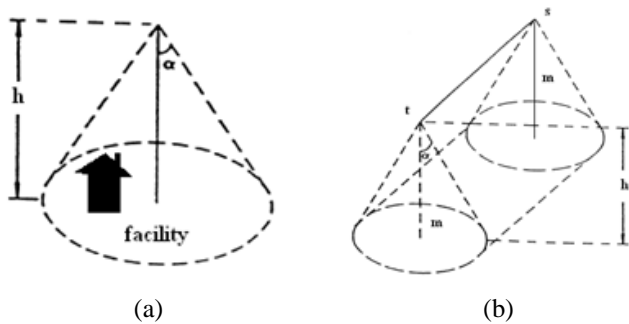
Fig. 1. Protection Angle: (a) facility protected by a vertical lightning rod air terminal, α , is the protective angle; (b) protected by a wire air termination or horizontal metallic conductor indicated by ts for a pair of standing mast m of its equivalent of height h .

On most turnkey projects involving petroleum facilities, and electrical transmission and distribution network main intake LPS are based on Cone of Protection / Protection Angle Method, IEC 62305 [3]. Cone of Protection is the creation of virtual 3-D cone with its apex point is at the top most point of the standing mast or monopole or vertical rod whether is standing independently or supported by a building structure. The virtual lightning collection volume is shown in Fig. 1 and Fig. 2.

The regeneration of volume of protection by laser beam based on Fig. 1 can be a mean to check the building orientation and misalignment due to seismic activities and flood impact. Fig. 2 shows the collection volumes generated from a pair of air terminal.

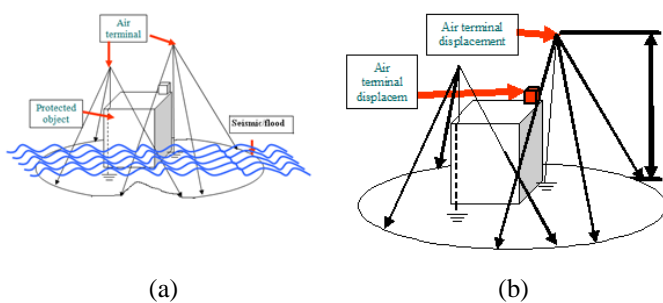
Fig. 2. The cone volume of protection generated from a pair of air terminal. (a) Prior to seismic/flood impact; (b) The misalignment of the collection volume result in certain segment of facility expose to lightning direct strike.

In Fig. 2.(b) the environmental displacement due to the seismic activities and flood results misalignment of the lightning collection volume. This in time bring about some part of the facility expose to lightning direct strike. In another word the probability of lightning to strike that part of concern is higher compared to other parts. If this scenario involves petroleum or other inflammable and explosive items, the consequents of a direct strike is very fatal.

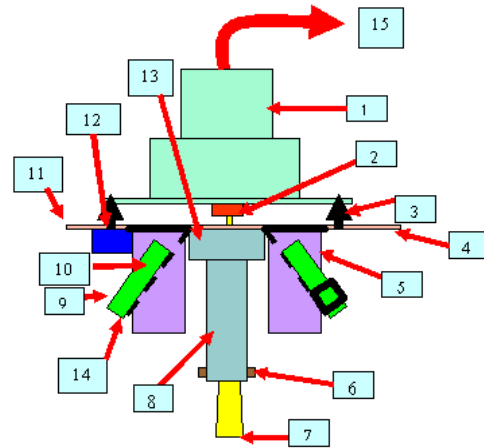
Fig. 3. The various parts and component to make up the device: 1) Main chassis – Remote control; 2) Shaft Driver – Hollow copper rod; 3) Screw – M3 Screw with nut; 4) Main Platform – Acrylic board; 5) Angle Shifter – Aluminium block; 6) Stabilizer – Screws; 7) Air terminal; 8) Air terminal holder – PVC pipe; 9) Laser beam holder – Pipe Clip; 10) Laser Indicator – Laser beam; 11) Switch; 12) Battery slot; 13) PVC coupling; 14) Shifter base – Pad locks; 15) Connector to antenna modem.

Few aspects of design have been considered in the development of the device i.e. (i) various angles of protection as per requirement based on the standard concerning lightning protection, (ii) horizontal displacement due to vertical placement of the instrument when attach to the test lightning rod, (iii) rotation of the shaft affixed laser pointer, and (iv) recording the laser focus image before and after the occurrence of a natural disaster. Fig. 3 shows the device and the technique general flowchart is shown in Fig. 4 which describes the whole activities involving the use of the device.

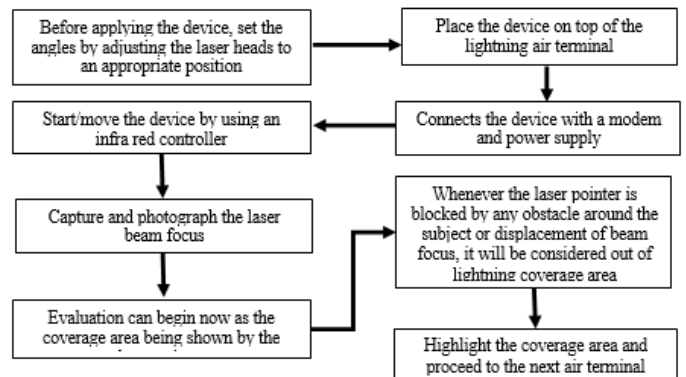
Fig. 4. System functionality flowchart

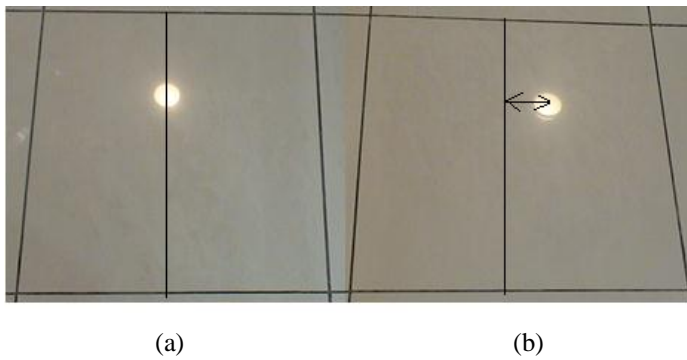
Fig. 5. The image was recorded by using a camera which was affixed at the same position. (a) The previous image of laser beam focus and (b) The later image of the laser recorded where there was misalignment has taken place.

The sensitivity and resolution of the laser beam images captured is very critical to determine the severity of seismic impact and flood displacement forces to the facilities. The camera should be an infra-red type that can record the low luminosity laser beam and they should continuously record the images while the instrument is used. The recorded images will be preserved for future reference.

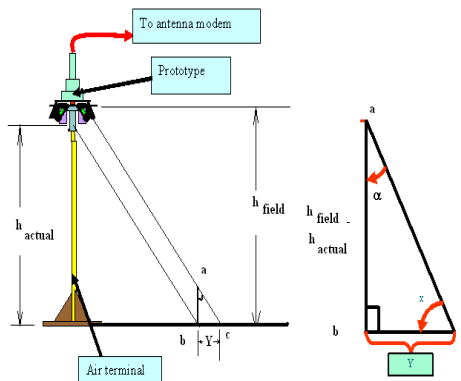
Fig. 6. Slight error being introduced to the measurement.

A systematic error is derived from the elevated positioning of the device which is placed on top of the lightning air terminal as shown in

Fig. 6. This fact is seemingly unavoidable except when the laser pointer placement is the same point of the apex of the air terminal and the device is designed as such which is very thin and slim. But at this point of time, the length of the device is quite sizable however if the actual air terminal is of substantial height, the integrated error compounded due to this on the image captured by the camera is relatively neglected. Another source of error could be also emerged if the lightning air terminal is tilted. In Error! Reference source not found.. the fractional comparison between Y and h_{actual} and also $x' - x$ with h'_{field} is very small. Thus the slight image displacement captured by the camera can be neglected and assume quite correct.

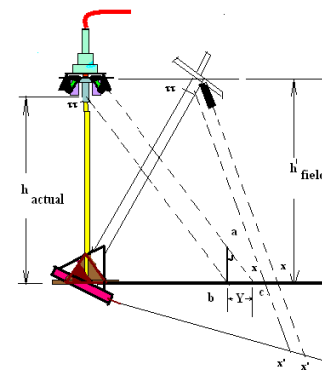
Fig. 7. The error involve in the tilting of building which correspondingly tilt the lightning air terminal

The need to evaluate the adequacy of lightning protection is gaining more importance when an occurrence of seismic activities and also flood. The fact these natural disasters can create environmental displacement which subsequently affects the building structures and other structures –involving the several of form utilities – especially when considering the petroleum facilities and power utilities. Taking for granted that seismic activities in this region will not adversely affect the facilities is not acceptable in relation to international professional practices and taking too much risk when involving with petroleum industries. So the invention of this technique and device is rather timely assisting building maintenance personnel to audit the buildings lightning protection system adequacy and with some form of analysis can provide certain forms of assessment of degree of seismic impact on infrastructure facilities. It is a common scenario in wide application of laser for measurement such as temperature, distance and others. Thus making the usage of laser beams for the determination of lightning collection volume variation is good method. The additional height being introduced to the air terminal which is subjected to test measurement due to the size of the device, introduce a degree of error to the resultant lightning collection volume generated by the laser beam.
