ANALYSIS OF SHORT AND MEDIUM TERM COASTAL ABRASION AND ACCRETION RATES USING GIS IN KARAWANG, WEST JAVA

Azis Kemal Fauzie

Dinas Lingkungan Hidup dan Kebersihan Kabupaten Karawang
Jl. Lingkar Tanjungpura No.1 Karawang, 41311
aziskemalfauzie@gmail.com

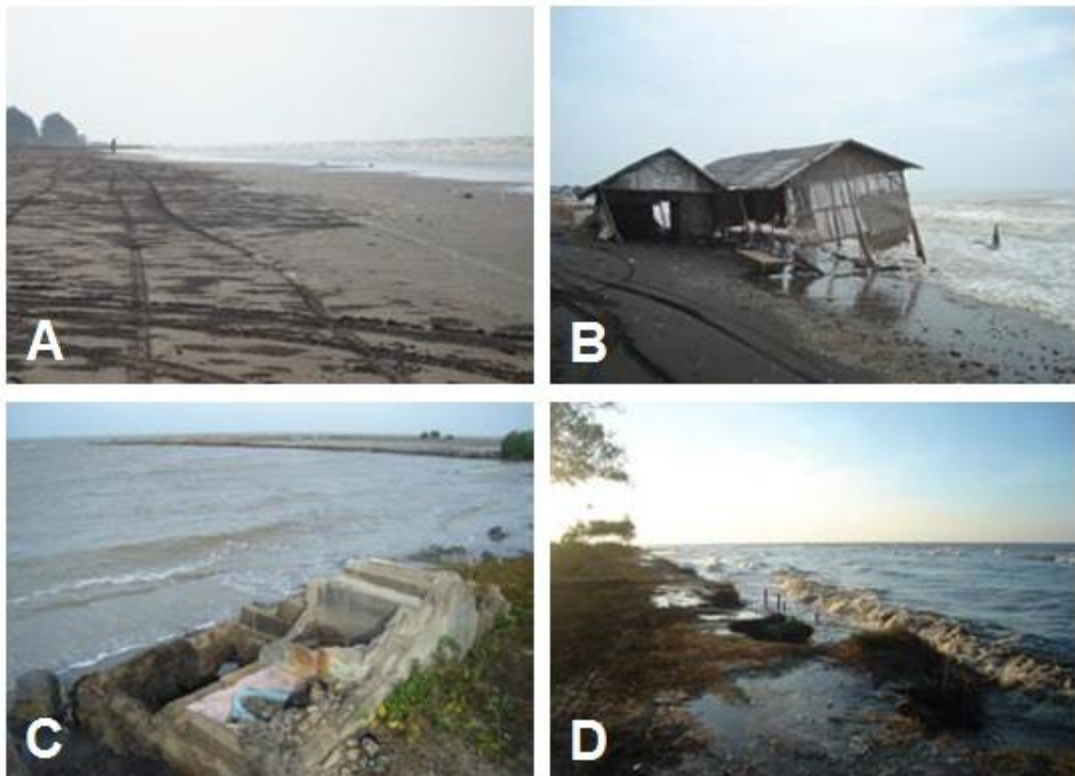
Figure 2. Site view of Karawang coastal area at (a) Zone I (b) Zone II (c) Zone III (d) Zone IV
 Source: DLHPE 2008.

Erosion has taken many areas of littoral lands such as aquaculture and agriculture lands, and damaged lots of public infrastructures such as housings and roads. Almost all beaches in Karawang face high threat of coastal erosion, particularly in the northmost villages of Pakisjaya, Batujaya, Tirtajaya, Cibuaya, Pedes, Cilebar, Tempuran, Cilamaya Kulon, and Cilamaya Wetan sub-regency. High abrasion impacts have been identified in Cibuaya and Cilebar beach. A significant number of public habitation, shops, restaurants, and religious buildings in both beaches were destroyed by abrasion. Asphalt roadway that lies along Cibuaya coast has been damaged since few years ago. Many buildings were abandoned

because of the retreat of the coastline. See Figure 2 for details. Coastline retreat has become major threats to Karawang regency. The occurrence of coastal erosion is always accompanied by accretion. Sediments scrapped by rip currents from eroded beach are transported gradually by longshore currents, in accordance with wind and wave direction, which cause land accretion in other beaches. The observation of Karawang coastline revealed that Cibuaya beach is the most impacted beach by coastal erosion, while accretion effect was found higher in Cilamaya Wetan beach than in any other beaches. Cilebar beach has been experiencing a high degree of both abrasion and accretion.

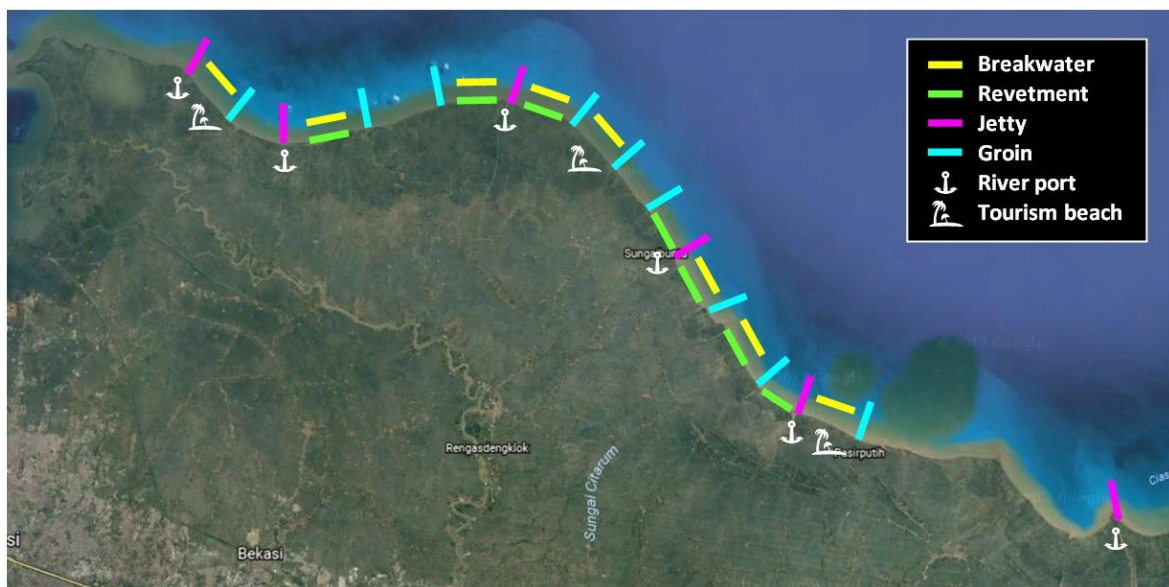
Figure 9. Proposed plan for constructing abrasion protection structures in Karawang location

A proposed plan for the locations of beach protection structure installation has been prepared. See Figure 9 for details. The plan examines the actual condition of Karawang coasts in each zone including beach shape and angle, land topography and bathymetry, annual windrose, surge storm and tide trends, existence of river mouths, littoral ecosystem characteristics, available public facilities like roadways, river ports and tourism beach, and the existing beach protection structures. Acute eroded area and nearshore roadways should be protected by combination scheme of breakwater, mangroves, revetment, and groin or jetty.
