Evaluation of the Aesthetic and Social Function of the Bendosari Park Salatiga City

To function improve from the Bendosari park value, aesthetic and social function evaluation must be conducted. This study aims to evaluate the landscape characteristics of Bendosari Park based on aspects of the aesthetic and social function. The research was conducted in Bendosari Park on Ring Road of Salatiga City, Central Java Province, Indonesia from June until August 2017. Evaluation of the aesthetic and social function used close questionnaire method toward 30 respondents with respondents criteria of aged over 12 years and analyzed using KPI (Key Performance Indicator) method to find out how far the two aspects (the aesthetic and social) are reached. The study indicates that Bendosari Park has fulfilled the social and aesthetic functions of the park which indicated by the value of KPI analysis greater than 0.67.

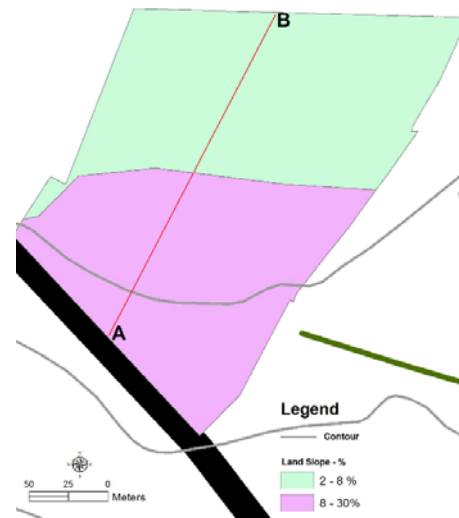
Bendosari park in Salatiga City is located on Ring Road with an area of 3.8 Ha. High place Bendosari park is 647-670 m above sea level and it has a land slope between 2-8% in the north and 8-30% in the south. The dominant landscape elements in the Bendosari park are vegetation trees and flower plants and some supporting facilities.

Figure 2. Land slope Bendosari park

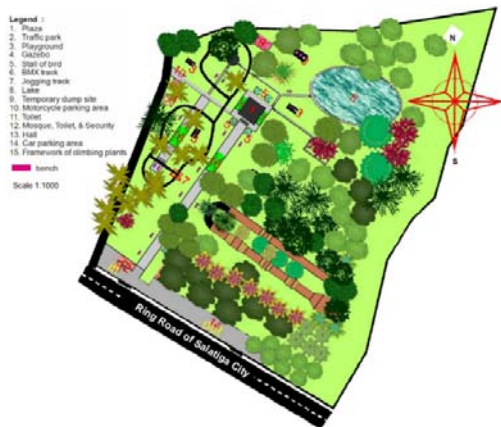
Figure 4. Landscape of Bendosari park

The Bendosari park has complete facilities that enough for park visitors needs such as sports, recreation, studying, or relax in one place than any other park in the Salatiga city. The main facilities provided in Bendosari park are the plaza, traffic park, children play area, gazebo, bird animal area, BMX track, and jogging track.

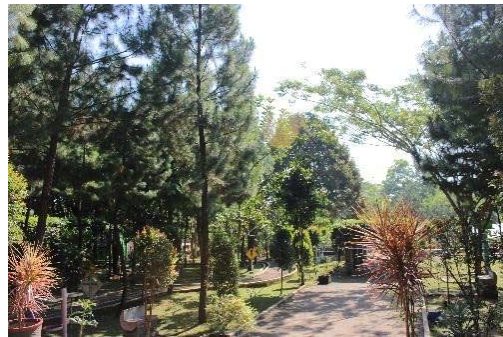
Figure 5. The vegetation proportion that is more dominant than the park buildings make the park shady.

2. Health Support. Adding other sports facilities such as sit-ups, pull-ups, and backups where the sports facilities are fairly familiar sports facilities that can be done in outdoor conditions that will encourage people to exercise in this place. This park is a convenient place to carry out sports activities because this park has a cool air condition. In addition, this park is also a shady park, so it is very convenient to exercise in this park.

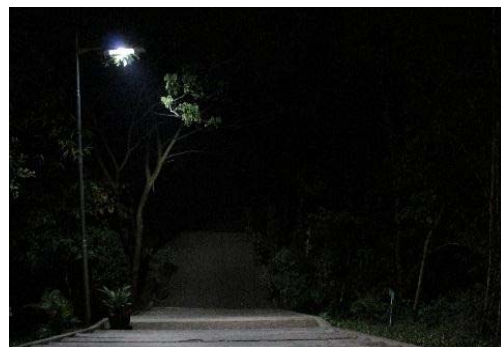
3. Security Level. Added lights evenly because in the main area of the park itself there is only one lighting lamp that is near the bottom toilet. Lack of lighting makes this park felt less safe to visit at night because it can potentially occur crime. In addition to the potential for crime, the lack of lighting can also trigger people to commit acts that are not responsible and not commendable.

Figure 6. The condition of the garden at night that is less lighting

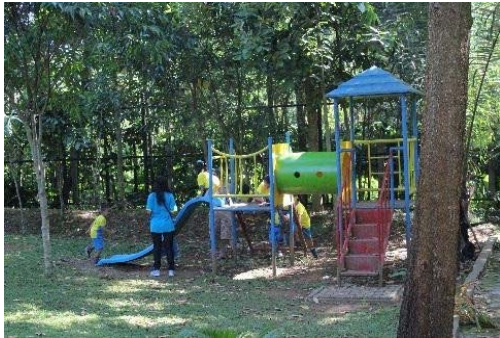
The game facilities for children in this park have groundcover in the form of grass. For that, it was needed a set rubber pad as pedestal tools to keep children safe when playing.

Figure 7. Ground cover tools for children game

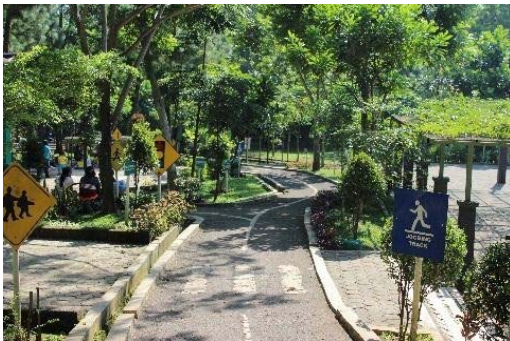
Figure 8. The condition of Bendosari park bench

4. Comfort Level. Added lighting to facilitate visitors who come at night. Adding the park bench because it is available only 23 benches or can be renovated of the bench to be more spacious because the available bench is very narrow (68 cm long, 44 cm wide, 50 cm high) and only able to accommodate two people of small-bodied. Separate the jogging track with the park traffic path so that visitors who use each facility is not interrupted.

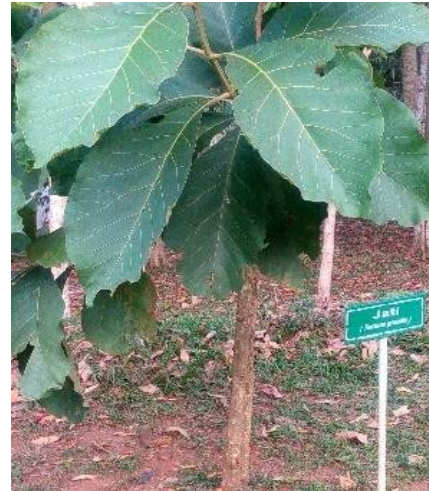
Figure 10. One of the plants that have been given a nameplate

6. Education. Completing the tree with a nameplate on a tree that has not been given a nameplate so that visitors can get to know more the names of plants and their form considering only a few types of plants are given a nameplate. The diversity of plants in this park becomes its own plus value because it can be an education media for visitors as well as on the other side of other parks in Salatiga City does not have the diversity of plants such as Bendosari Park.

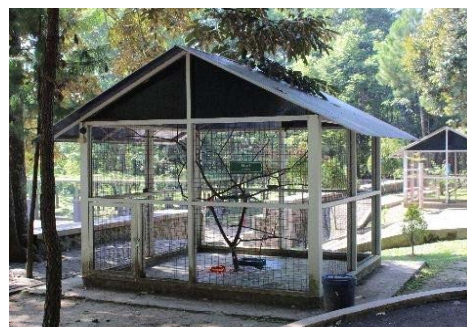
Figure 11. One of the birds collection in Bendosari Park, the parrot.

Need to add some collection of other animals so that visitors can enjoy the mini zoo and also can be more familiar with various types of animals, especially for parents who want to introduce various types of animals to their children. Another way that can be done if the way before is difficult to do is completing the collection of birds because the collection of birds in this park can be said to be less diverse, there are only five species of birds namely parrot (*Gracula religiosa*), parrot (*Eclectus roratus*), lovebird (Agapornis), pigeons (Columbidae), and parakeets (*Melopsittacus undulates*).

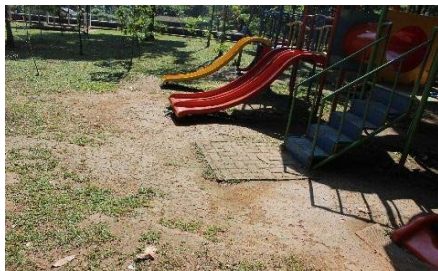
Figure 12. The grass around the children's game facility becomes damaged by frequent trampling

1. Beauty. In the game facilities, areas need to be mounted pavement with the rubber pads type. Due to the game facility area is crowded with visitor activity so if the pavement only with grass then the grass will be easily damaged and will make the aesthetic value decreases.

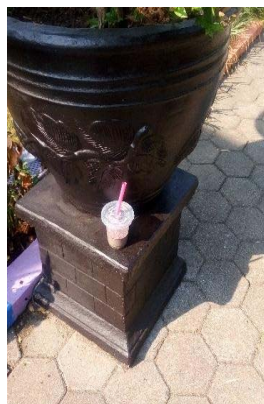
Figure 13. Example of disorderly visitor behavior in a garbage disposal.

2. Cleanliness. Park cleanliness can affect the park beauty, so the thing to do need a cleaning of the park, because of its behavior of visitors who are not orderly in disposing of garbage.

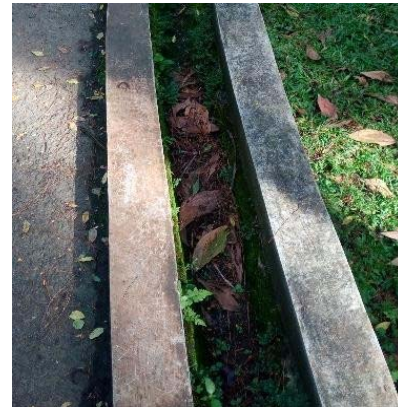
Figure 14. Garbage on the park gutter.

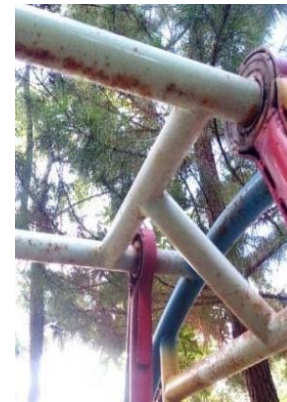
Figure15. Game facilities begin to rusty

3. Infrastructure Facilities. Infrastructure facility on the Bendosari park needed to be repainted for children's play facilities so that the game equipment is not porous because of rusting considering the game equipment is in an outdoor location.

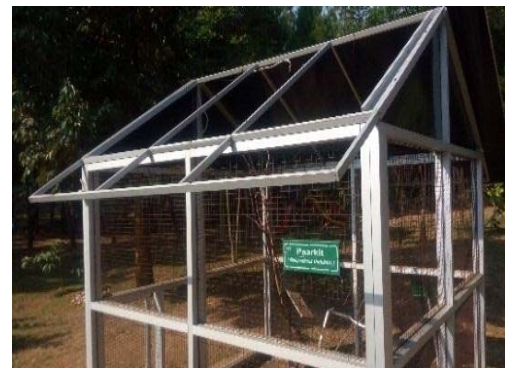
On other hands, it must repair the construction of the roof of the cage building because of the damage that occurs all there is on the roof of the cage that causes the birds to escape. This damage if not immediately fixed will reduce the aesthetic value of the cage.

Figure 16. Roof on the bird cage damaged

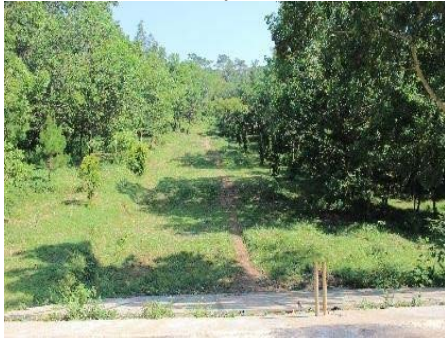
Figure 17. The path is overgrown with weeds

Weed controlling in the BMX track is required to avoid

damage to the track construction and to reduce the aesthetic value of this facility.
