GEOTECHNICAL ANALYSIS OF CARSINGTON DAM FAILURE

Sukiman *

Abstract

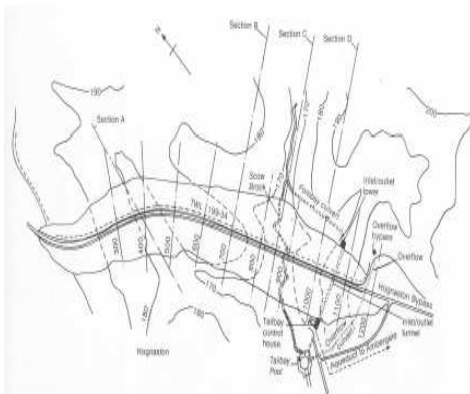
Figure 1. Plan of Carsington Dam (chainage and elevation in meters)

Carsington Dam is located near the village of Hognaston in Derbyshire and has a maximum design height of 35 m. Plan of the Dam is presented in Fig. 1. This Dam was due to finish placing of filling material back in May 1984 when a crack was reported on the dam crest of its upstream part. This crack enlarged and had not stopped until 6 June, with the berm enlargement continued for a few more days. In chainage 675 m, the upstream toe had moved 13 m laterally and had lifted by about 2.5 m in addition of severe disruption of the upstream slope (Fig. 2).

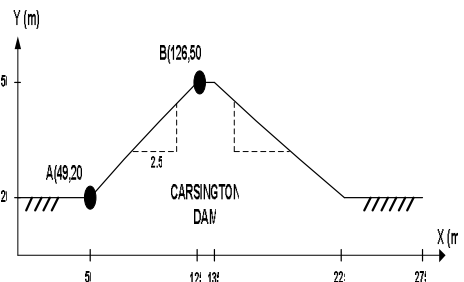
Figure 5. 2-D appearance of the Carsington Dam as an input data for OASYS-SLOPE

For this analysis, the dam was assumed to be made of homogeneous material with a unit weight of 20kN/m³. In addition, groundwater level was set to be deep below the ground surface and circular failure surface was specified. The 2-D appearance of the Dam is shown in Figure 5.

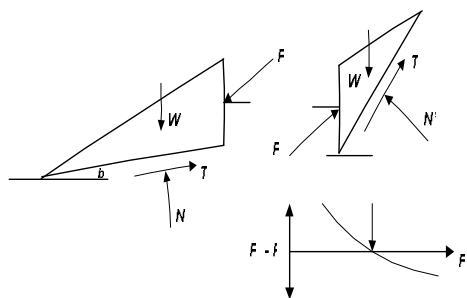
Figure 9. Simplified two-wedge model of the cross section at chainage 725

From Fig. 8 above, the plane surface can be separated into two wedges with vertical interfaces with an inter-wedge force P_1 and P_2 . If $P_1 = P_2$ then the correct value of factor of safety (F) has been chosen. In other words a trial approach is required by adjusting the value of F until convergence is achieved (Fig. 9).

From Fig. 9 above, the magnitude of P_1 and P_2 can be found from a polygon force providing an assumption about its inclination $q = f'_m$ or $\tan q = \tan f' / F$, where f'_m represents the mobilised angle of shearing resistance. The magnitude of total force W_1 and W_2 were obtained from the area of each wedge multiplied by the unit weight of soil.

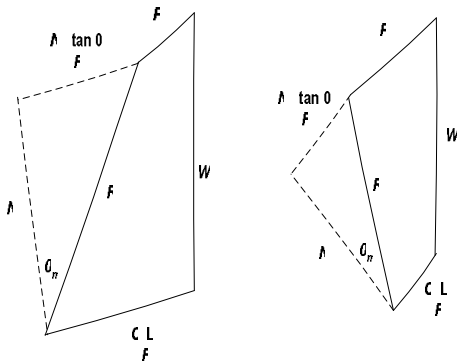
Figure 10. Simplified two-wedge model of the cross section at chainage 725

After several attempts, the most reasonable convergence value of factor of safety was approximately 1.25. Several calculation results are presented in Table 5.

It can be concluded that because the factor of safety is above 1.00, thus the dam is considered to be safe against slope stability failure.

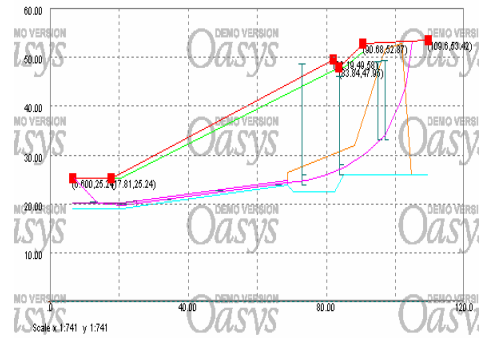
Figure 12. Position of the piezometer grid at the input geometry

The values of pore pressure ratio (r_u) were 0.42, 0.53, and 0.00 for the core, boot, and yellow clay respectively. Because of the limitation of the SLOPE software, the information had to be inputted in the form of a piezometric grid (Fig. 12). The piezometer water level can be calculated using the equations as follow:
