ANALYSIS OF THE INSPECTION RESULTS ON THE PRIMARY COOLING PIPE OF RSG-GAS REACTOR

Abdul Hafid

Center for Nuclear Reactor Technology and Safety (CNRTS)-BATAN

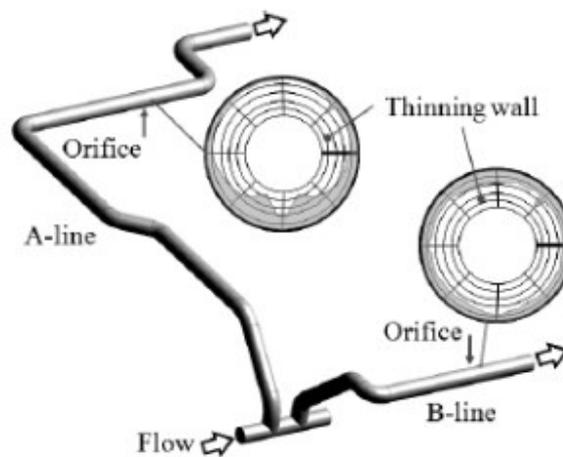
Fig. 5. Prototype pipeline of Mihama power plant^[9]

Lessons learned from the accidents that occurred at Mihama nuclear power plant (NPP) in Japan found that thinning of the pipe wall leading to accident should be partial as shown in Figure 5. It is known as the non axi-

symmetric pipe wall thinning that occurs in the pipe orifice A^[9]. Thus, it means that the test with average calculations can't always be used to indicate the wall thinning.
