DEVELOPMENT OF DIGITAL MONITORING METHODOLOGY

By :
Nahar Cahyandaru, S.Si
Brahmantara, ST

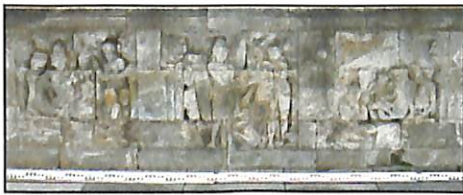
a. Taking photograph the panels

The technical difficulties of this methodology are to get the photograph

picture from the exact view of each monitoring period, and also the good picture without lens distortion. The photographer has to take the picture from the same distance and angle. To get the good picture without lens distortion the photographer must use the suitable instrument quality.

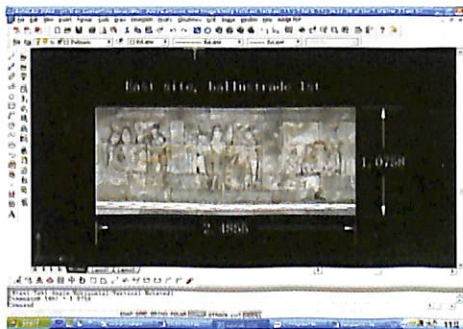
b. Importing the picture to AutoCAD program and fitting the dimension picture with the original

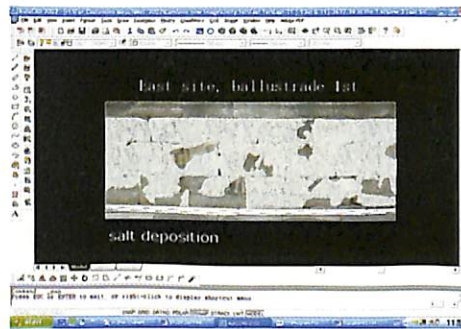
d. Digitalizing the area of each deterioration on AutoCAD. Digitalization is conducted by the personnel taking part in conducting the survey in the field to avoid the mistake in processing data. Digitalization lines are made in various colours to differentiate the parameter one to another, as the following:

Other sample of the digitalization beside salt deposit above is ochre, as figured below.
