Mitigation of land degradation at Juana Watershed, Central Java

I.B. Pramono*

Watershed Management Technology Center, Agency of Forestry Research and Development, Ministry of Forestry.

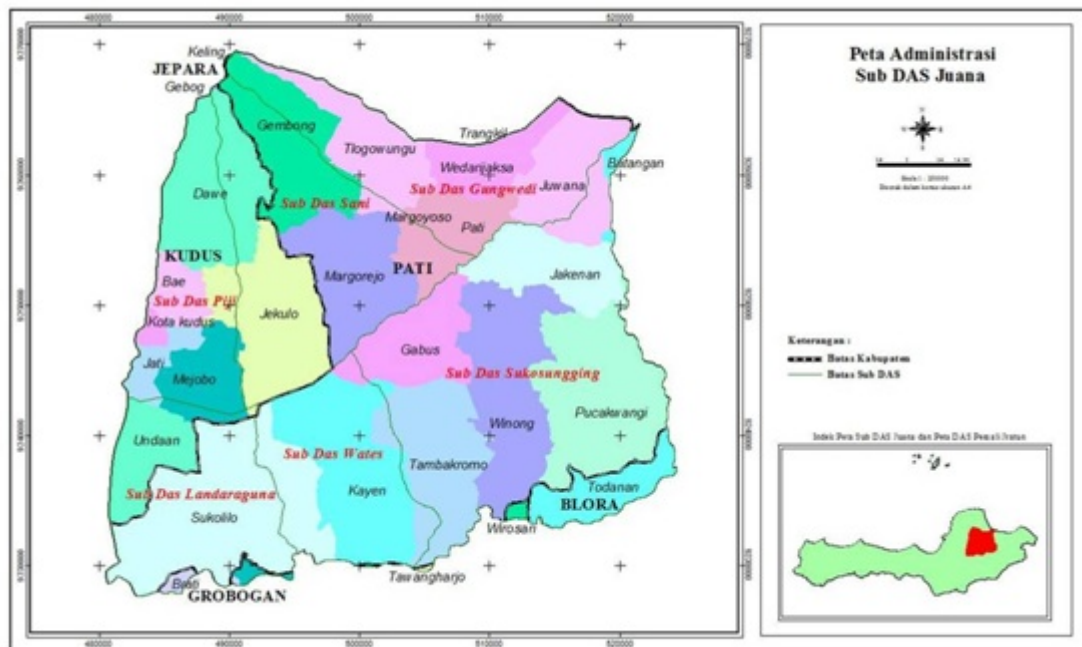
Figure 1. Administration Map of Juwana Watershed

Geographically Juana watershed in the position coordinates between 110 ° 49 '10 " - 111 ° 12' 57" East Longitude and between 6 ° 36 '48" - 6 ° 59' 29" South Latitude Juana watershed administratively includes five (5) districts namely Pati regency 97672.8 ha (74.91%), Kudus 28356.17 ha (21.75%), Blora 3411.96 ha (2.62%), Grobogan 941.71 ha (0.72 %), and the district of Jepara 8:59 ha (0.007%). The administration map of Juwana watershed is presented in Figure 1.

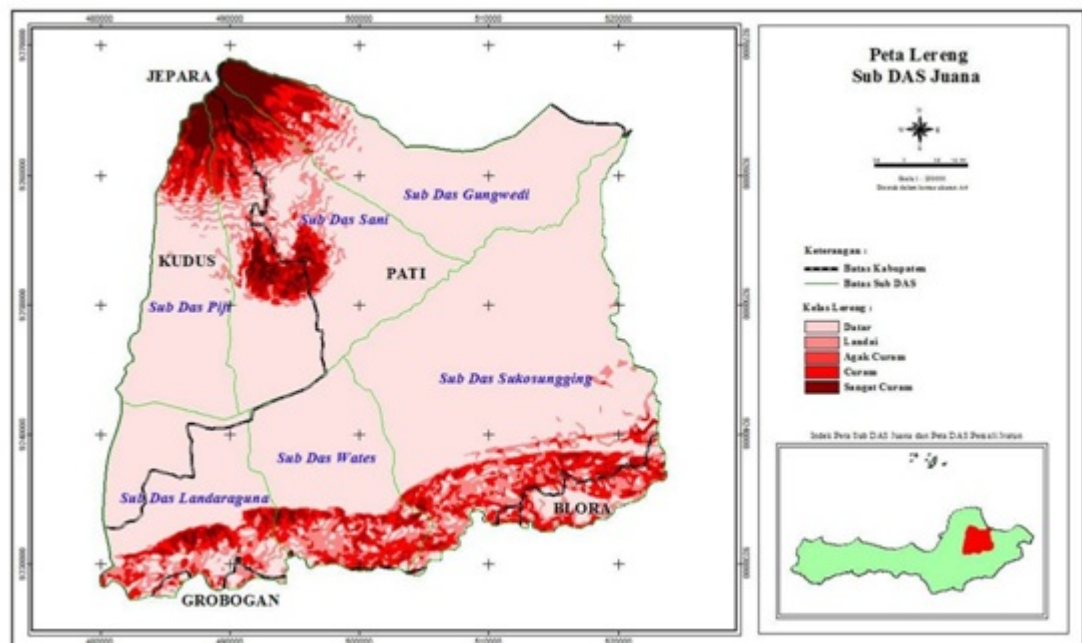
Figure 2. Slope Map of Juwana Watershed

Slope steepness of Juana watershed is dominated by flat areas with a form region that has a slope of 0-8%. This includes ± 75% of the watershed area of Juana. Areas with gentle slopes (8-15%) cover ± 10.38% region, rather steep slope (15-25%) covers an area of 7.9%, a steep slope (25-40%) covers 3.9% of the territory and the rest with a steep slope (> 40%) covers 2.76% wide area. It can be said that 13.36% of the watershed area Juana is on a rather steep slope conditions up to very steep. This field slope rate affects the speed

and erosive power of overland flow. In detail the condition of the slope basin Juana is presented in Table 1 and the distribution of slope in the watershed as shown in Figure 2.

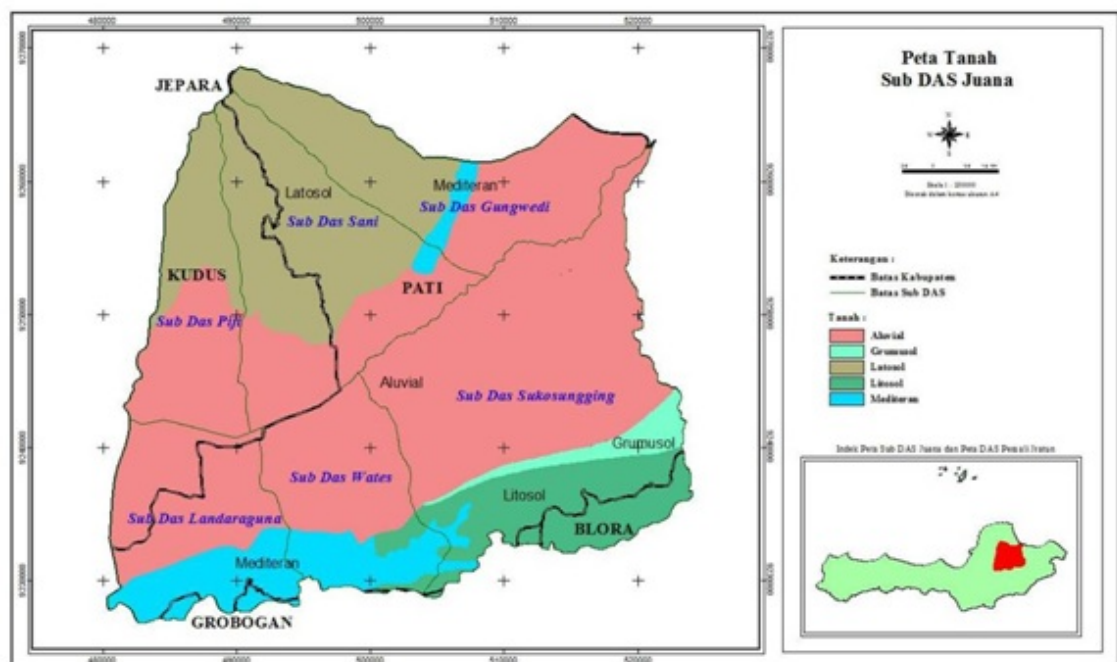
Figure 3. Soil Map of Juana Watershed

The type of soil in Juana watershed include Alluvial, Grumusol, Latosol, Litosol and the Mediterranean. The most dominating soil type is the type of Alluvial (58.25% of the territory). Alluvial soil types derived from alluvium parent material has a moderate to high fertility, it distributed in the river alluvial plain, coastal alluvial plains and basins. alluvial soil types are

generally classified in the sub-group entisols with physiographic regions formed on flood plains. materials sediment carried by the river then deposited and accumulated in this area. Then followed by the type of clay texture latosol having

up to blocky and crumb structure covers an area of 22.41%. in more detail the area of each soil type in the basin Juana presented in Table 2 and Soil Map in the watershed can be seen in Figure 3.

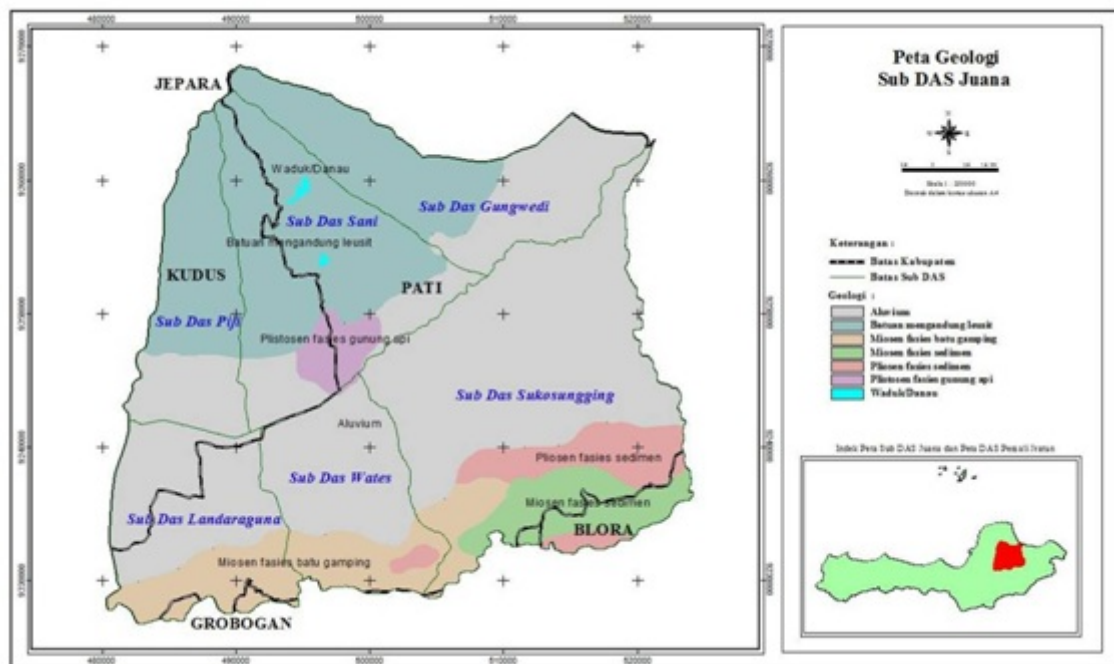
Figure 4. Geological Map of Juana Watershed

Based on the analysis of geological map, the type of rock in the basin Juana include alluvium, rock containing leusit, Miocene limestone facies,

Miocene sedimentary facies, sedimentary facies Pliocene, Pleistocene volcanic facies and reservoir / lake. The extent of each type of rock Juana basin is presented in Table 3 whereas Geological Map of the watershed as shown in Figure 4.

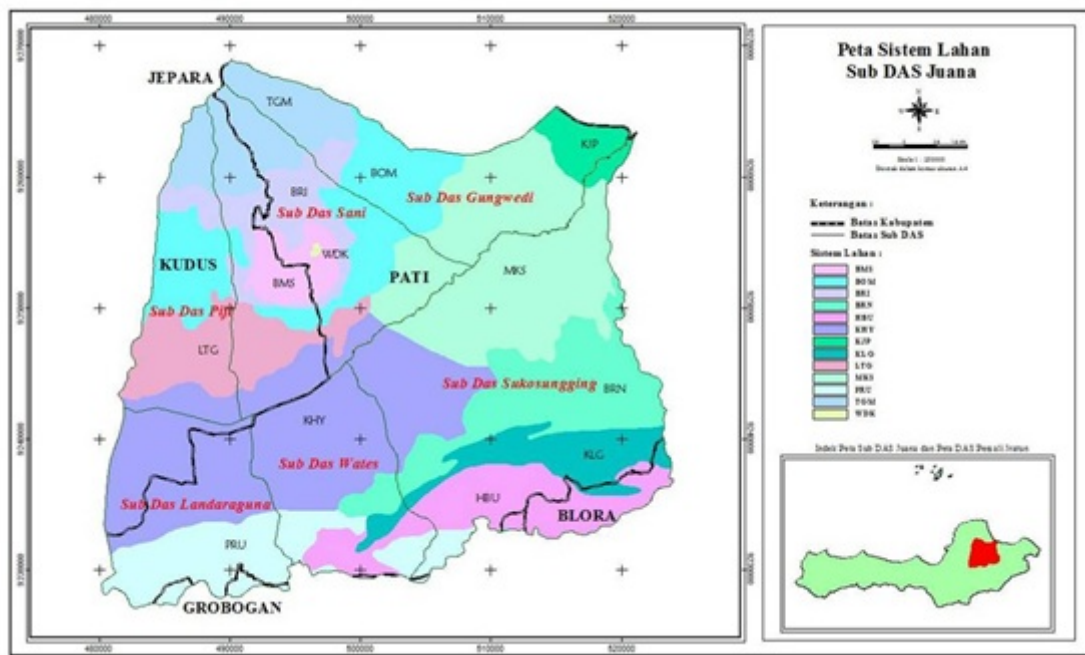
Figure 5. Land System Map of Juana Watershed

The division of the land system describes the shape, description of the parent material, rock type, soil type, slope, annual rainfall, wet months and dry months. Under the system of land, divided into 10 watershed Attack land system are: KHY (Kahayan), MKS (Napier), BRN (Bogoran), LTG (Loud), KJP (Kajapah), HBU (Hiliboru), KLG (Necklace), BMS (Masung hill), BOM (Bombong), BRI (Bonto Sapiri), and WDK (Reservoir). Land in the watershed system deployment Attack can be seen in Figure 5.

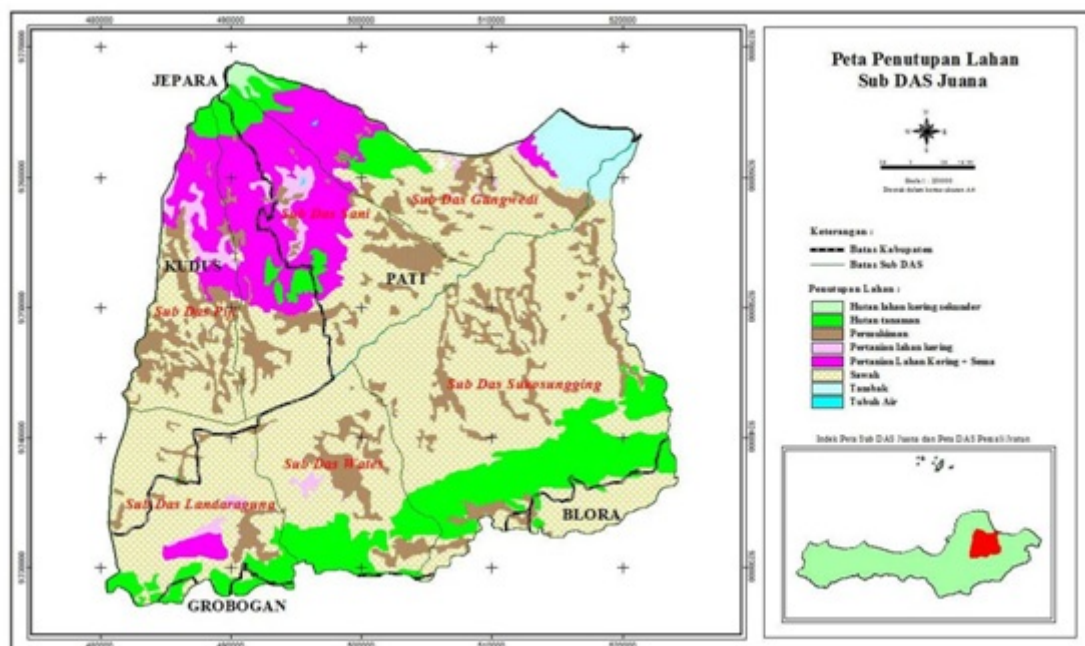
Figure 6. Land cover map of Juana watershed

Types of land cover in the watershed varies from Paddy Field, Rainfed rice fields, dry land, Estate Plantations, Forests, Settlements, Salting, grassland, scrub and others. The most extensive land cover in the watershed is use for irrigated rice field which covers 45.41% of the territory,

then the use of land to dry land covers an area of 13.94%. land use such as forests covering an area of 1.22%. in more detail the area of each land use in the watershed presented in Table 5 and the distribution of the land cover as shown in Figure 6

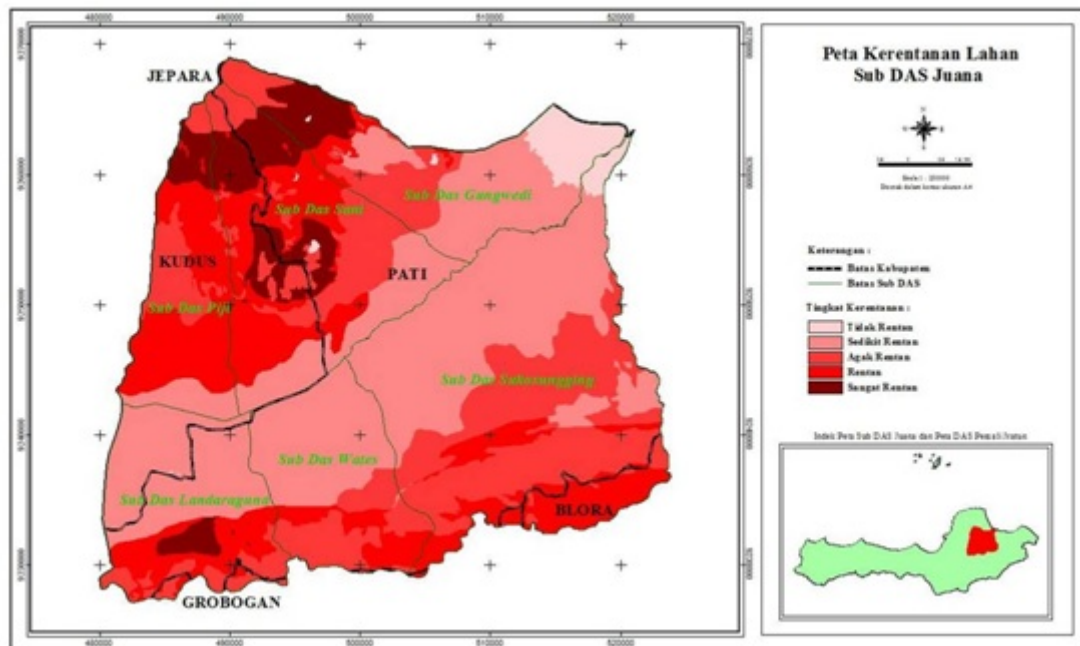
Figure 7. Land Susceptibility Map of Juana Watershed

One of the factors that cause degradation of natural resources in the Juana watershed is a land utility. Optimal land productivity and sustainable land use will be achieved when adapted to the ability of carrying capacity. Most of the degraded land in Juana watershed occurred in the upper part where the slope is steep (25 – 40 %) and the land

was utilized for dry land agriculture. Consequently, soil erosion will severe and the land will be unfertile. The most degraded land took place in Kudus and Pati regency. Furthermore, degraded land also occurred in Grobogan dan Blora regency but it less severe than in Pati and Kudus regency as shown in Figure 7.

Based on Figure 7, the local government of Kudus and Pati district should pay attention on their heavy degraded land. They have to collaborate to solve the problem because the heavy degraded areas are located in their administrative border. One of alternative solution is introducing agroforestry system where the land is cultivated mixing between tree and cash crops. Alwi et al. (2011) mentioned that plantation of cocoa, orange, pepper, bananas, and maize can reduce soil erosion and surface runoff in South East Sulawesi. The farmer and local government should determine the most suitable tree and cash crops in their land. Some soil conservation measure should be applied in certain areas where slope steepness is high. Although district of Blora and Grobogan have small contribution area in Juana watershed, they should rehabilitate their degraded land because the impact will influence in lower part of the watershed.
