Slope Stability Analysis on Railroad Line in Lahat Lubuk Linggau, South Sumatra

The Lahat Lubuklinggau railroad line is a strategic railroad line in the DIVRE III area of South Sumatra. Several incidents have occurred there in recent years. The incidents indicate the condition of the railroad at Lahat Lubuklinggau crossing is prone to landslides and subsidence areas, which can disrupt rail traffic. Consequently, it results in the inconvenience of train travel, which threatens the safety of rail traffic if not immediately get comprehensive repair. This study aims to analyze the vulnerability of slopes in the Lahat-Lubuklinggau railroad area using the GEO5 program to determine the slope safety number, which shows the stability of the slopes. GEO5 programs are designed to perform deformation and stability analysis in geotechnical engineering. The analytical methods used include Bishop, Fellenius, Spencer, and Janbu. After modeling and analyzing slopes using the GEO5 program, the soil reinforcement increased the safety factors according to SNI 8460:2017. With the use of slope reinforcement, the increased value of the safety factor supports the operation of train travel in the Lahat Lu

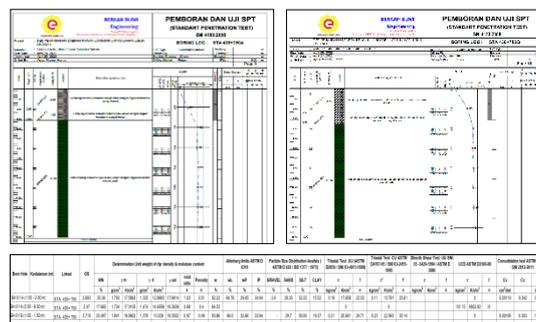
The drilling point is located around the Gunung Gajah tunnel. N-SPT drilling test using an automatic hammer. Drilling is carried out to a depth of 15 meters with a Ground Water Level (MAT) of 7.5 meters (point A) and 0.5 meters (point B) from the ground. Soil classification obtained clay at a depth of 0-3 meters and stone at a depth of 3-15 meters. Hard soil is found at a depth of 3-4 meters with an average N-SPT value of 58 (point A) and 62.34 (point B). At a depth of up to 3 meters, the casing is installed for drilling and sampling for laboratory testing. UDS samples each drilling hole with varying depths between 1-2 meters. From laboratory testing, it is known that the average Gs value from the test results is 2.42, the water content (w) is 34.32% on average, the average dry density is 1.34 gr/cm³, the average void ratio (e) is 0.98, the average plasticity index of 35.52% with the soil classification obtained is CH-OH. Based on triaxial testing, the average cohesiveness value is 0.2 kg/cm², and the average internal shear angle is 26.37°.

Figure 1. N-SPT Drill Results and laboratory test results at STA 435+650/850

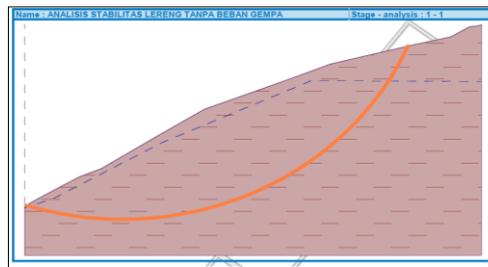
The results of the analysis using the GEO5 program for landslide-prone areas in existing conditions without earthquake loads at STA 435+650/850 showed that the value of the safety factor (SF) obtained for the area was 1.13 with the Bishop method, 1.08 with the Fellenius method, 1.15 with the Spencer method, and 1.16 with the Janbu method did not meet the safe conditions according to SNI 8460:2017.

Figure 3. Modeling results using GEO5 for existing conditions without earthquake loads at STA 435+650/850.

Slope stability verification (all methods)	
Bishop :	FS = 1.13 < 1.25 NOT ACCEPTABLE
Fellenius / Petterson :	FS = 1.08 < 1.25 NOT ACCEPTABLE
Spencer :	FS = 1.15 < 1.25 NOT ACCEPTABLE
Janbu :	FS = 1.16 < 1.25 NOT ACCEPTABLE
Morgenstern-Price :	The solution has not been found.

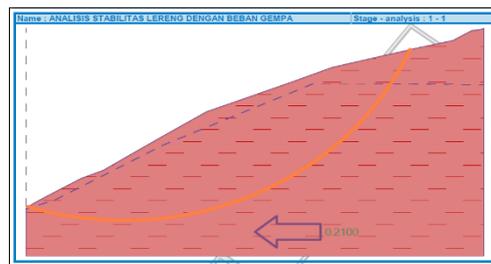
The results of the analysis using GEO5 for landslide-prone areas in existing conditions with earthquake loads at STA 435+650/850 showed that the value of the safety factor (SF) obtained was 0.73 with the Bishop method and 0.69 with the Fellenius method so that it did not meet the safe conditions according to SNI 8460:2017.

Figure 5. Modeling results using GEO5 for existing conditions with earthquake loads at STA 435+650/850.

Slope stability verification (all methods)	
Bishop :	FS = 0.73 < 1.00 NOT ACCEPTABLE
Fellenius / Petterson :	FS = 0.69 < 1.00 NOT ACCEPTABLE
Spencer :	The solution has not been found.
Janbu :	The solution has not been found.
Morgenstern-Price :	The solution has not been found.

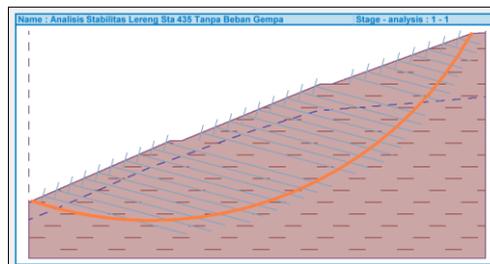
The analysis of slope reinforcement using GEO5 for landslide-prone areas without earthquake loads at STA 435+650/850 showed that the value of the safety factor (SF) obtained was 2,14 with the Bishop method so that it met the safe conditions according to SNI 8460:2017.

Figure 7. Slope reinforcement modeling results with soil nailing on GEO5 without earthquake loads at STA 435+650/850

Slope stability verification (Bishop)	
Sum of active forces :	$F_a = 1247.39$ kN/m
Sum of passive forces :	$F_p = 2668.40$ kN/m
Sliding moment :	$M_a = 40003.91$ kNm/m
Resisting moment :	$M_p = 85575.64$ kNm/m
Factor of safety =	2.14 > 1.25
Slope stability ACCEPTABLE

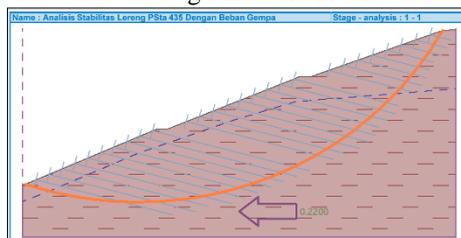
The analysis of slope reinforcement using GEO5 for landslide-prone areas with earthquake loads at STA 435+650/850 shows that the value of the safety factor (SF) obtained is 1.29 with the Bishop method, so it meets safe conditions according to SNI 8460:2017.

Figure 9. The results of soil nailing reinforcement modeling on slopes using GEO5 with earthquake loads at STA 435+650/850.

Slope stability verification (Bishop)
 Sum of active forces : $F_a = 1968.13$ kN/m
 Sum of passive forces : $F_p = 2531.48$ kN/m
 Sliding moment : $M_a = 63117.98$ kNm/m
 Resisting moment : $M_p = 81184.71$ kNm/m
 Factor of safety = 1.29 > 1.00
 Slope stability ACCEPTABLE

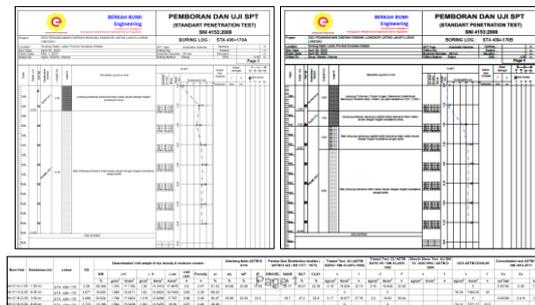
N-SPT drilling is carried out to a depth of 15 meters with a Ground Water Level (MAT) height of 0.5 meters (points A and B) from the ground. Soil classification obtained clay at a depth of 0-2.5 meters and stone at a depth of 2.5-15 meters. Hard soil is found at a depth of 6-8 meters with an average N-SPT value of 66.515. At a depth of up to 2.5 meters, the casing is installed for drilling and sampling for laboratory testing. From laboratory testing, it is known that the average Gs value from the test results is 2.64, the water content (w) is 23.46% on average, the average dry density is 1.41 gr/cm³, the average void ratio (e) is 0.87, the average plasticity index is 27.29%. Based on triaxial testing, the average cohesiveness value is 0.195 kg/cm², and the average internal shear angle is 31.345°.

Figure 11. N-SPT Drill Results and laboratory test results at STA 436+1/2

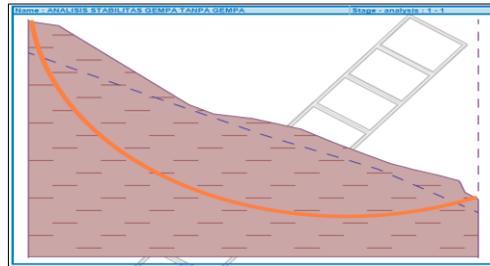
The analysis results using GEO5 for landslide-prone areas in existing conditions without earthquake loads at STA 436+1/2 show that the value of the safety factor (SF) obtained for the area is 1.08 with the Fellenius method meeting the safe conditions according to SNI 8460:2017.

Figure 13. Modeling results using GEO5 for existing conditions without earthquake loads at STA 436+1/2.

Slope stability verification (Fellenius / Petterson)	
Sum of active forces :	$F_a = 960.55 \text{ kN/m}$
Sum of passive forces :	$F_p = 1253.50 \text{ kN/m}$
Sliding moment :	$M_a = 18269.69 \text{ kNm/m}$
Resisting moment :	$M_p = 23841.66 \text{ kNm/m}$
Factor of safety =	$1.30 > 1.25$
Slope stability ACCEPTABLE

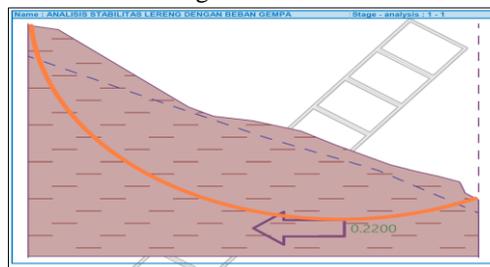
- Slope modeling in existing conditions with earthquake loads
 The analysis results using GEO5 for landslide-prone areas in existing conditions with earthquake loads at STA 436+1/2 show that the value of the safety factor (SF) obtained is 0.85 with the Fellenius method; it does not meet the safe conditions according to SNI 8460:2017.

Figure 15. Modeling results using GEO5 for existing conditions with earthquake loads at STA 436+1/2.

Slope stability verification (Fellenius / Petterson)	
Sum of active forces :	$F_a = 1401.57 \text{ kN/m}$
Sum of passive forces :	$F_p = 1187.96 \text{ kN/m}$
Sliding moment :	$M_a = 26013.05 \text{ kNm/m}$
Resisting moment :	$M_p = 22048.47 \text{ kNm/m}$
Factor of safety =	$0.85 < 1.00$
Slope stability NOT ACCEPTABLE

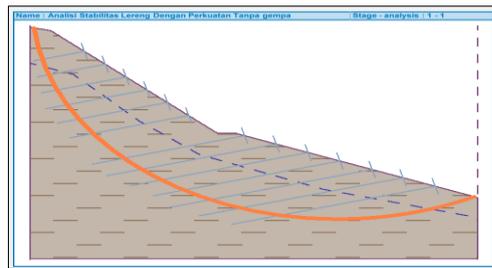
- Modeling of slope reinforcement without earthquake loads
 The results of the analysis of slope reinforcement using soil nailing on GEO5 for landslide-prone areas without earthquake loads at STA 436+1/2 show that the value of the safety factor (SF) obtained is 2.17 with the Bishop method so that it meets the safe conditions according to SNI 8460: 2017.

Figure 17. Slope reinforcement modeling results with soil nailing on GEO5 without earthquake loads at STA 436+1/2.

Slope stability verification (Bishop)	
Sum of active forces :	$F_a = 786.23 \text{ kN/m}$
Sum of passive forces :	$F_p = 1702.85 \text{ kN/m}$
Sliding moment :	$M_a = 13680.34 \text{ kNm/m}$
Resisting moment :	$M_p = 29629.52 \text{ kNm/m}$
Factor of safety = 2.17 > 1.25	
Slope stability ACCEPTABLE

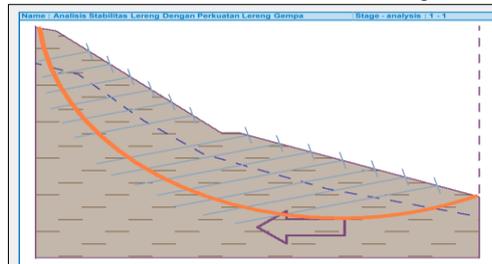
The results of the analysis of slope reinforcement using soil nailing on GEO5 for landslide-prone areas with earthquake loads at STA 436+1/2 show that the value of the safety factor (SF) obtained is 1.52 with the Bishop method so that it meets safe conditions according to SNI 8460:2017.

Figure 19. The results of soil nailing reinforcement modeling on slopes using GEO5 with earthquake loads at STA 436+1/2.

Slope stability verification (Bishop)	
Sum of active forces :	$F_a = 1066.41 \text{ kN/m}$
Sum of passive forces :	$F_p = 1622.59 \text{ kN/m}$
Sliding moment :	$M_a = 18555.48 \text{ kNm/m}$
Resisting moment :	$M_p = 28233.00 \text{ kNm/m}$
Factor of safety = 1.52 > 1.00	
Slope stability ACCEPTABLE

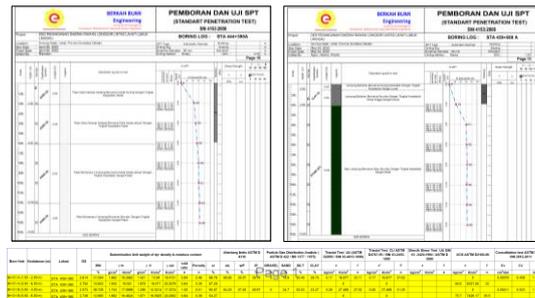
The N-SPT drilling test uses an automatic hammer with a borehole diameter of 89 mm. Drilling is carried out to a depth of 15 meters with a Ground Water Level (MAT) of 0.5 meters above the ground. Soil classification obtained fine sand at a depth of 0-6 meters and sand mixed with very dense clay at a depth of 6-15 meters. Hard soil is found at a depth of 8-15 meters with an average N-SPT value of 63.23. At a depth of up to 6 meters, the casing is installed for drilling and sampling for laboratory testing. UDS samples each drilling hole with varying depths between 1-6 meters. From laboratory testing, it is known that the average G_s value from the test results is 2.67, the water content (w) is 24,53% on average, the average dry density is 1.50 gr/cm³, the average void ratio (e) is 0.79, the average plasticity index is 32,87%. Based on triaxial testing, the average cohesiveness value is 0,22 kg/cm², and the average internal shear angle is 34,13°.

Figure 21. N-SPT Drill Results and laboratory test results at STA 444+350/450

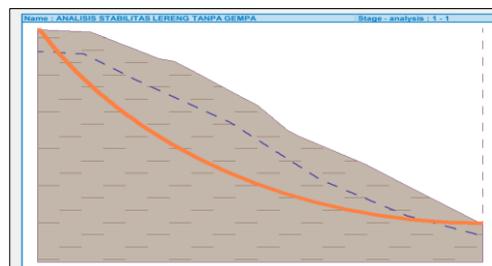
The analysis results using GEO5 for landslide-prone areas in existing conditions without earthquake loads at STA 436+1/2 show that the value of the safety factor (SF) obtained for the area is 1.30 with the Fellenius method meeting the safe conditions according to SNI 8460:2017.

Figure 23. Modeling results using GEO5 for existing conditions without earthquake loads at 444+350/450.

Slope stability verification (Bishop)	
Sum of active forces :	$F_a = 3181.12 \text{ kN/m}$
Sum of passive forces :	$F_p = 4139.31 \text{ kN/m}$
Sliding moment :	$M_a = 155047.79 \text{ kNm/m}$
Resisting moment :	$M_p = 201750.01 \text{ kNm/m}$
Factor of safety =	$1.30 > 1.25$
Slope stability ACCEPTABLE

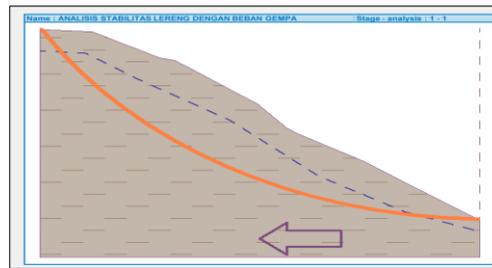
The analysis results using GEO5 for landslide-prone areas in existing conditions with earthquake loads at STA 436+1/2 show that the value of the safety factor (SF) obtained is 0.91 with the Fellenius method, so it does not meet the safe conditions according to SNI 8460:2017.

Figure 25. Modeling results using GEO5 for existing conditions with earthquake loads at STA 444+350/450.

Slope stability verification (Bishop)	
Sum of active forces :	$F_a = 3979.16 \text{ kN/m}$
Sum of passive forces :	$F_p = 3601.94 \text{ kN/m}$
Sliding moment :	$M_a = 206239.80 \text{ kNm/m}$
Resisting moment :	$M_p = 186688.72 \text{ kNm/m}$
Factor of safety =	$0.91 < 1.00$
Slope stability NOT ACCEPTABLE

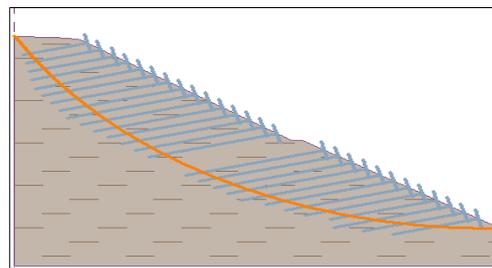
The results of the analysis of slope reinforcement using soil nailing on GEO5 for landslide-prone areas without earthquake loads at STA 444+350/450 show that the value of the safety factor (SF) obtained is 1,74 with the Bishop method so that it meets the safe conditions according to SNI 8460: 2017.

Figure 27. Slope reinforcement modeling results with soil nailing on GEO5 without earthquake loads at STA 444+350/450.

Slope stability verification (Bishop)	
Sum of active forces :	$F_a = 2978.04 \text{ kN/m}$
Sum of passive forces :	$F_p = 5176.63 \text{ kN/m}$
Sliding moment :	$M_a = 145149.50 \text{ kNm/m}$
Resisting moment :	$M_p = 252309.01 \text{ kNm/m}$
Factor of safety =	$1.74 > 1.25$
Slope stability ACCEPTABLE

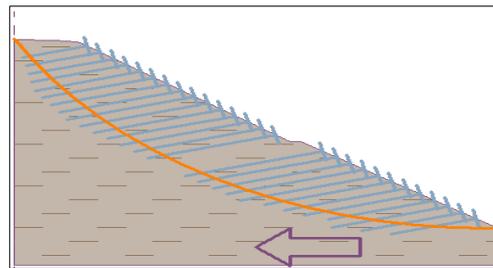
The results of the analysis of slope reinforcement using soil nailing on GEO5 for landslide-prone areas with earthquake loads at STA 444+350/450, the results show that the value of the safety factor (SF) obtained is 1.52 with the Bishop method so that it meets safe conditions according to SNI 8460:2017.

Figure 29. The results of soil nailing reinforcement modeling on slopes using GEO5 with earthquake loads at STA 444+350/450.

Slope stability verification (Bishop)	
Sum of active forces :	$F_a = 1066.41 \text{ kN/m}$
Sum of passive forces :	$F_p = 1622.59 \text{ kN/m}$
Sliding moment :	$M_a = 18555.48 \text{ kNm/m}$
Resisting moment :	$M_p = 28233.00 \text{ kNm/m}$
Factor of safety =	$1.52 > 1.00$
Slope stability ACCEPTABLE

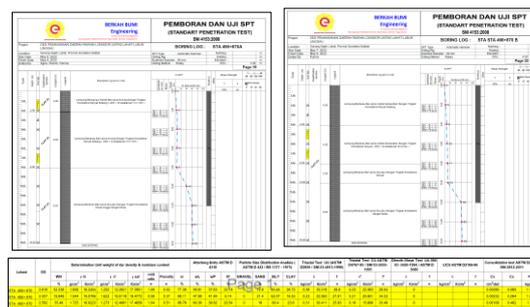
The N-SPT drilling test uses an automatic hammer with a borehole diameter of 89 mm. Drilling was carried out to a depth of 15 meters with a Ground Water Level (GWL) of 2.5 meters above the ground. Soil classification obtained clay (clay) at 0-16 m. Hard soil is found at a depth of 16 meters with an average N-SPT value of 63 cm. At a depth of up to 12 meters, the casing is installed for drilling and sampling for laboratory testing. UDS sampled each drilling hole with varying depths between 1-1.5 m and 7-7.5 m. From laboratory testing, it is known that the average G_s value from the test results is 2.6, the water content (w) is 30.50% on average, the average dry density is 1.37 gr/cm³, and the void ratio (e) is average. The average is 0.91; the average plasticity index is 17.62%. Based on triaxial testing, the average cohesiveness value is 0.2 kg/cm², and the average internal shear angle is 31.77°.

Figure 31. N-SPT Drill Results and laboratory test results at STA 490+870.

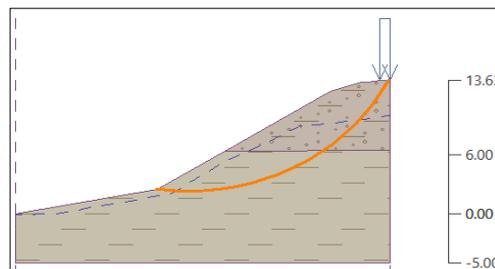
The analysis results using GEO5 for landslide-prone areas in existing conditions without earthquake loads at STA 490+870 show that the value of the safety factor (SF) obtained for the area is 1.75, with the Bishop method meeting the safe conditions according to SNI 8460:2017.

Figure 33. Modeling results using GEO5 for existing conditions without earthquake loads at 490+870.

Slope stability verification (Bishop)	
Sum of active forces :	$F_a = 700.13 \text{ kN/m}$
Sum of passive forces :	$F_p = 1224.10 \text{ kN/m}$
Sliding moment :	$M_a = 14086.68 \text{ kNm/m}$
Resisting moment :	$M_p = 24628.94 \text{ kNm/m}$
Factor of safety =	$1.75 > 1.25$
Slope stability ACCEPTABLE

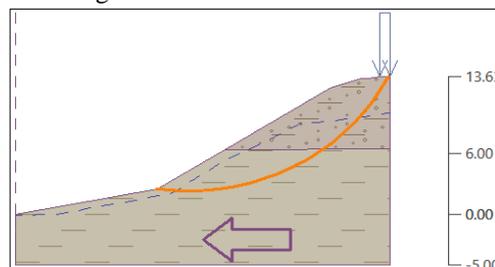
The analysis results using GEO5 for landslide-prone areas in existing conditions with earthquake loads at STA 490+870 show that the value of the safety factor (SF) obtained is 1.18 with the Bishop method, so it meets safe conditions according to SNI 8460:2017.

Figure 35. Modeling results using GEO5 for existing conditions with earthquake loads at STA 490+870.

Slope stability verification (Bishop)	
Sum of active forces :	$F_a = 962.52 \text{ kN/m}$
Sum of passive forces :	$F_p = 1139.25 \text{ kN/m}$
Sliding moment :	$M_a = 19365.85 \text{ kNm/m}$
Resisting moment :	$M_p = 22921.76 \text{ kNm/m}$
Factor of safety =	$1.18 > 1.00$
Slope stability ACCEPTABLE
